## ОКОНЧАТЕЛЕН ДОКЛАД

разследване на авиационно произшествие, реализирано на 07.06.2014 г. със самолет PIPER PA-28-161, рег. знаци YU-DDB, при извършване на полет за разпръскване на ваксина в района на с. Градище, област Шумен

investigation of an aviation incident, occurred on June 07, 2014 with PIPER PA-28-161, registration marks YU-DDB, while in a vaccine dispersal flight in the vicinity of Gradishte village, Shumen district

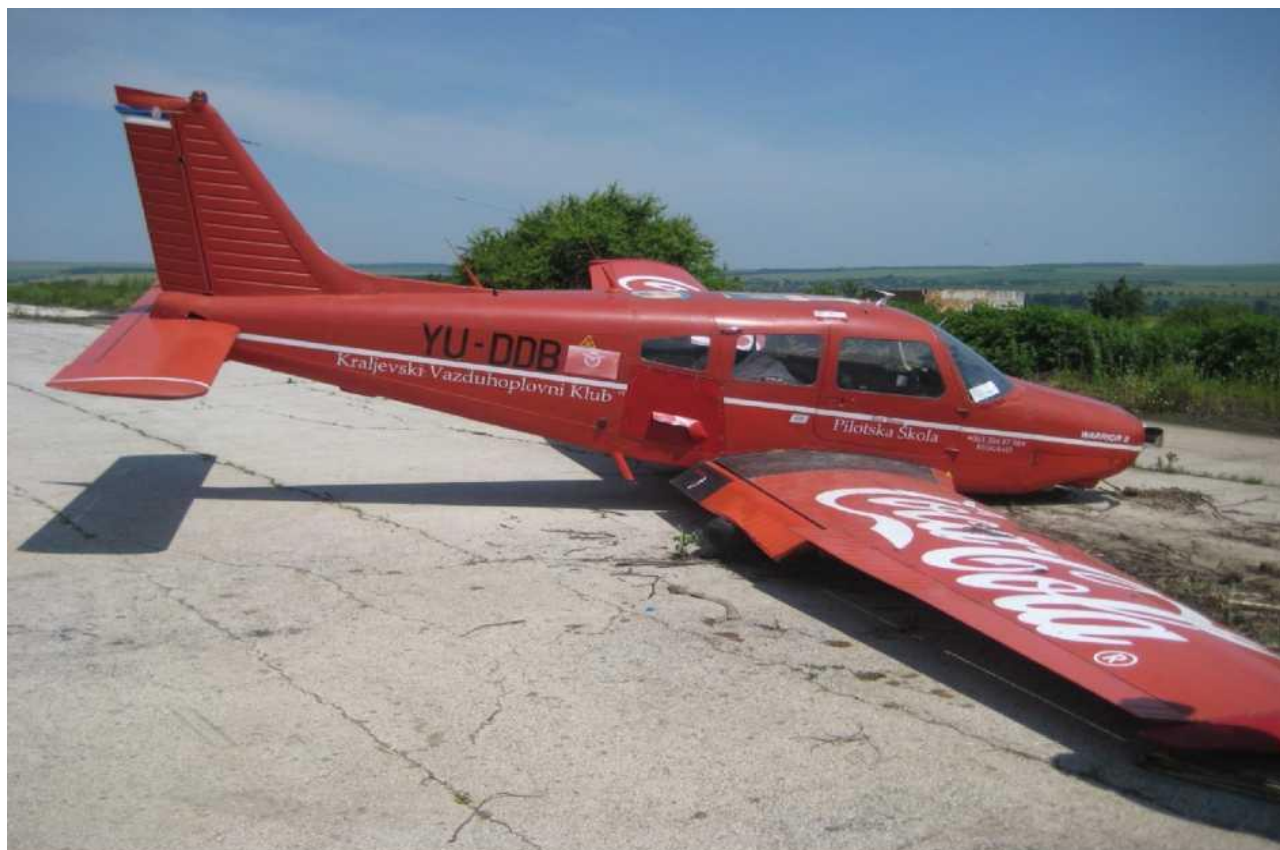
Фиг. 1

Общият изглед на самолета на мястото на произшествието е показан на фиг. 1 от Приложение 1.

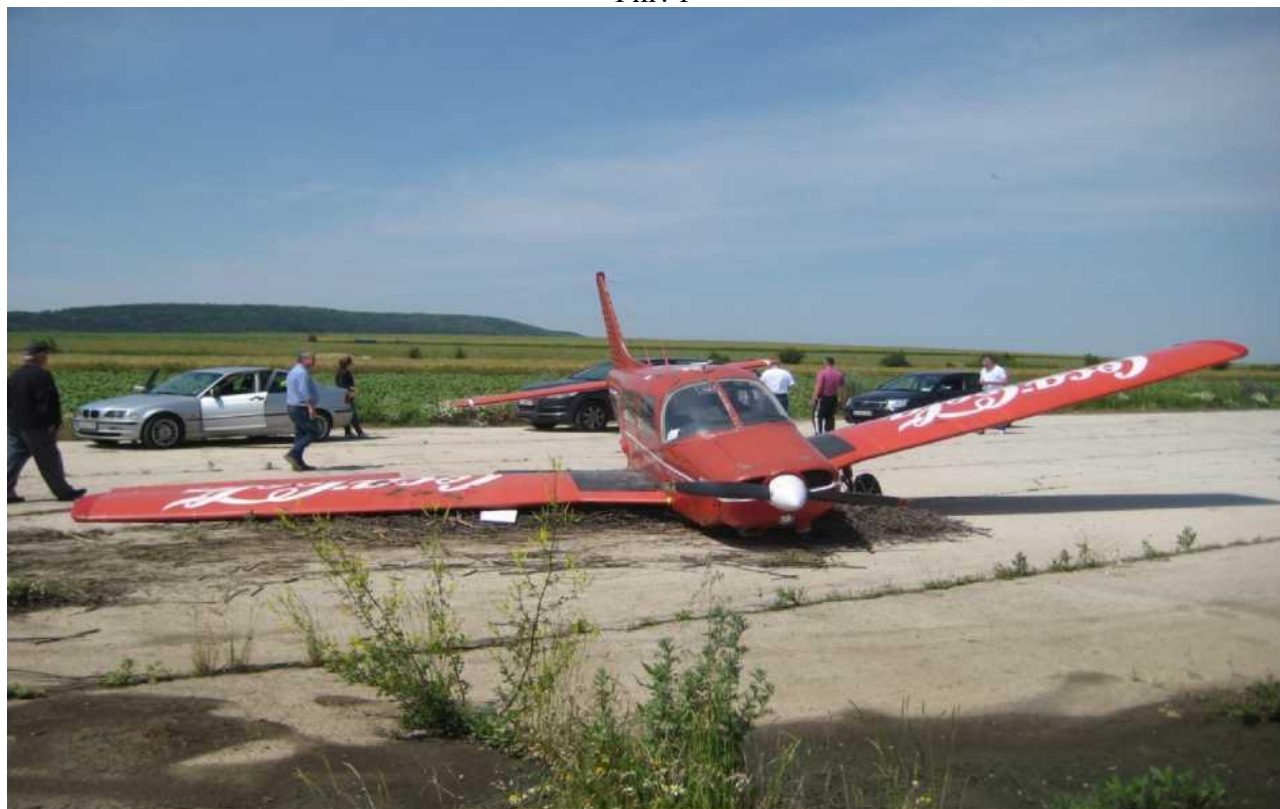
Фиг. 2

Снимки на ВС на мястото на окончателното му спиране са показани на фиг. 2 и фиг. 3 на Приложение 1.

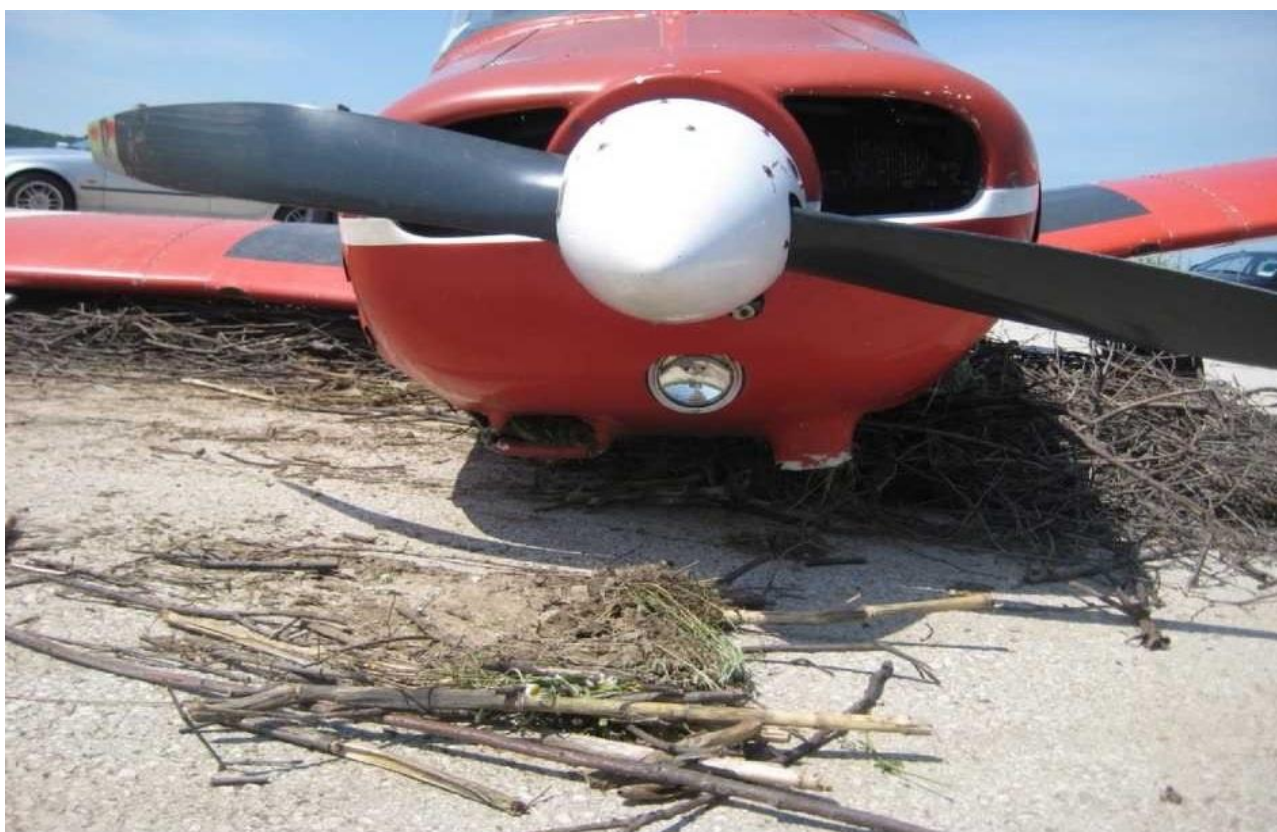
Фиг. 4

-на двулопатното витло има наличие на огъване назад на едната лопата с около 32 cm, както и следи от драскотини по предната ѝ повърхност. (фиг. 4 от Приложение 1). Втората лопата и обтекателят на витлото бяха без деформации и драскотини. При завъртане на ръка лопатите позволяват свободно движение на витлото в рамките на 200;

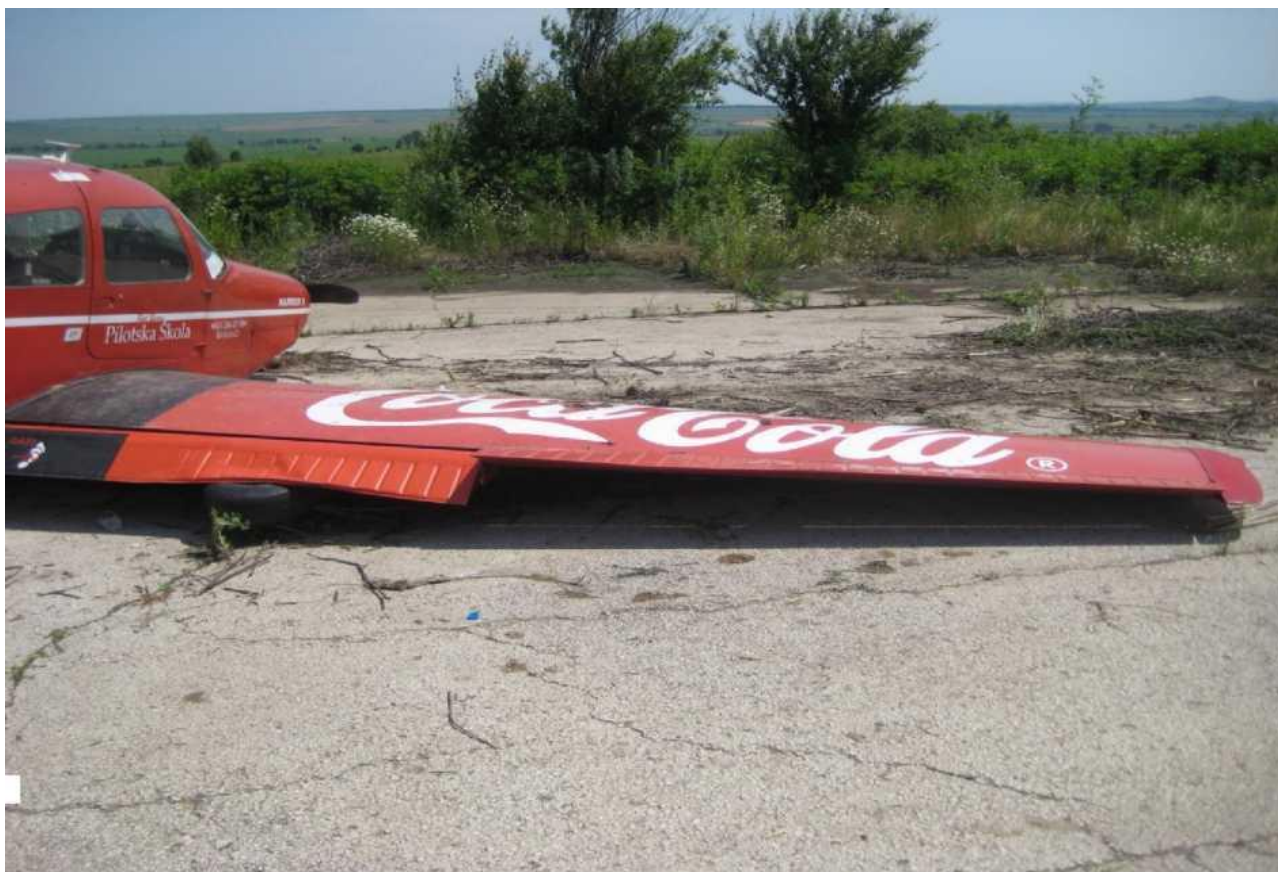
Фиг. 5

-дясната задкрилка е опряла върху гумата на десния колесник и е деформирана (фиг. 5, Приложение 1);

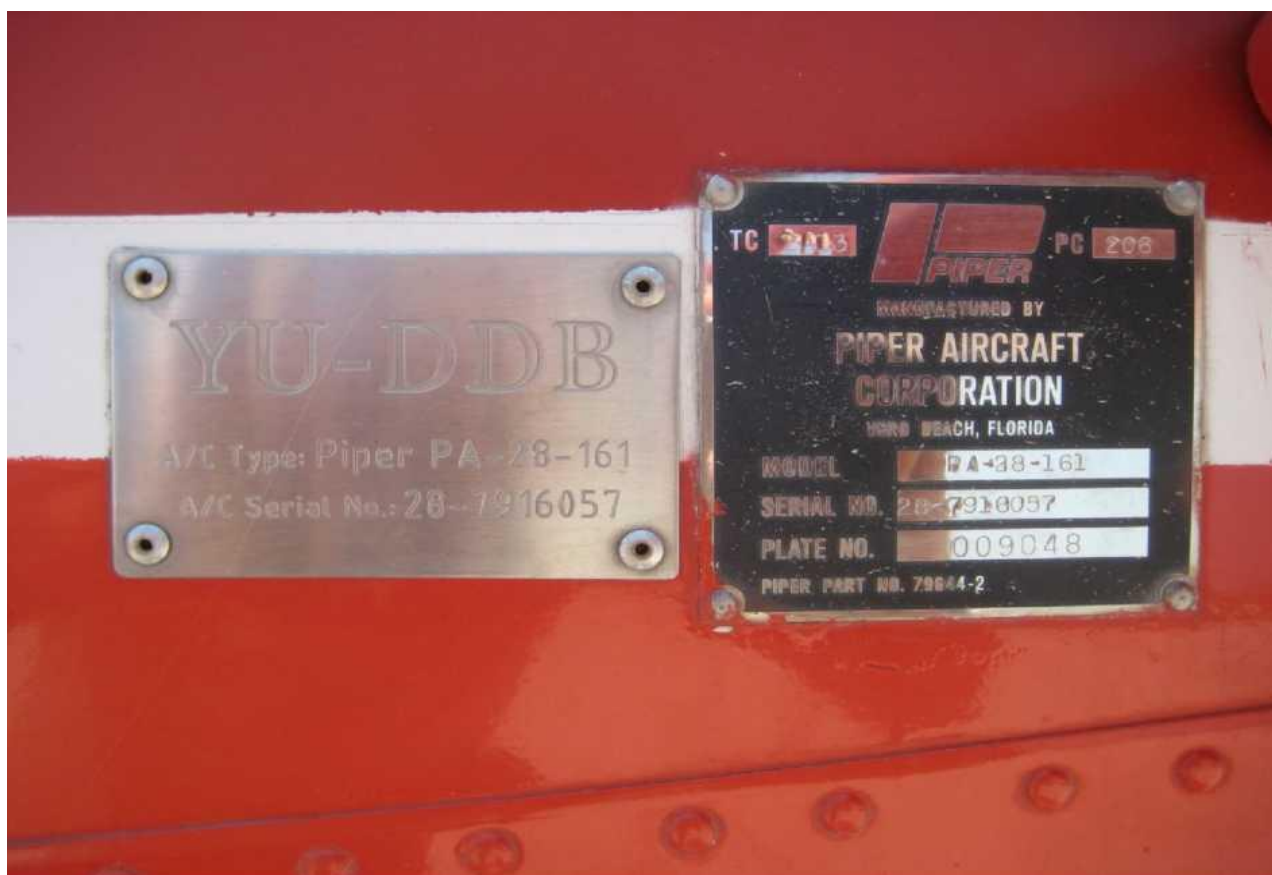
Фиг. 9

- aircraft identification plates with its registration markings YU-DDB, type-PA-28-161, and serial No 28-7916057 were found on the left side of the aircraft (Fig. 9, Appendix 1);

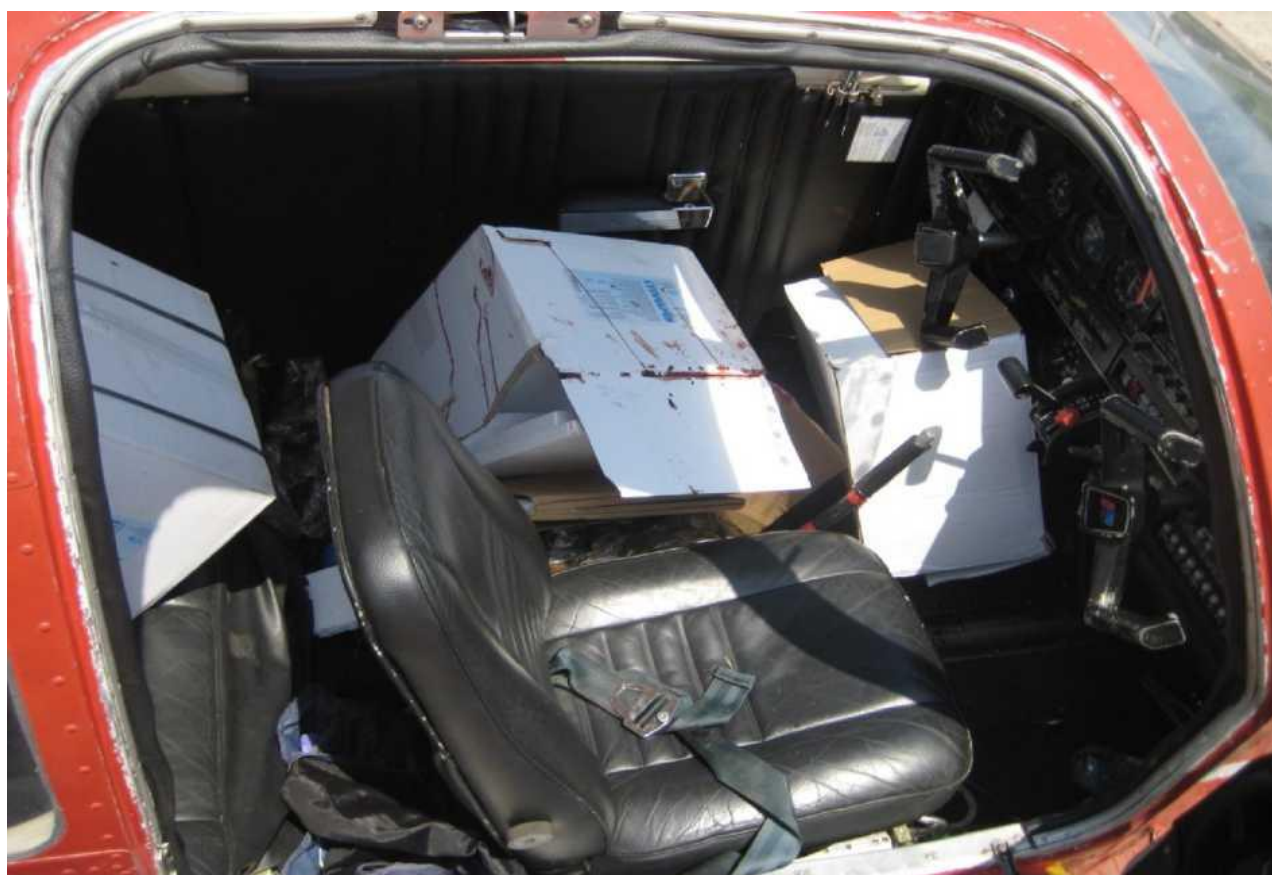
Фиг. 10

- the cabin of the airplane is equipped with one front seat to the right, equipped with a seat belt (Fig. 10, Appendix 1);
- the front left seat is missing;
