Investigation Report

Type of Occurrence:	Accident
Date:	28 January 2017
Location:	Eschbronn - Mariazell
Aircraft:	Airplane
Manufacturer / Model:	F.A. UTVA, Pancevo / UTVA 66
Injuries to Persons:	Pilot severely injured
Damage:	Aircraft destroyed
Other Damage:	Crop damage
Information Source:	Investigation by BFU external experts for field investigation
State File Number:	BFU 17-0096-CX

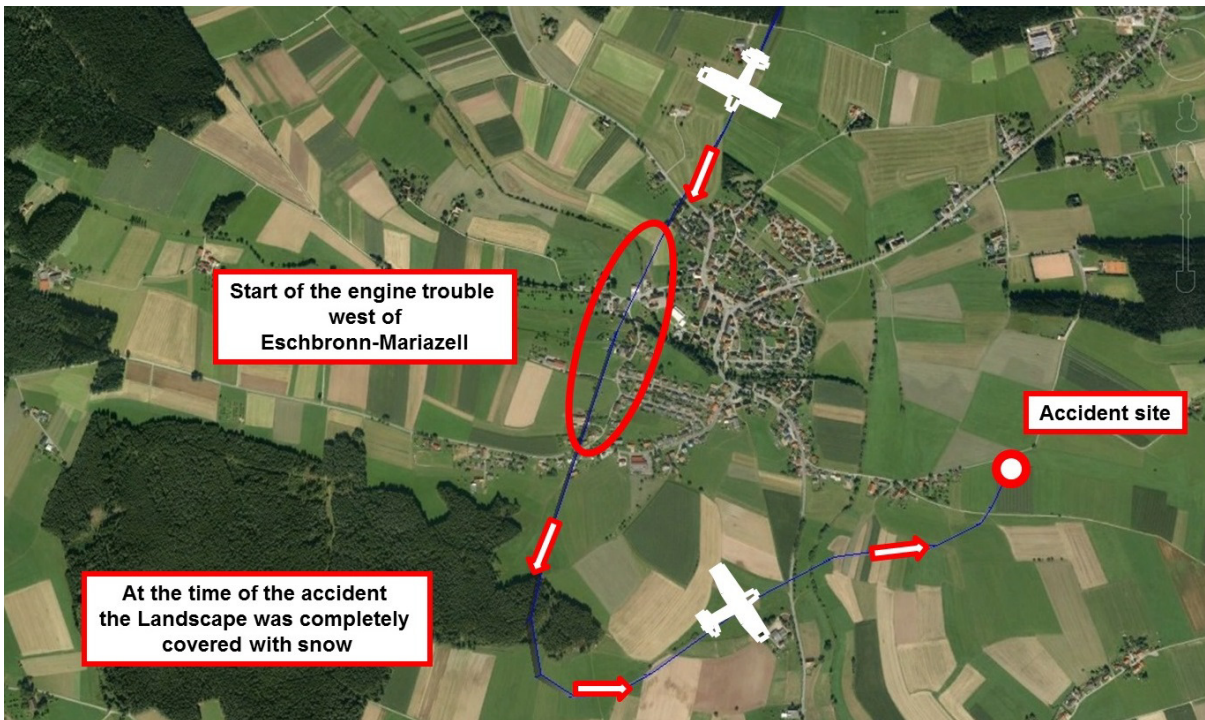
Flight path and accident site

South-west of the control zone Stuttgart the pilot noticed that the fuel level was very low and shortly afterwards the engine began to misfire.

At the time of the engine failure he was west of Eschbronn-Mariazell flying south at about 1,000 ft AMSL, approximately 30 km from the destination.

After the engine had failed the pilot decided at about 1615 hrs to attempt an emergency landing east of Eschbronn-Mariazell at an ascending, open space covered in snow.

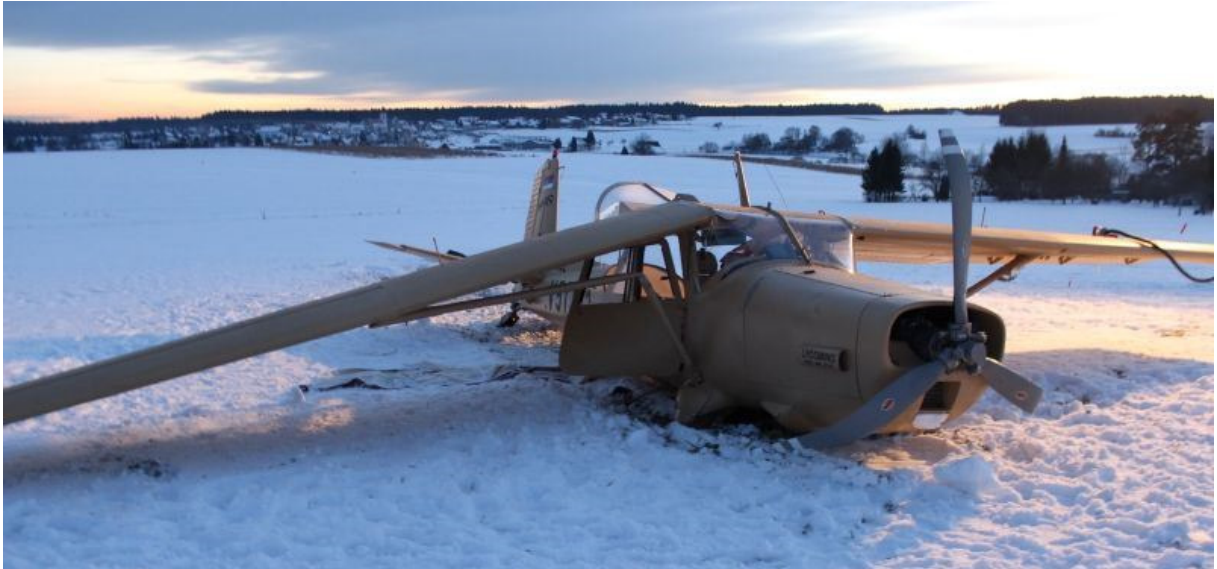
Accident site

The airplane was found on a meadow ascending from south to north and covered in snow. The fuselage pointed toward 360°.

Elevation was 720 m AMSL and the snow was approximately 15 to 20 cm deep.

Approximately 100 m north of the wreckage a street running west to east was located.

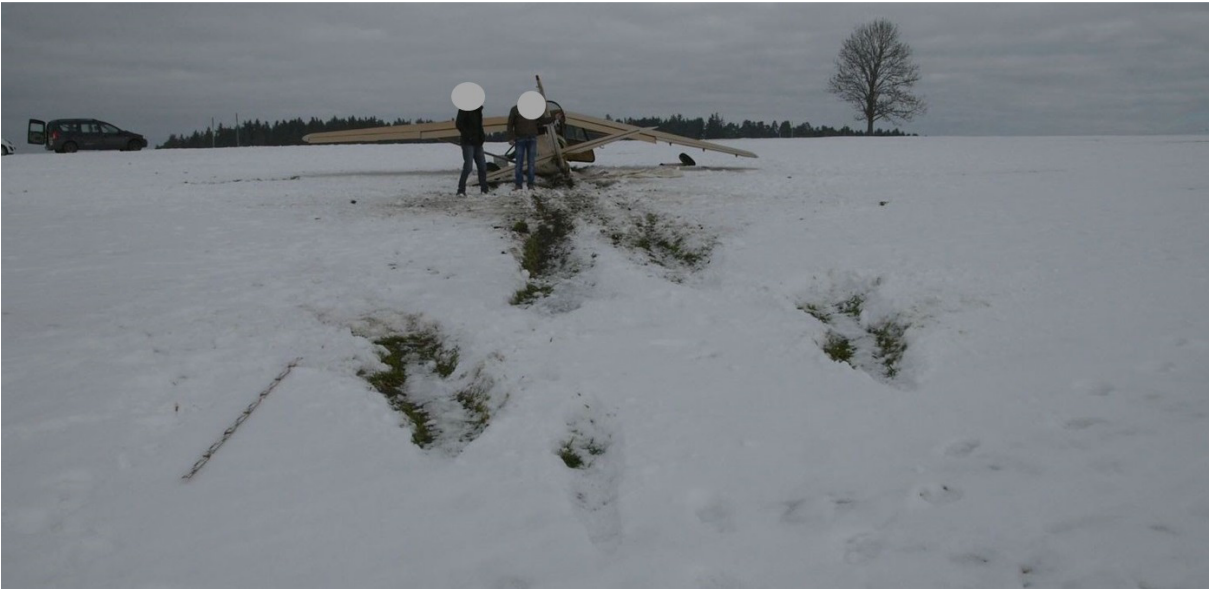
Accident site and impact traces

Impact and sliding traces of 16 m length were found in the snow south of the wreckage.

The wreckage of the UTVA was complete. The tail was still connected with all control cables and rods but had been torn off to the left. The tail section had not been damaged and remained connected to the tail.

Visually the left wing was intact, the right bent, and the right strut compressed. The flaps were found in approximately position 10° (flaps and lever position).

The propeller turned freely and the blades were bent backwards.

The fuselage was compressed, the left cockpit door dented. The right door was found open and could no longer be closed. The main landing gear leg was found next to the wreckage.
