FINAL REPORT

the investigation to a serious incident occurred on September 17, 2017 with involved a MXP140, registration marks YU-A019, at landing at Slivnitsa airfield.

2018

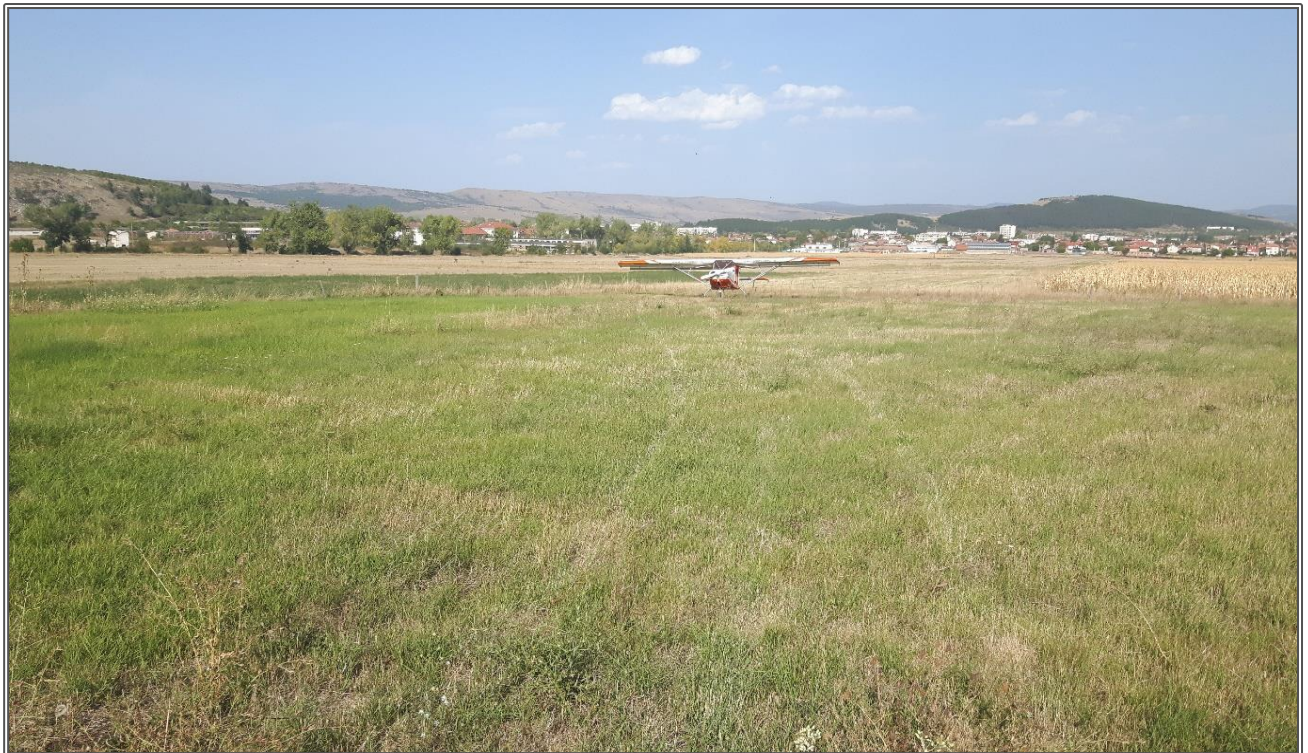
Fig. 1.

In the pictures in Fig. 1 and 2 of Appendix 1, the airplane is shown at its final position, turned 180°. Breaking tracks of a 39 m length ending at 49 m from the end of RWY 08 have been found during the asphalt coating inspection. At the end of the stopping track, it was found a trace of a working fluid spillage (possibly braking fluid) of 5 m length. On the airplane's trajectory, 5 m before the end of RWY 08 there is a second trace of working fluid spilling with a length of 5 m as well.

The peripheral fence of airfield was in a condition that makes it difficult to carry out its main function of preventing intrusion into the territory of the airfield. It is shown in Fig. 1, 5, 6, 7 & 16 of Appendix 1.

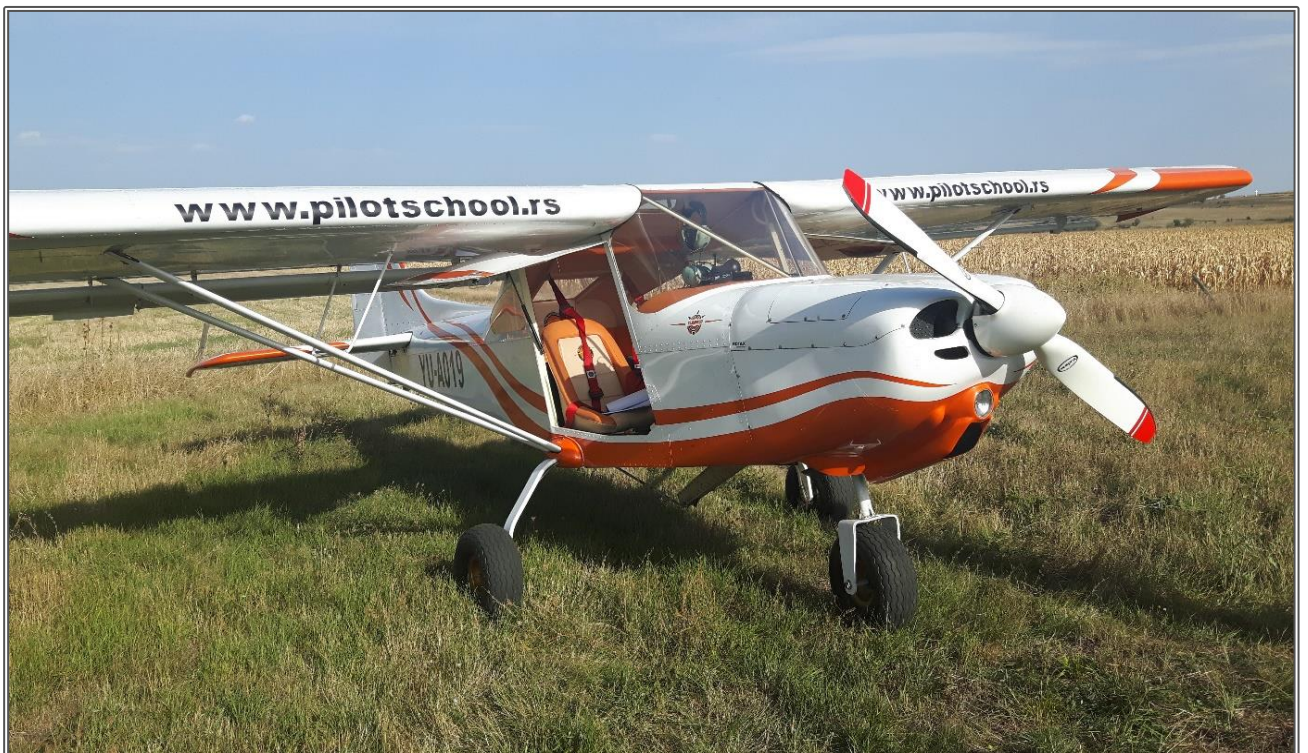
Fig. 2.

- Damaged leading edge of the propeller periphery part, as about 2 cm of one of the two blades were broken off (Fig. 3, Appendix 1);
- Bruises and warping on the right-hand side of the engine cowling (Fig. 2, Appendix 1);
- Damage to the lacquer coating and scratches on the upper bonnet of the engine (Figures 3 and 5 of Appendix 1).
- Deformed wheel frame of the nose landing gear; (Fig. 12 of Appendix 1).
- Deformation in the controlling fork of the nasal wheel.
- Scratches and cracks on the windscreen of the cockpit (Fig. 4 and 5 of Appendix 1).
- Leakage of brake fluid from the brake packing of the right-hand main gear (Fig. 14 and 15 of Appendix 1).
- Deformations of the left-hand wing bracing strut; (Fig. 6 of Appendix 1);
- Bruises on leading edge of leading edge slat of the left-hand half-wing; (Fig. 4 and 7 of Appendix 1).

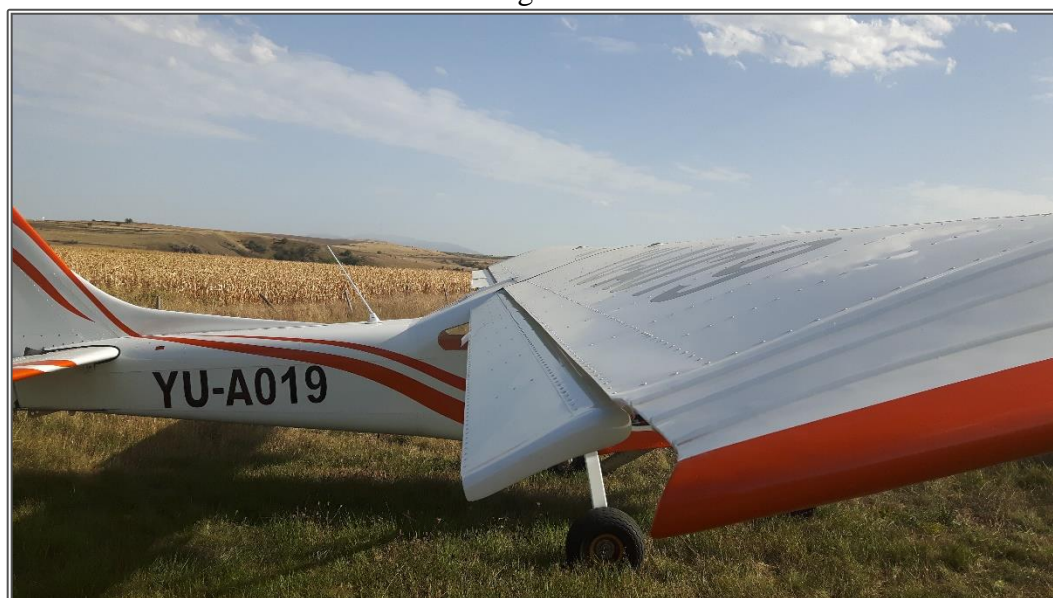
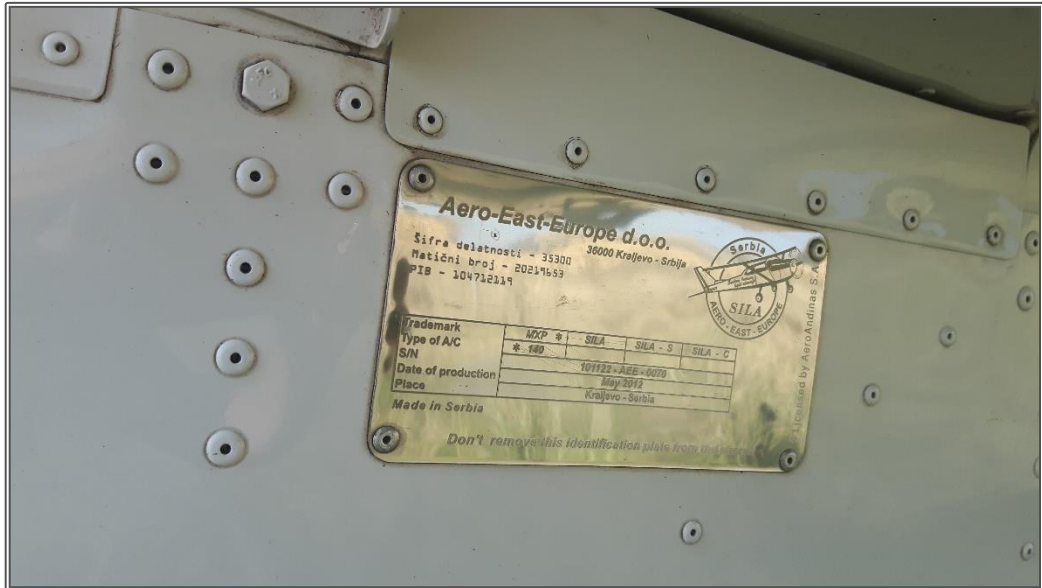
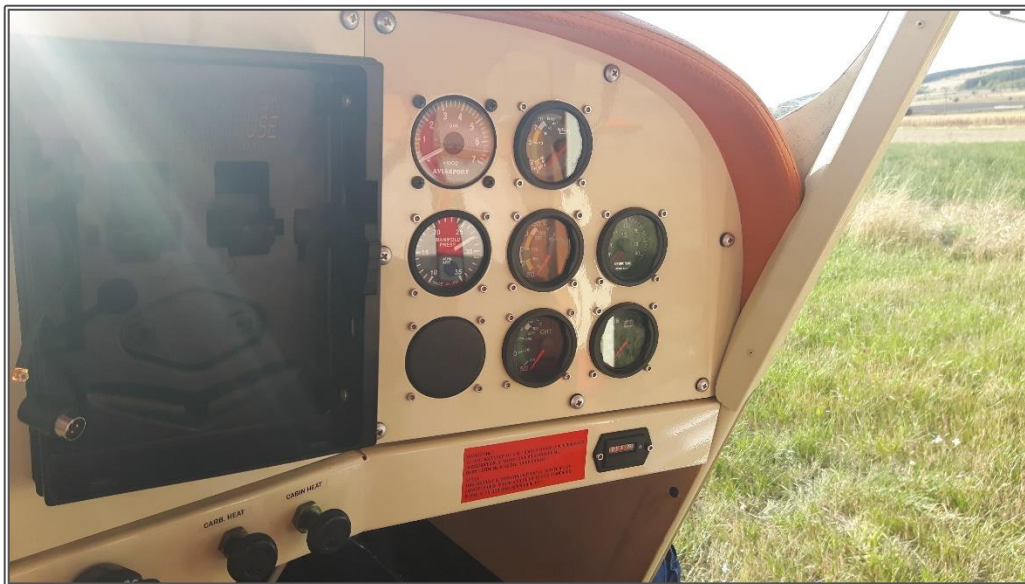
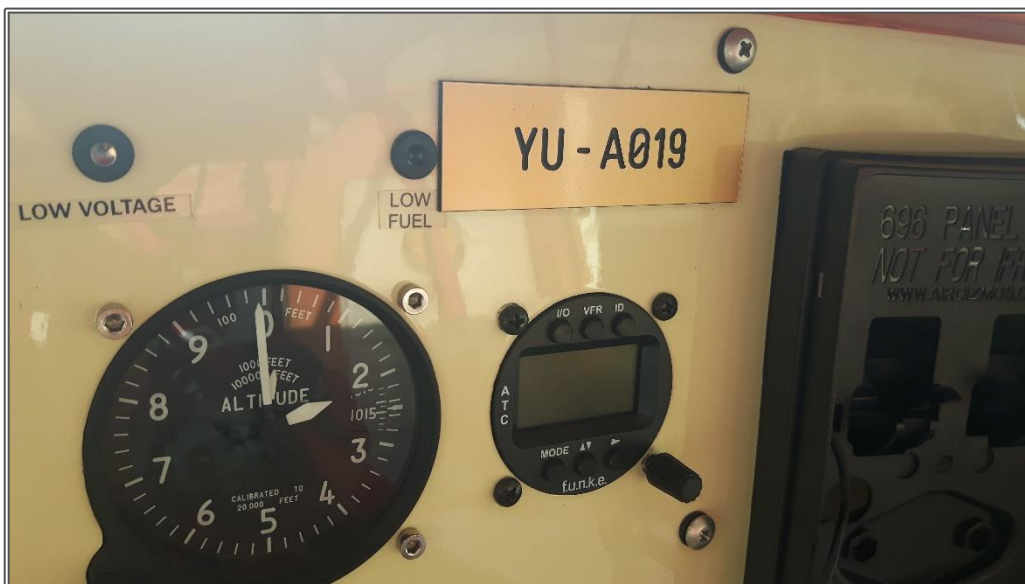
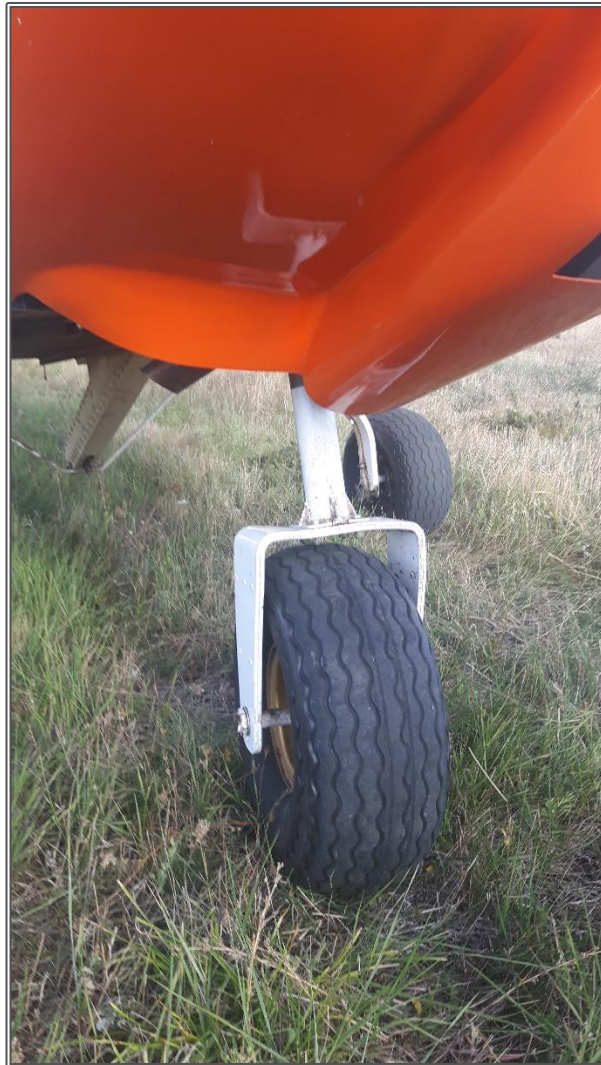
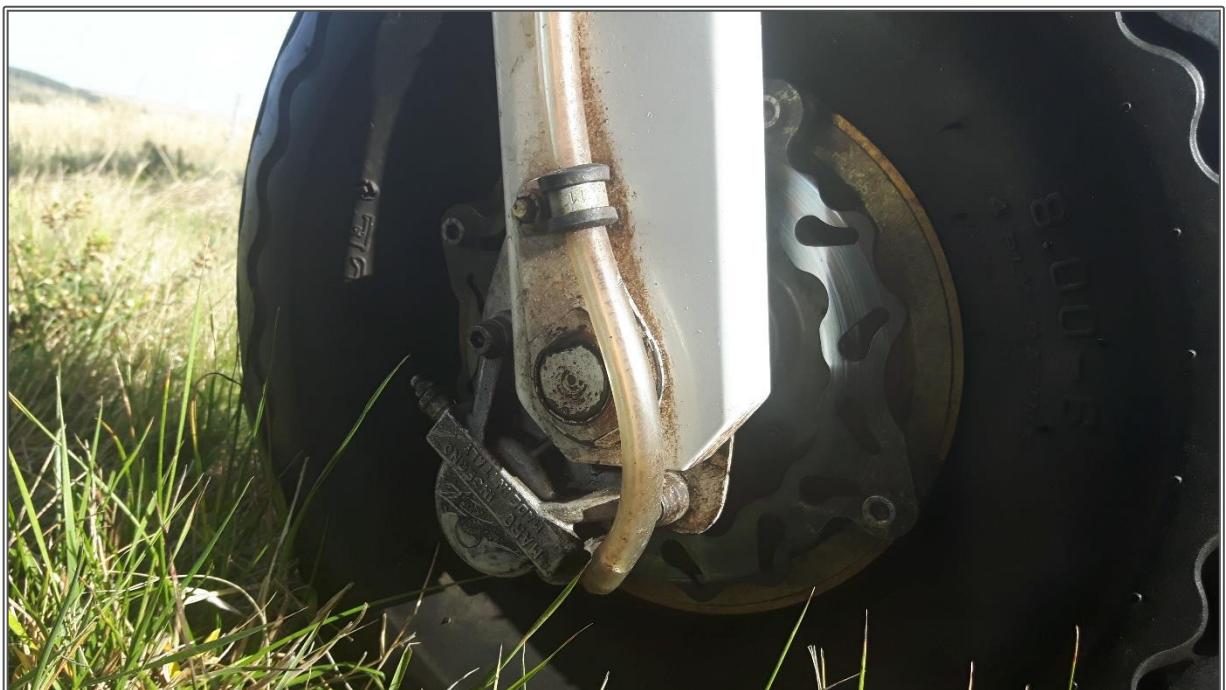
The inspection conducted by the safety investigation commission revealed that the aircraft had suffered minor damages as shown in Figures 2 through 15 in Appendix 1. These damages include:

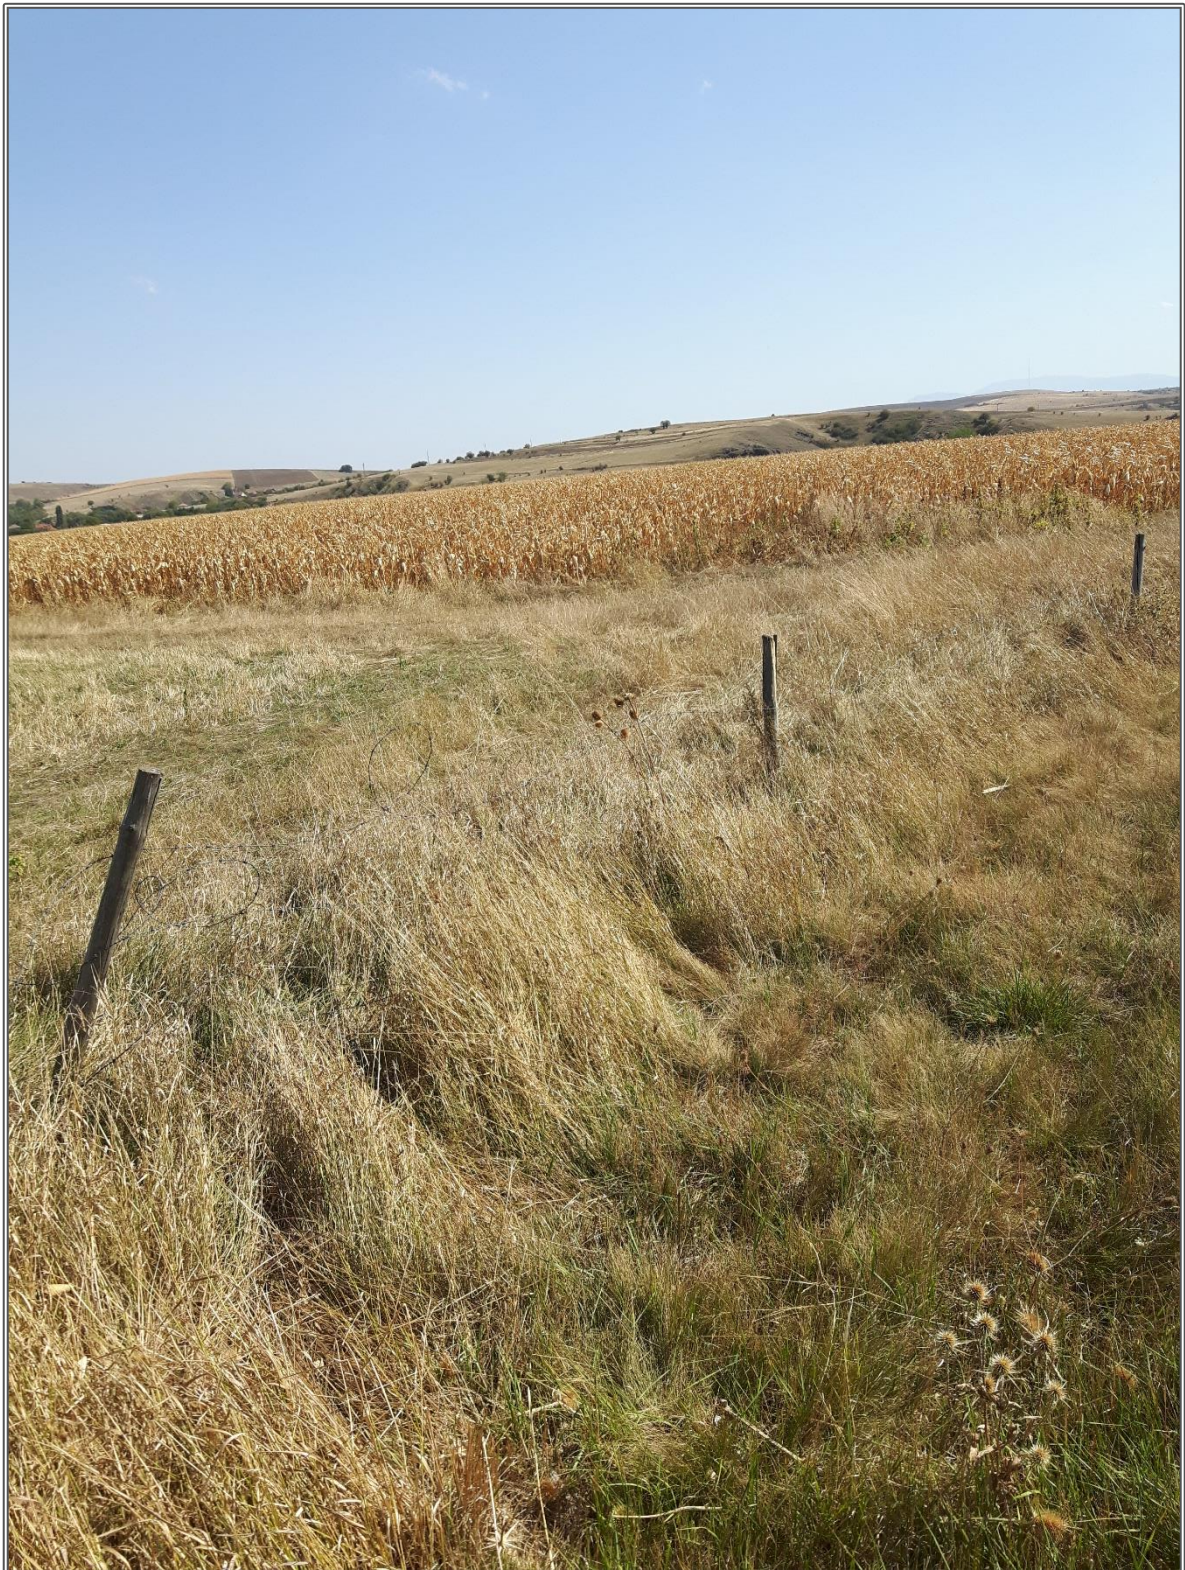
Fig. 16.

The end of RWY08 is located 60 m from the perimeter fence of the flight site. Fig. 16 shows a photo of the fence at the airplane stop.
