FINAL REPORT

of civil aviation safety investigation

PIPER PA-28-161

YU-DDB

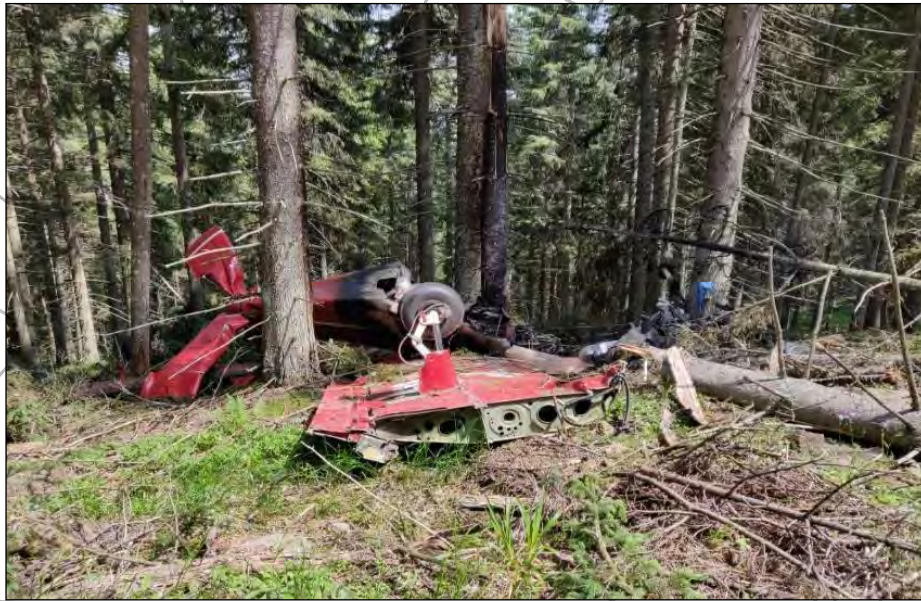
Fig. 1 Burned wreck

After the ground impact, the aircraft caught fire and burned almost completely.

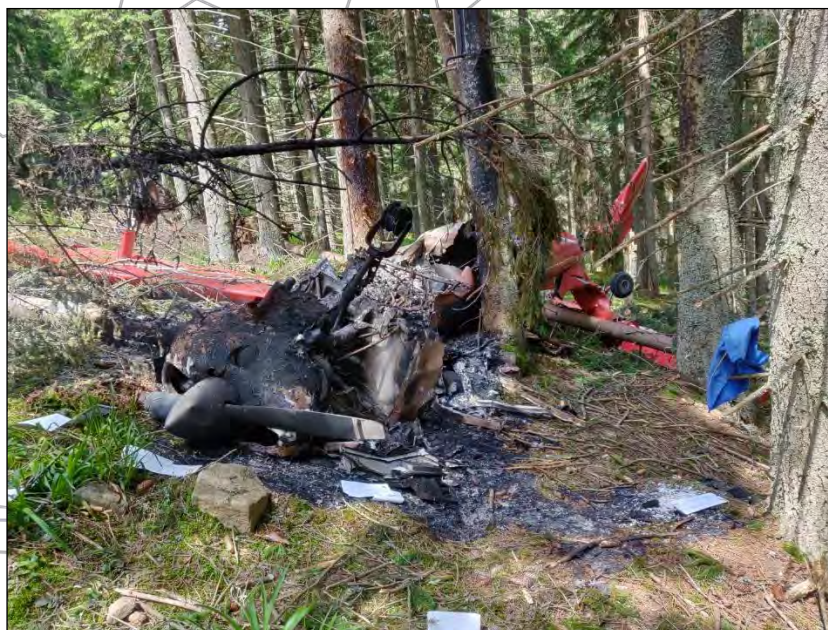
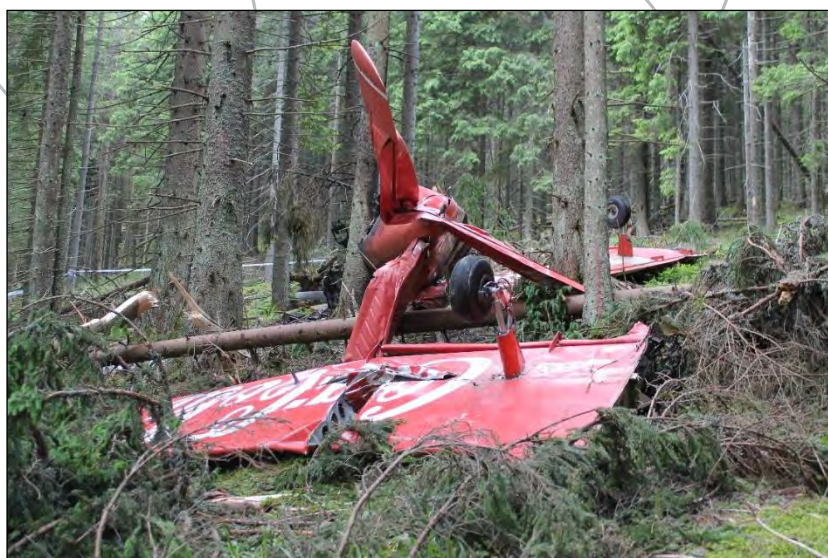
Fig. 3 – Wreck after impact and fire

After hitting the fir trees and the post-impact fire, the aircraft was almost completely destroyed.

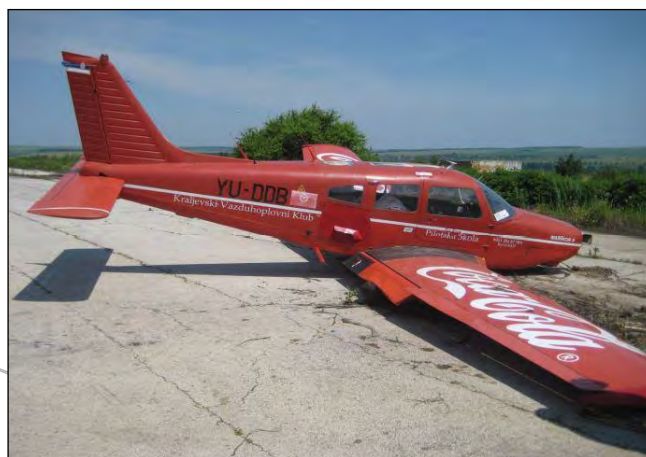
Fig. 4 – Photo taken from the Final Report of the Bulgarian Investigation Authority

The aircraft touched down the ground before the runway threshold and it hit the runway concreted threshold. The vaccine bait scattering device operator was seriously injured. The aircraft pilot-in-command was not injured, and the aircraft suffered significant damage.

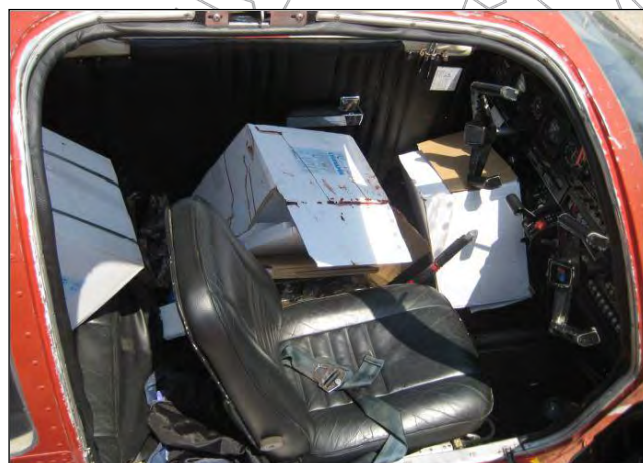
Fig. 5 – Photo with the aircraft cockpit taken from the Final Report of the Bulgarian Investigation Authority

From the photos attached in the report elaborated by the Bulgarian Investigation Authority it can be noticed that the right pilot seat was installed, but the left pilot seat was removed:

The modification project was approved at 25.08.2014 (after the accident occurrence in Bulgaria). This requires changing the orientation of the right seat and does not refer to removing one of the pilot seats.

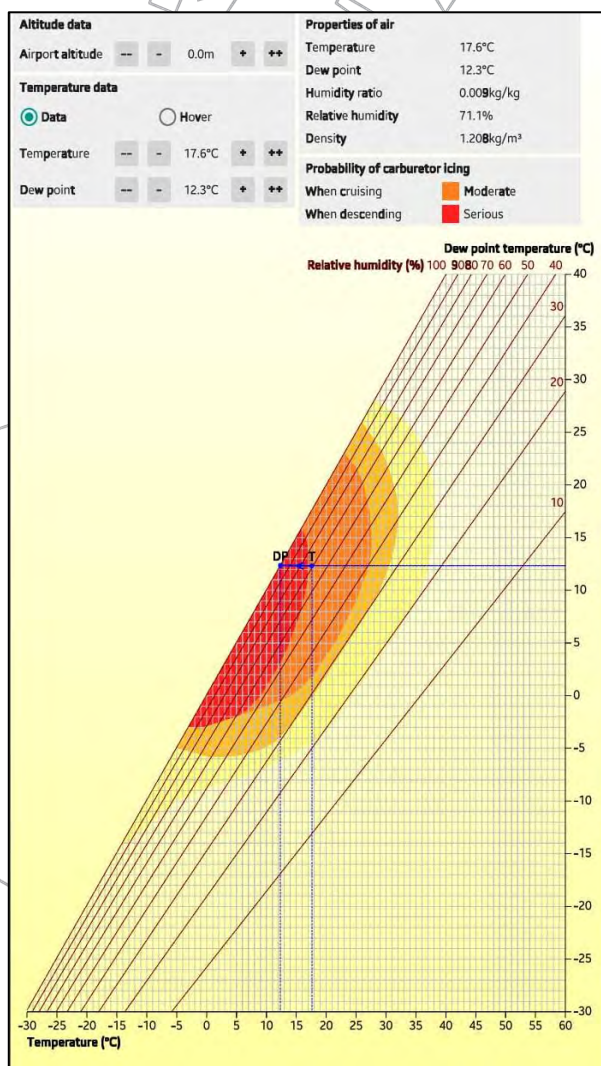
Fig. 6 – Carburettor icing probability nomogram

According to the carburettor icing probability nomogram (Fig. 10), it can be noticed that at the time of the accident, for the descent flight, the carburettor icing probability was serious, and for the cruise flight it was moderate.

The probable cause of the accident occurrence was the appearance of the carburettor icing phenomenon, which led to the engine power loss, under the conditions of a descent flight over a forested mountain area.

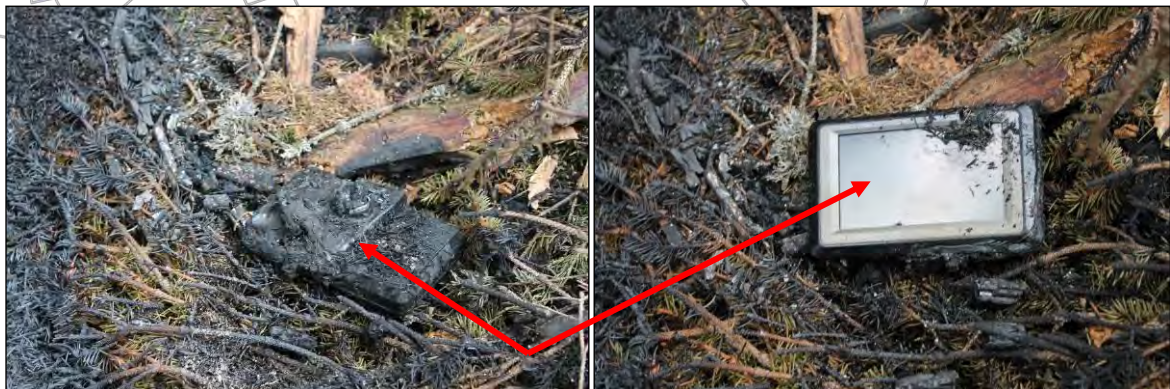
Fig. 9 – GPS - Garmin Aera 500 device

Following the fire started after the impact, this device was partially damaged.

The GPS device was inspected and disassembled to check the status of the circuit board and the internal memory chip. After verification it was found that the circuit board was not affected by fire.

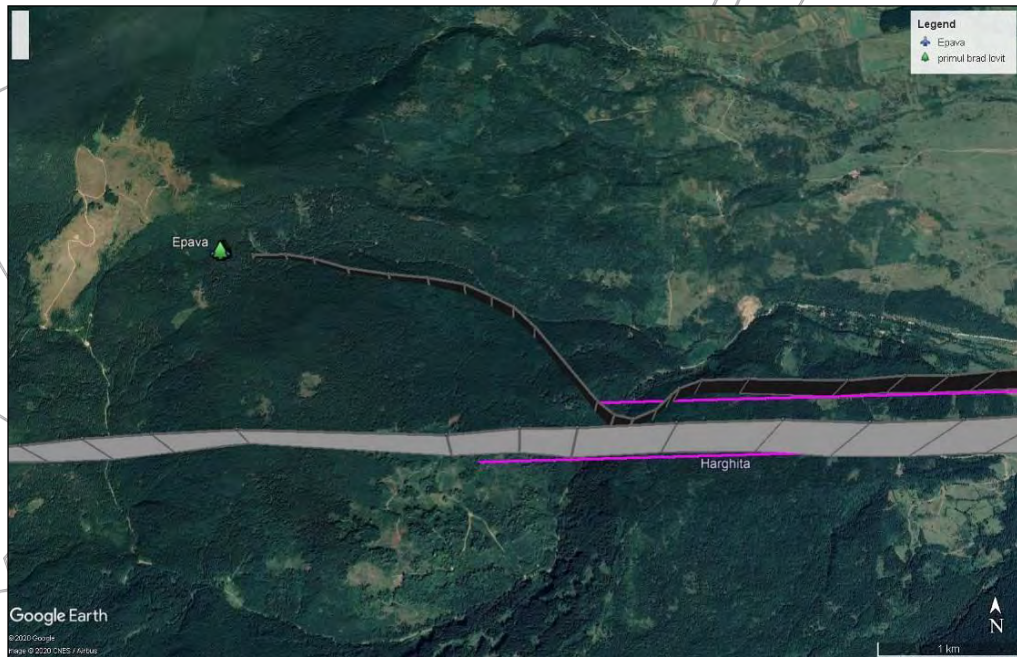
Fig. 10 – Aircraft final trajectory and the i

The first impact with the fir trees was at a distance of 15 m from the aircraft final position. The investigation commission identified a number of nine fir trees hit by the aircraft.

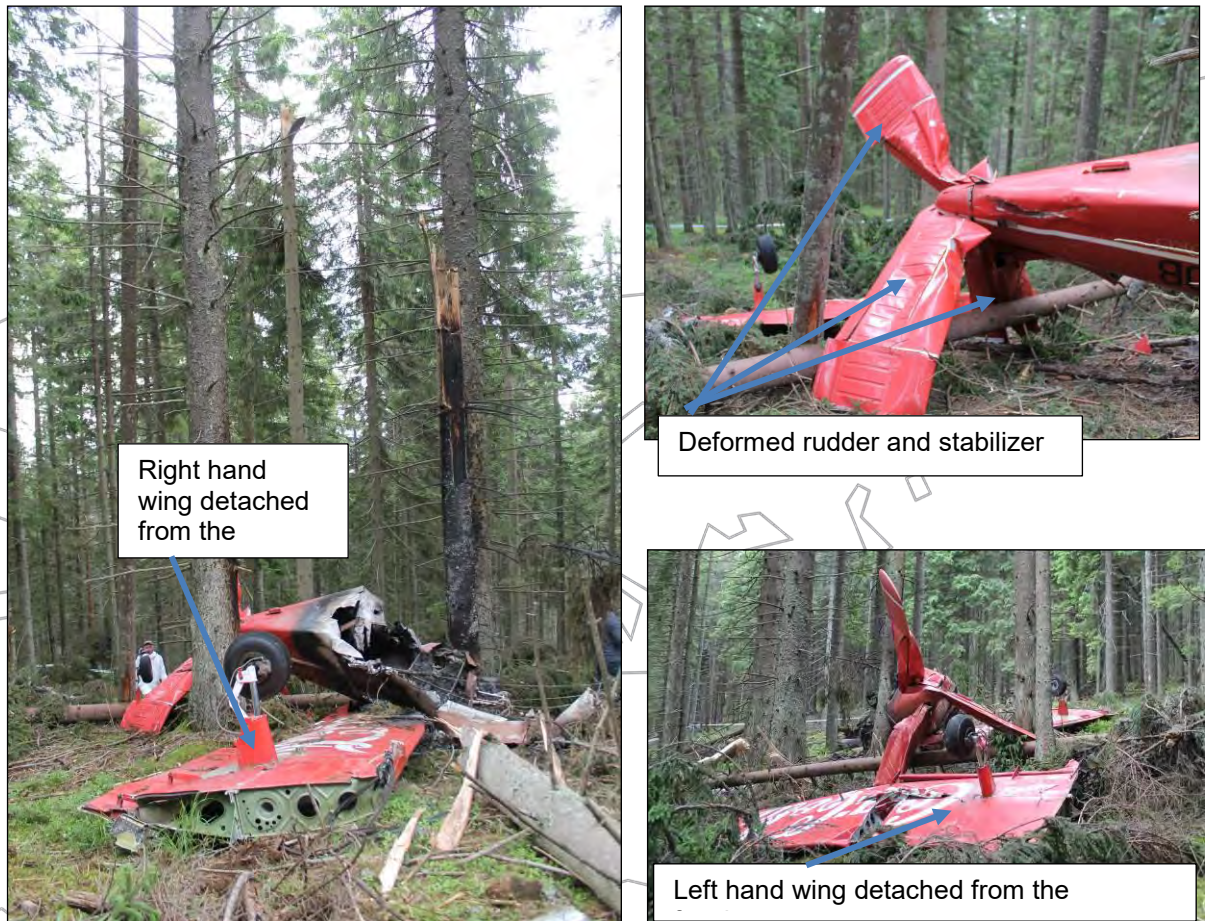
Fig. 11 – Deformations suffered by the aircraft upon impact with the firs/ground

The right and left half-plane suffered severe hits, detaching from the fuselage. The horizontal stabiliser and the steering presented severe deformations after contact with the firs.

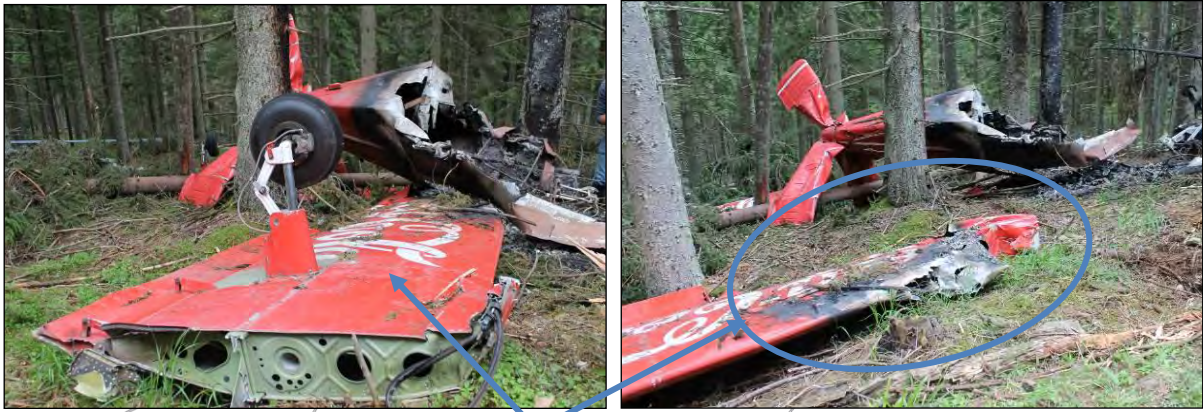
Fig. 12 – Left half-plane caught under the burned fuselage

The aircraft fuselage burned almost completely. The left half-plane was caught under the aircraft fuselage and burned partially. The right half-plane, detached from the fuselage was not affected by fire.

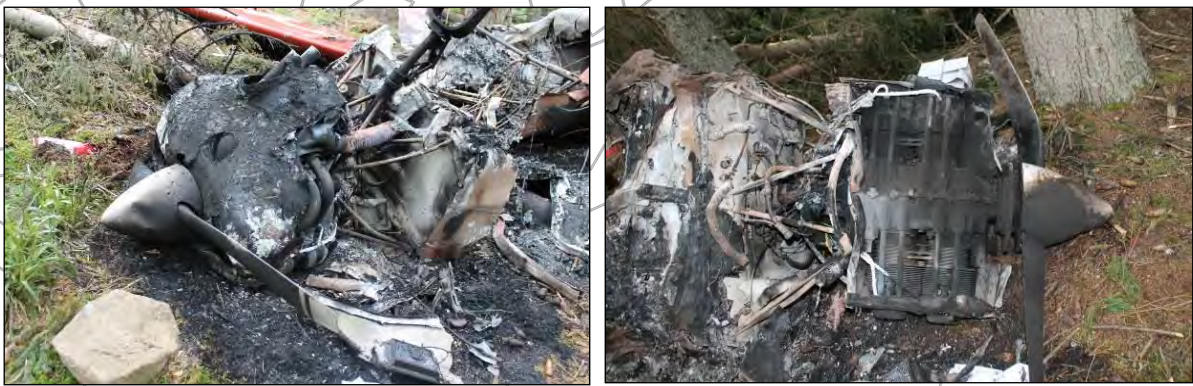
Fig. 13 – Engine Lycoming O-320-D3G model

The engine compartment burned completely, the aircraft engine being seriously affected by the fire.

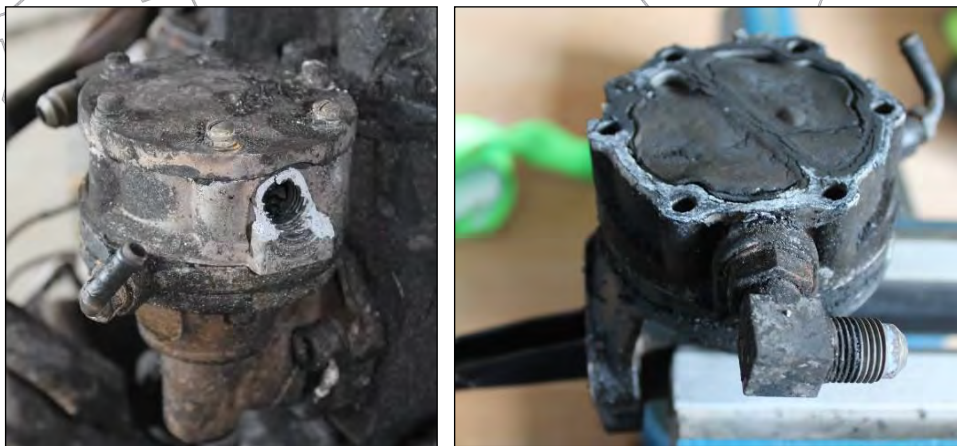
Fig. 14 – Mechanical fuel supply pump

The two aircraft fuel pumps were seriously affected by the post-impact fire, so that their functional condition could not be determined.

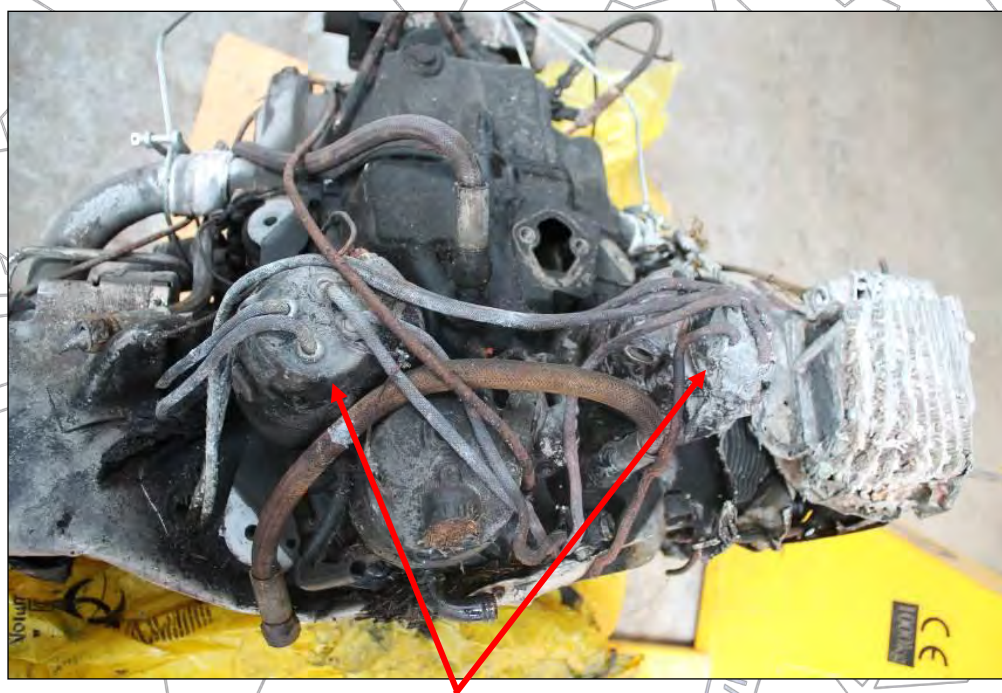
Fig. 16 – Magnetos affected by the fire

The magnetos were seriously affected by the fire, the cases being deformed, and the interior components melted.

In this case also, due to the post-impact fire, which seriously affected the two magnetos, the investigation commission did not manage to determine their operating condition.

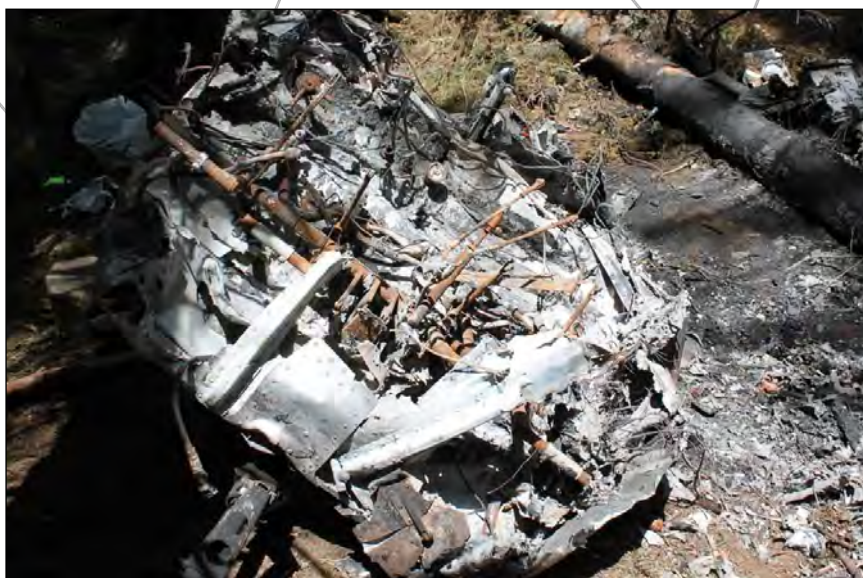
Fig. 19 – Instrument panel

The instrument panel was completely destroyed, as well as the engine fuel supply selector tap.
