REPUBLIC OF SERBIA,
CENTER FOR INVESTIGATION OF ACCIDENTS IN TRAFFIC,
SECTOR FOR INVESTIGATION OF ACCIDENTS IN WATERBORNE TRAFFIC,
NEMANJINA 11, 11000 BELGRADE

No.: 342-00-7/2023-03-34

Date: 28.12.2023.

ANNUAL REPORT FOR 2022

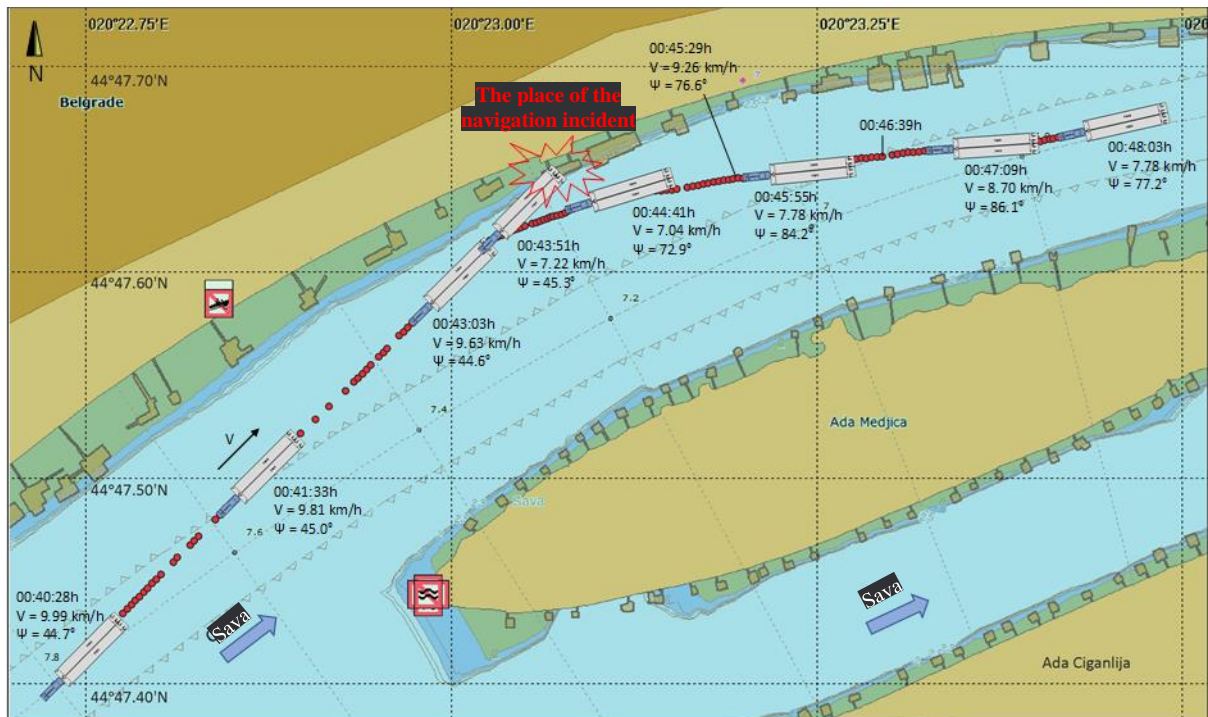
Figure 4.1.1.7. Trajectory of the pushed composition, a change in speed and the course angle in the zone where the impact into a floating object (raft) occurred

Bearing in mind that the analyzed inland navigation incident occurred on this section (Fig. 4.1.1.7.) – an impact into a floating object (raft), the listed data below on the navigation of the pushed composition "GAJO II" are presented in more detail. Following the waterway, the pushed composition sails towards the considered section at a uniform speed of about 10 km/h, relative to the bottom, at a course of about $\Psi=45^\circ$. At the height of Ada Medica, the waterway, following the natural curve of the river flow, meanders to the right. However, the pushed composition of "GAJO II" continues straight navigation and at 00:41:33 a.m., at a speed of 9.81 km/h and a course of $\Psi=45^\circ$, crosses the left border and leaves the waterway at 7 km + 575 m. The pushed composition thus sails for another 230 m, approaching the left bank. This kind of movement indicates the lack of timely reaction of the master, navigator. It is only at 00:43:03 a.m. that an almost insignificant decrease in speed of 0.2 km/h ($v = 9.63$ km/h) is observed, while the course remains unchanged. At that moment, the bow of the barge "71610" is already too close to the left bank. This navigation continues until 00:43:51 a.m. when, at a course of $\Psi=45.3^\circ$, the bow of the barge "71610" hits a floating object (raft) at 7 km + 250 m. Then there is a significant drop in speed to 7.22 km/h.

After the contact, the left part of the bow of the barge "71610" slides down the raft, which, along with the rudder deflecting to the right and an additional drop in speed to 7.04 km/h, enables the pushed composition to continue downstream navigation. Less than a minute after the impact on the raft (00:44:41 a.m.), the pushed composition "GAJO II" sailed downstream at a speed of 7.04 km/h on a course of $\Psi=72.9^\circ$, moving away from the place of the navigational accident. At 00:46:39 a.m., at a speed of 8.51 km/h, the pushed composition returns to the boundaries of the waterway.

Looking at the changes in the speed and course of the pushed composition immediately before the inland navigation incident, it can be concluded that the ship master did not react in time, did not adjust the speed and course of the pushed composition to the conditions on the waterway, which resulted in leaving the waterway and the impact of the pushed composition into a floating object (raft), which caused material damage to the floating object (raft) and to "71610".

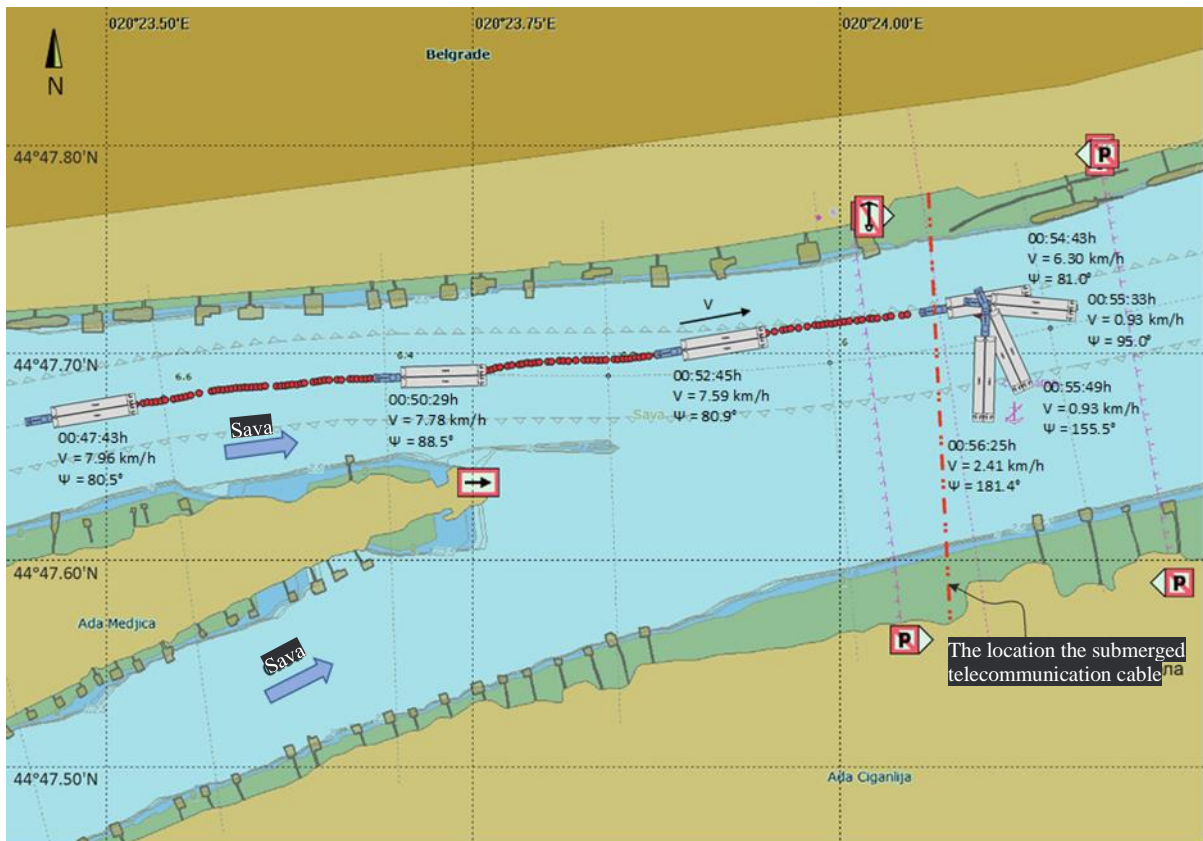
Figure 4.1.1.8. Trajectory of the pushed composition in the zone where the submerged telecommunication cable is found

At 00:54:43 a.m., a significant drop in speed is observed, after which there is a sudden change in the angle of the vessel's course, i.e. the bow of the pushed composition drifts to the right (to the right bank) without further movement in the downstream direction.

This kind of movement, the navigation of the pushed composition clearly indicates the forced impossibility of downstream navigation. With the subsequent check, during the investigative procedure and the report of the crew members, it was established that the anchor on the barge "71610" had become detached during the navigation and that the anchor chain, 100 m long, had completely dropped - outside the sprocket.

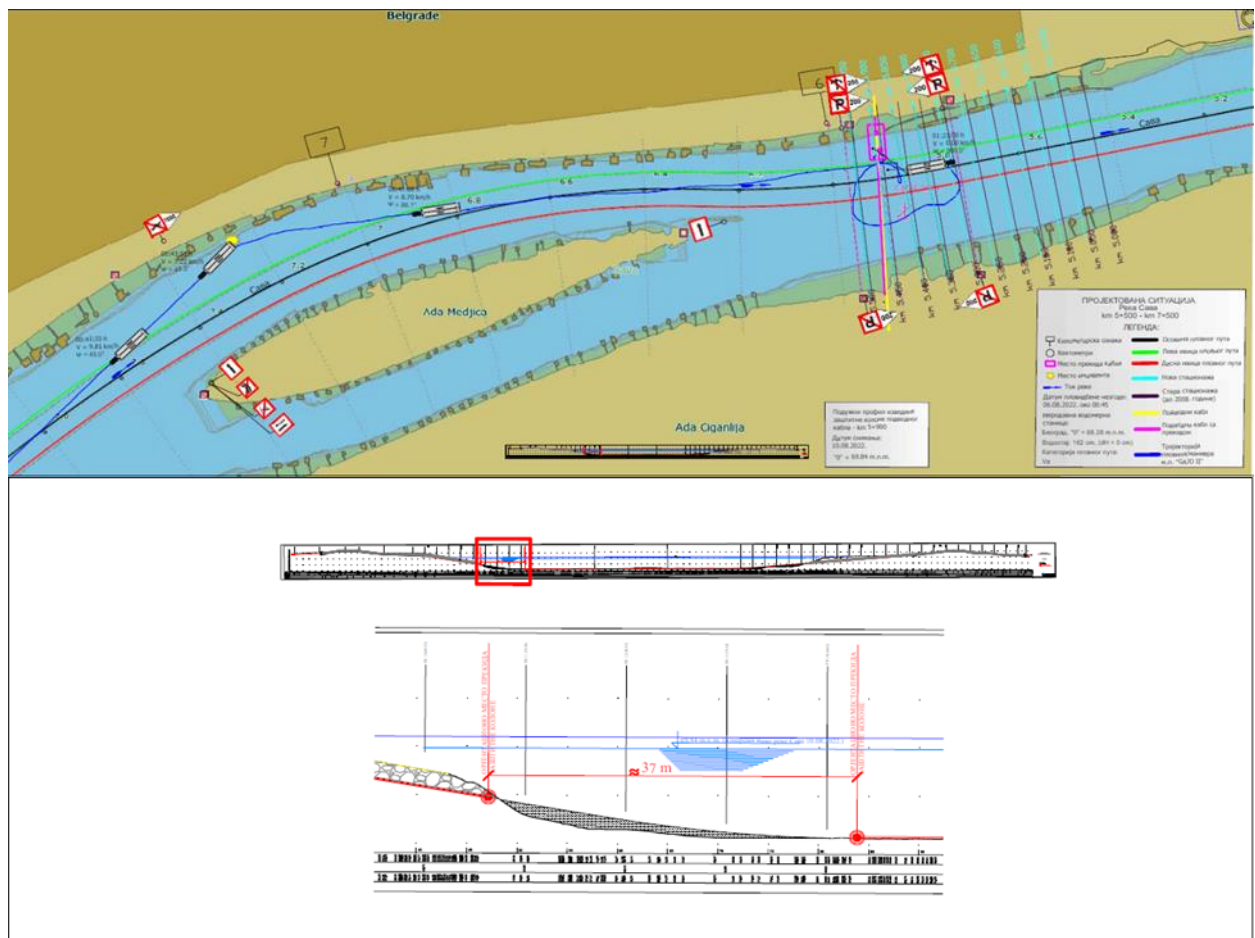
Figure 4.1.1.9. Damage to the submerged telecommunication cable

If the length of the barge, the length of the pusher, the length of the dropped anchor chain, as well as the position of the submerged telecommunication cable are taken into account, the conclusion is clearly imposed that the anchor, which became detached and was dragged along the bottom (anchor plowing) during the navigation of the pushed composition "GAJO II", caught on the submerged cable, which led to the impossibility of further downstream navigation of the pushed composition and the described changes in speed and course. On that occasion, the submerged telecommunication cable was damaged.

It should be emphasized that the anchor, after raising it before setting sail, was not secured with a stopper, which was the obligation of the crew member, crewman - the sailor, in accordance with Article 135 of the Law on Navigation and Ports on Inland Waters. The role of the stopper, which is located between the anchor windlass and the anchor throat chain pipes, is to take the force from the weight of the anchor and thereby relieve the windlass mechanism, and at the same time additionally secure the anchor and prevent unwanted release, knocking down of the anchor. In the case of the anchor device of the cargo barge "71610", the force, which is a consequence of the weight of the anchor (1.000 kg) was carried only by the peripheral brake, on the tension drum of the anchor windlass.

Arriving at the position of 5 km + 950 m, the anchor that came loose and was dragging on the bottom (plowing the anchor) during the navigation of the pushed composition "GAJO II" it caught the underwater cable and on that occasion the underwater telecommunication cable was damaged, which led to the impossibility of further downstream navigation of the pushed composition and the described changes in speed and course. On that occasion, the submerged telecommunication cable was damaged and torn. After stopping the pushed composition at the mentioned position, it turned upstream and anchored around 01:00 a.m. at 5 km + 750 m in the zone of the axis of the waterway. With the aforementioned actions, the shipmaster acted contrary to Article 172, paragraph 1, point 1) and 2) of the Law on Navigation and Ports on Inland Waters ("Official Gazette of RS", No. 73/10, 121/12, 18/15, 96/15, 92/16, 104/16, 113/17, 41 /18, 95/18, 37/19, 9/20 and 52/21). namely:

SR_01/22 The shipmaster had the obligation to establish contact with the crewman -sailor on the deck after the technical operation of lifting the anchor was completed and via the ship's internal radio link to check whether the anchors were properly secured. In accordance with the general duty of care, the ship master is obliged to take all precautionary measures required by the general duty of due care and navigational practice, in particular to avoid: endangering human life, damage to the vessels, coasts, buildings, installations or other objects on the waterway, Article 48, paragraph 2, Law on Navigation and Ports on Inland Waters.

It is recommended to the shipmaster of the vessel "GAJO II", that after the technical operation of the maneuver of lifting the anchor from the water, to place it in the intended berth, which is an integral part of the construction of the ship's hull according to the technical rules of construction. According to the instructions for handling the anchor windlass, the anchor should be provided with a fuse (stopper) on the anchor chain between the anchor windlass and the throat (chain pipes) of the anchor chain, in order to prevent the possibly uncontrolled loosening of the brake on the drive shaft of the anchor windlass and the anchor falling into the water. Based on Article 144, paragraphs 1 and 4 of the Law on Navigation and Ports on Inland Waters ("Official Gazette of the RS", No. 73/2010, 121/2012, 18/2015, 96/2015, 92/2016, 104/2016, 113/2017 and 41/2018), the shipmaster is obliged to check the ship's condition before departure and take care of the maintenance of the devices and equipment on the ship.

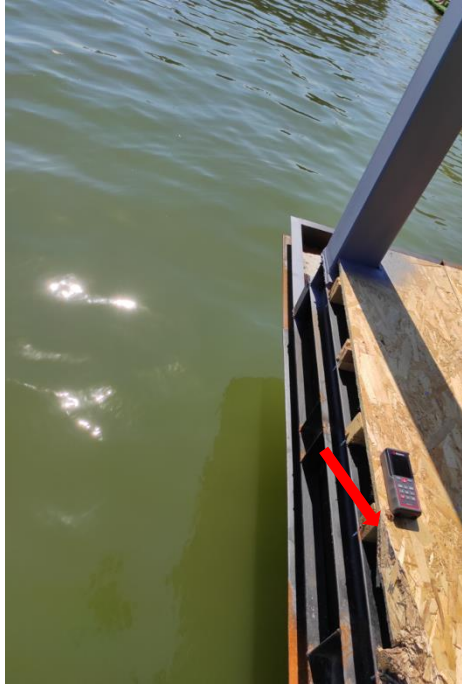
Figure 4.1.1.10.

- The first initial lateral contact in the zone of the edge of the deck at a distance of 91 cm from the first vertical metal pillar, square cross-section (Figure 4.1.1.10.).

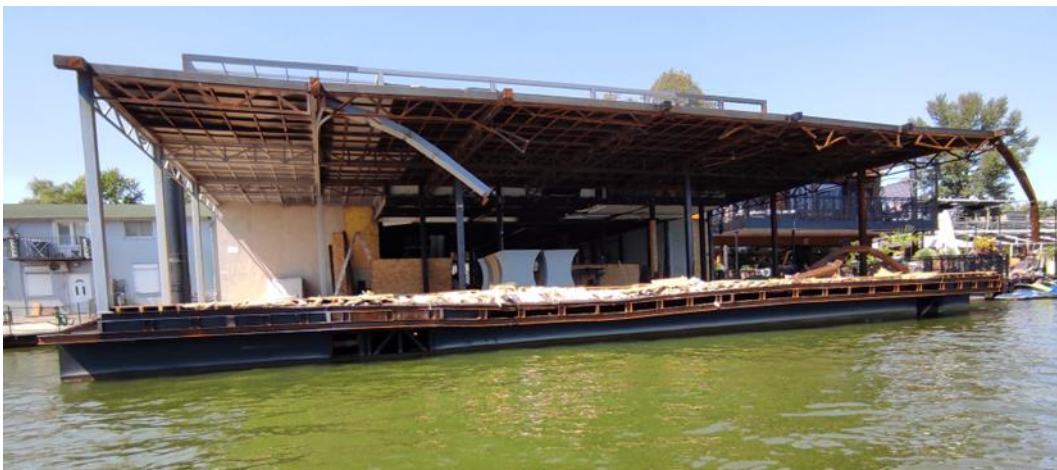
Figure 4.1.1.11.

- The contact of the barge continues continuously laterally downstream along the length of the outer-edge part of the deck of the floating object (Figure 4.1.1.11.).

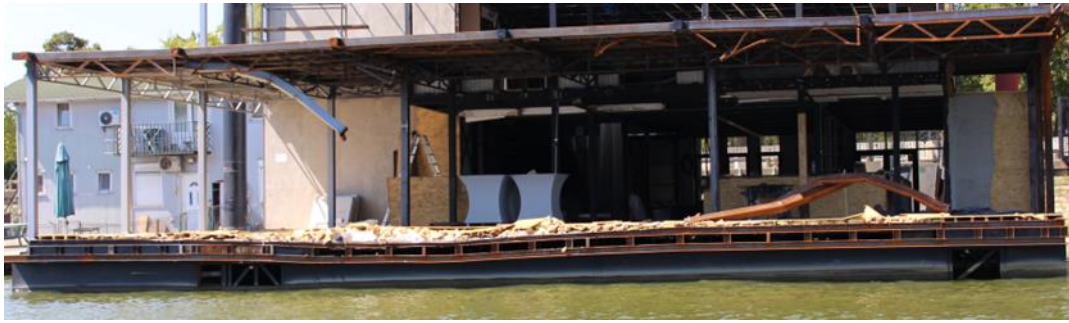
Figure 4.1.1.12.

- At a distance of 2.47 m from the mentioned undamaged supporting vertical metal pillar, deformation of the outer-edge part of the lower base metal structure that connects the pontoons was observed (Figure 4.1.1.12.).
- Damage to the 4.91 m long side vertical metal grating (Figure 4.1.1.12.).

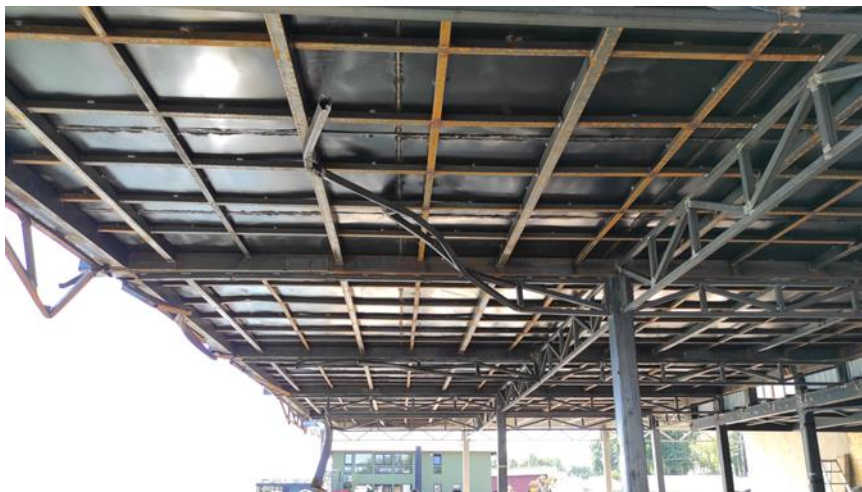
Figure 4.1.1.13.

- Damage to five transverse stiffeners (Figure 4.1.1.13.).

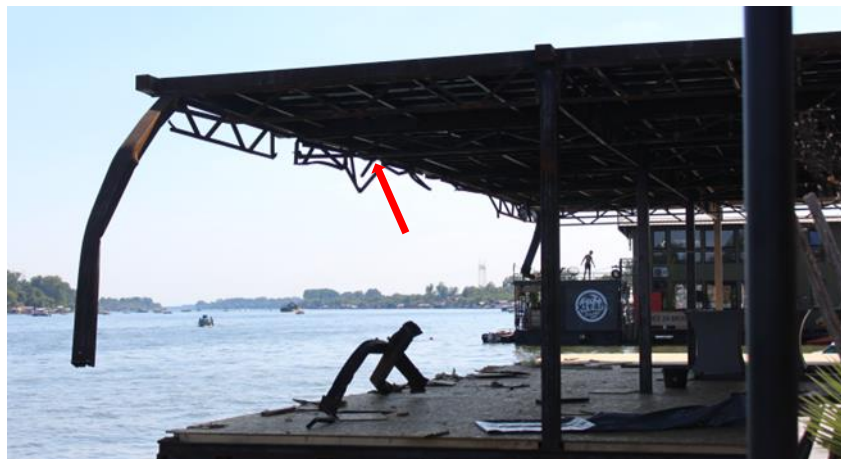
Figure 4.1.1.14.

- Five vertical metal supporting columns suffered tearing stress from the stiffening of the anchor point of the deck structure, they also suffered plastic deformation along their length, due to the action of the resulting axial force (Figure 4.1.1.11).
- The sixth and last downstream supporting vertical metal supporting pillar rolled out from the anchoring point of the deck metal structure, suffered plastic deformation along its entire length with partial fracture and separated from the final supporting horizontal metal beam of the roof structure (Figure 4.1.1.14.).

- On the final part, the circumferential metal longitudinal grid of the roof structure suffered plastic deformation (Figure 4.1.1.14).
- Vertical transverse metal lattice supporters between the first and second rows of supporting pillars, suffered partial plastic deformation, namely: on the second external support towards the inner part of the deck, as well as on the third, fourth, fifth and sixth pillars (transverse lattice stiffeners between the supporting pillars), Figure 4.1.1.15.

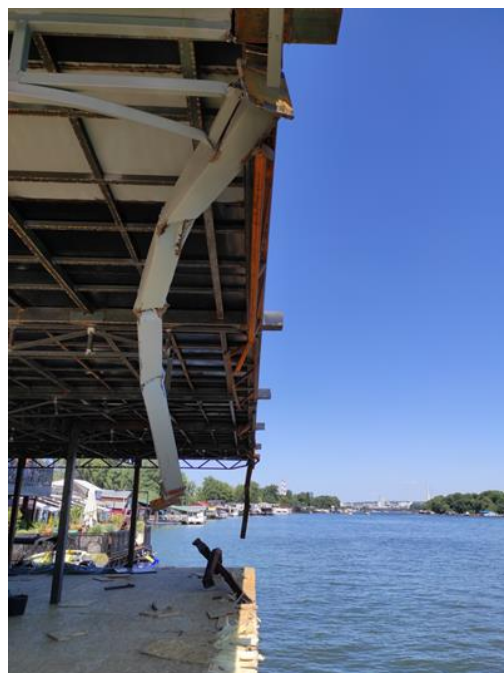
Figure 4.1.1.16.

- The second supporting metal vertical pillar rolled out from the stiffening of the anchor point of the deck metal structure, and complete plastic deformation with torsion elements. The same separated from the stiffening in the resistance of the support on the roof structure and caused partial plastic damage to the transverse metal lattice structure of the roof (Figure 4.1.1.16.).

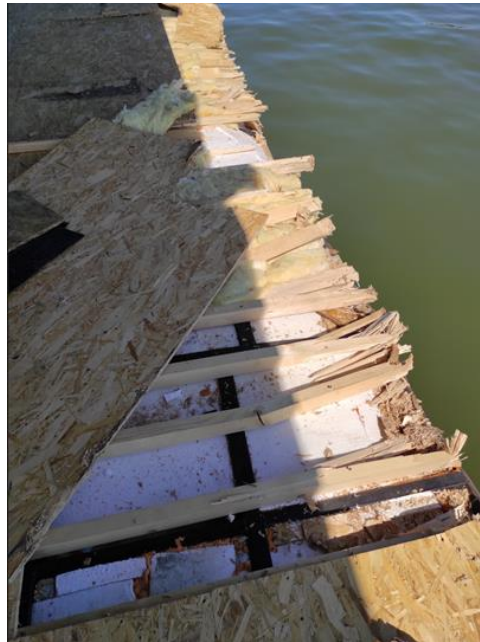
Figure 4.1.1.17.

- Damaged OSB boards of the deck along the entire length of the contact, as well as supporting wooden beams with insulation (Figure 4.1.1.17.).

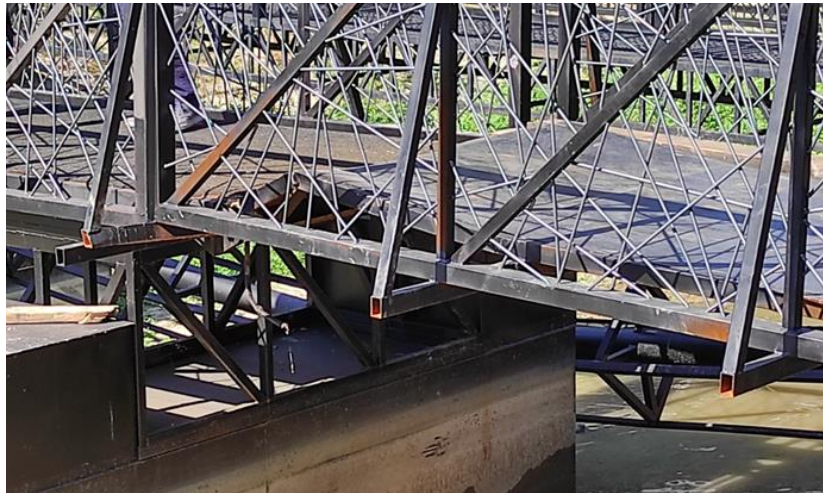
Figure 4.1.1.18.

- On the access bridge, the deformation of the joint connecting the two segments of the deck walkway (Figure 4.1.1.18.).

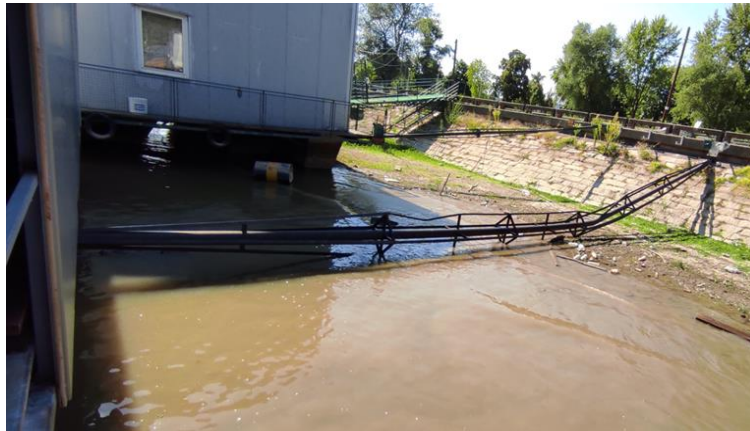
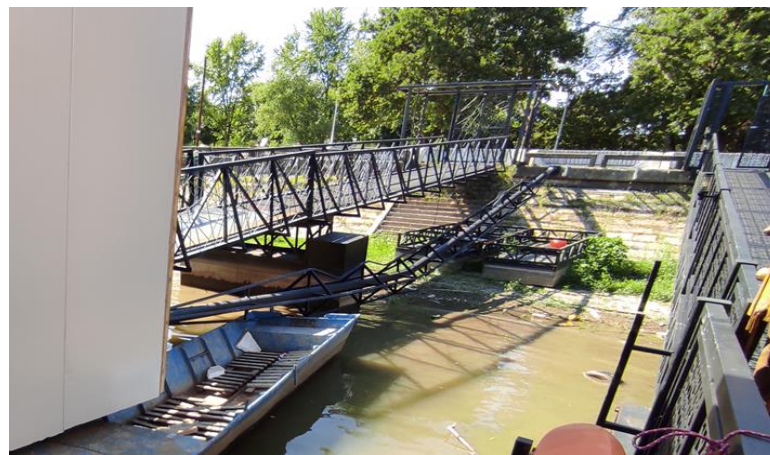
- Longitudinal deformation of the metal bow and stern bumper, due to the effect of stress force on pressure (Figure 4.1.1.19. and 4.1.1.20.).

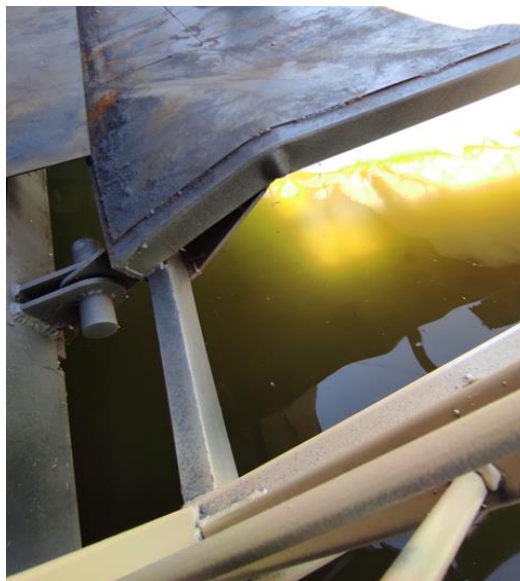
Figure 4.1.1.21.

- Deformation of the deck path (plastic convex deformation of the shape of a triangle). At the end of the access bridge in the connection zone with the deck of the floating object (Figure 4.1.1.21.).

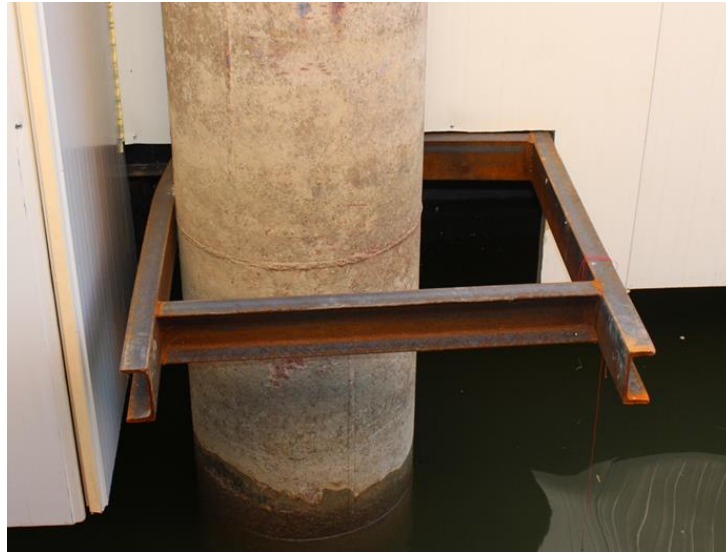
Figure 4.1.1.22.

- Deformation of the horizontal metal holder of the downstream pile (Figure 4.1.1.22.).

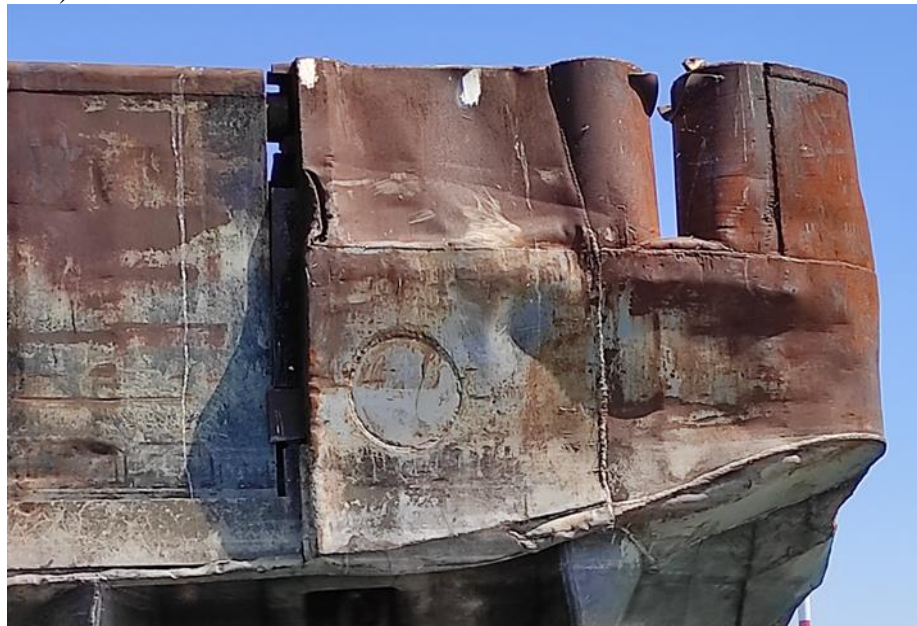
Figure 4.1.1.23.

- On the left side of the hull in the area of the bow on the bend that joins the side plating and the bow transom, plastic deformation of the plating and wale about 120 cm. At the end of the initial contact on the bow transom vertically about 70 cm, the plating is separated from the structure (Figure 4.1.1.23.).

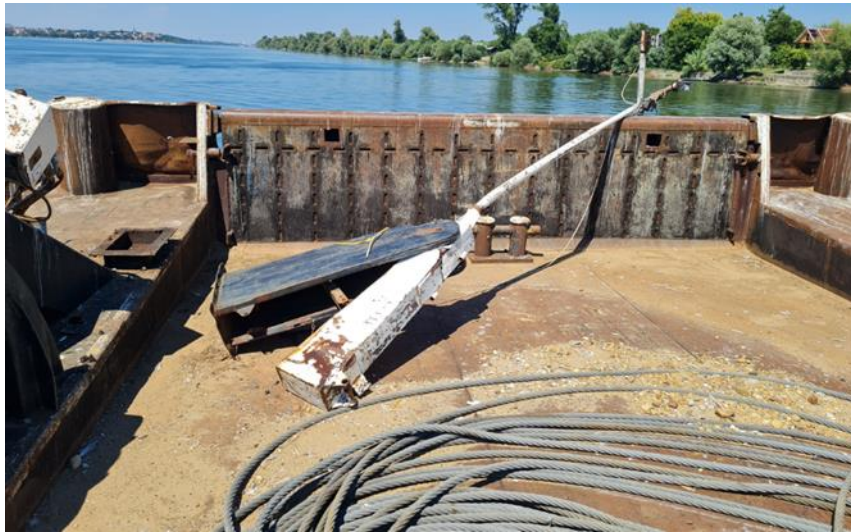
Figure 4.1.1.24.

- A signal mast with a base spread out-torn off from the deck foundation, a rectangular foundation (Figure 4.1.1.24.).

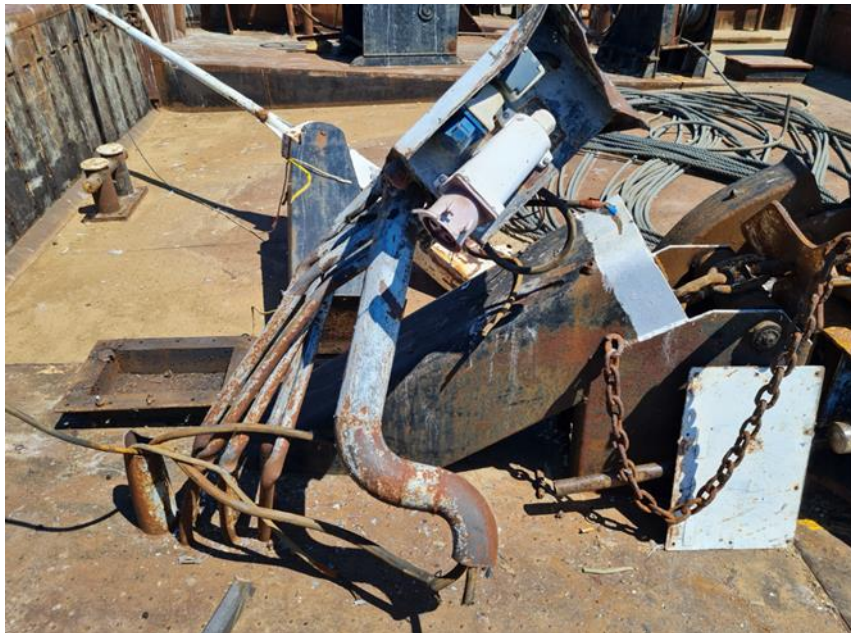
Figure 4.1.1.25.

- Torn off deck support pillar with the cabinet of electrical installations and the command for manipulative operations with the ship's anchor. As part of the mentioned fixed deck equipment, deformed metal inlets for electrical cables (Figure 4.1.1.25.).

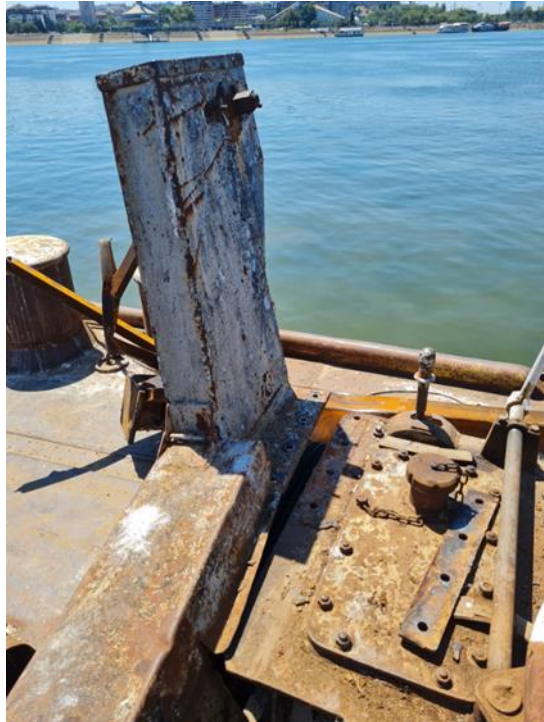
Figure 4.1.1.26.

- Metal protective box with a support partially separated from the anchor windlass reducer housing (Figure 4.1.1.26.).

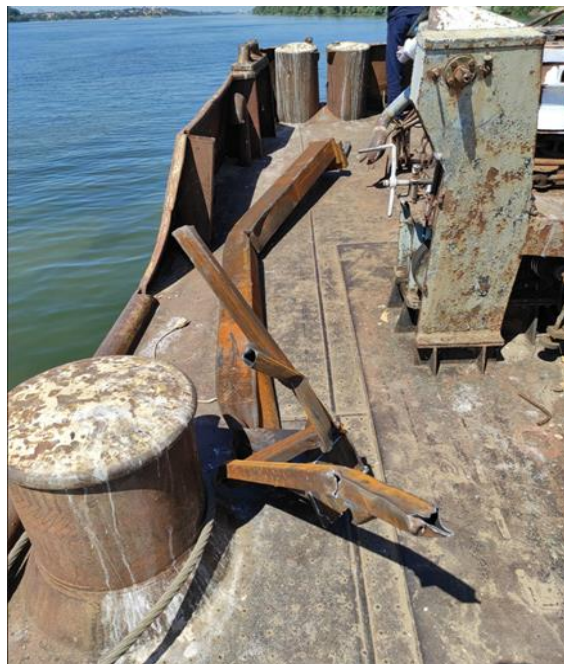
Figure 4.1.1.27.

- The damaged anchor windlass is not functional for manipulative operations, capable of lifting the anchor once.
- A metal pillar support with a rectangular profile of 150×150 mm was observed on the bow deck, torn off from the floating object (Figure 4.1.1.27.).

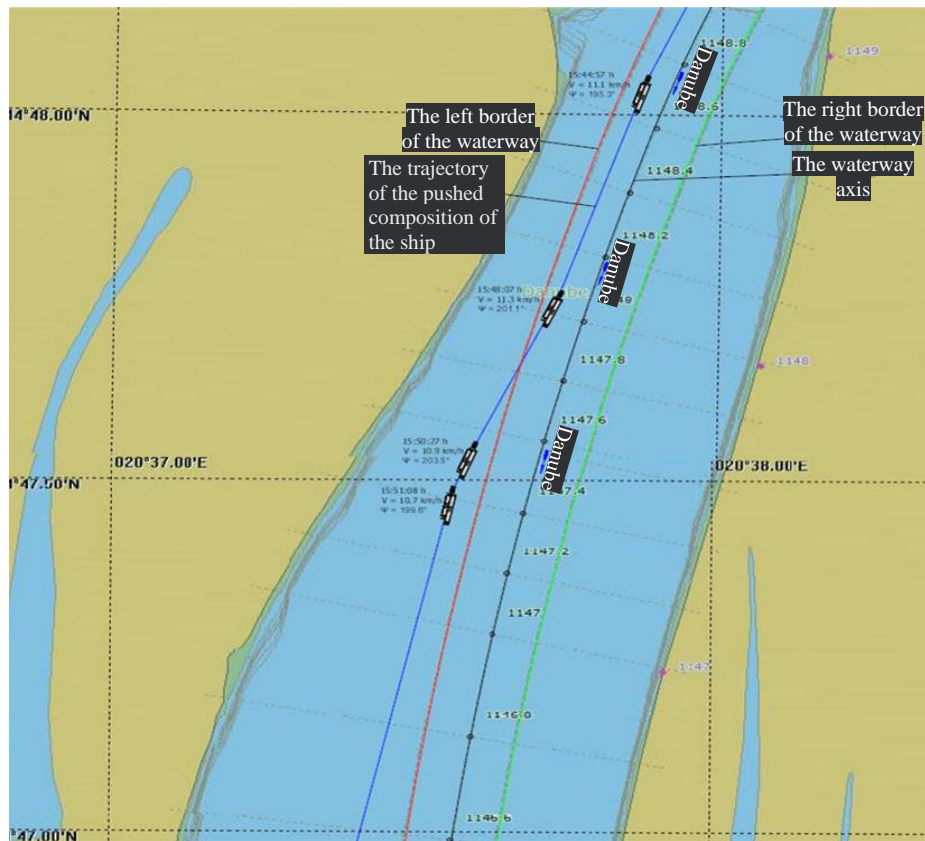
Figure 4.2.1.2.

- According to the available data from the video recording on the ENC map in real time, the downstream navigation and positions on the navigation corridor (waterway) of the pushed composition of the vessel "ROVINARI" from 1148 km + 600 m to the position when the downstream composition at 1147 are shown km + 800 m over the right edge of the waterway leaving the same, on course $\Psi=201.1^\circ$, at speed $v=11.3$ km/h at 15:48:07 (Figure 4.2.1.2.).

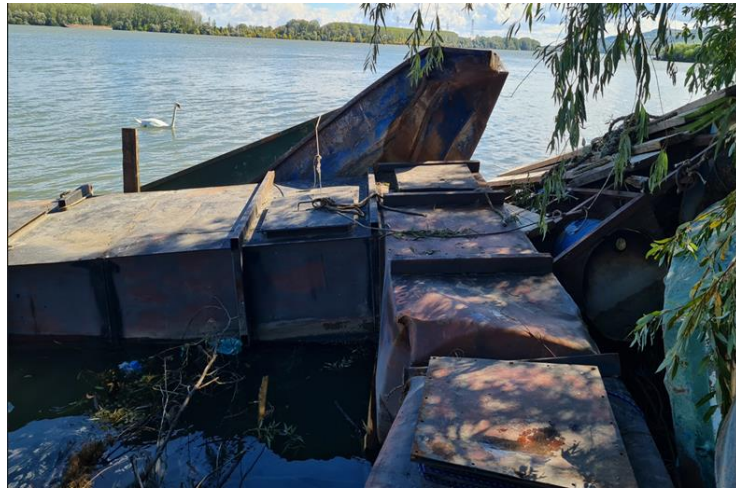
Figure 4.2.1.5.

- Metal pontoon in the shape of a cube, connected in the form of an (L) construction, suffered longitudinal and transverse plastic deformations (Figure 4.2.1.5).

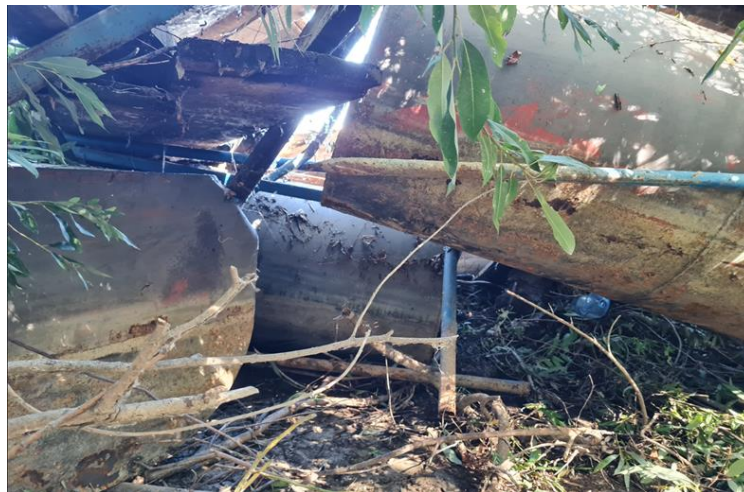
Figure 4.2.1.6.

- Catamaran-type torus pontoon, the same connected to each other by a metal lattice structure, suffered plastic deformation and stranded on the shore (Figure 4.2.1.6).

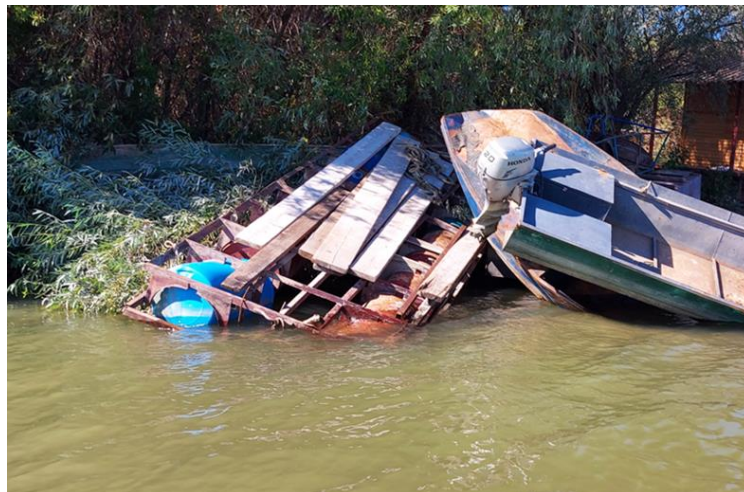
Figure 4.2.1.7.

- Pontoon on barrels, most of the surface stranded on the shore. Deck board covering damaged and separated from the lattice supporting structure (Figure 4.2.1.7.).

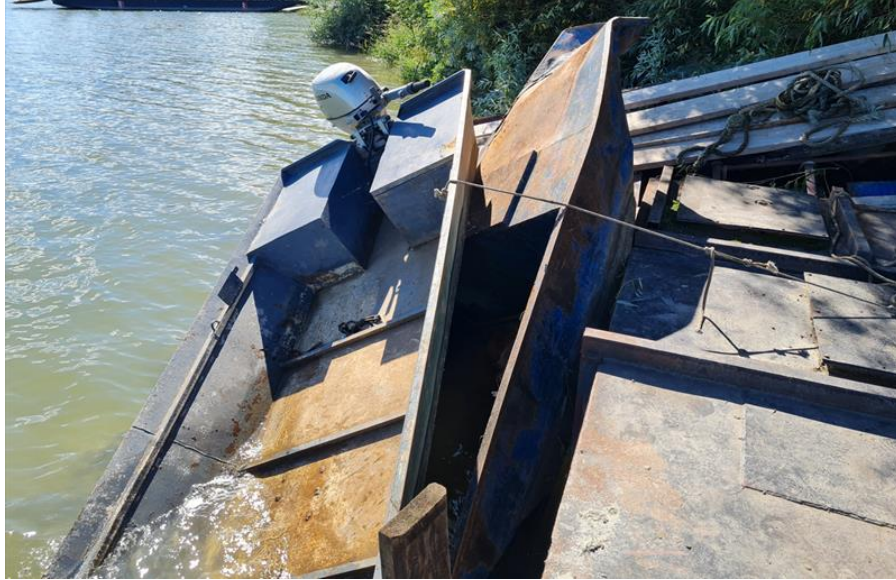
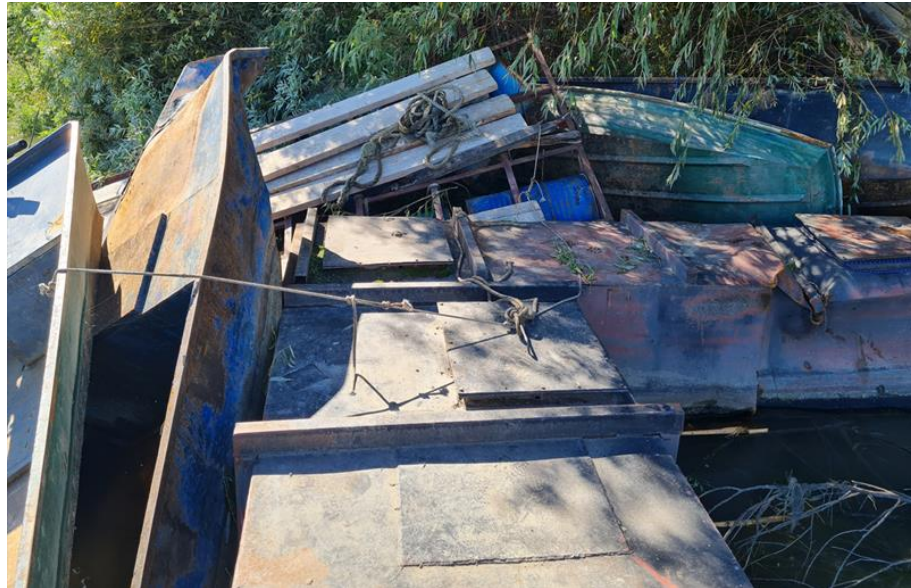
- Five metal boats without registration plates pushed and stranded on the shore suffered plastic deformation of the hull, while another boat was submerged under the water mirror and pressed by the pontoon structure (Figure 4.2.1.8. and 4.2.1.9.).
