REPUBLIC OF SERBIA
CENTER FOR INVESTIGATION OF ACCIDENTS IN TRANSPORT
SECTOR FOR INVESTIGATION OF ACCIDENTS IN RAILWAY TRAFFIC
Nemanjina 11, 11000 Belgrade

No.: 340-00-8/2020-02-38

Date: 24.09.2020.

ANNUAL REPORT FOR 2019

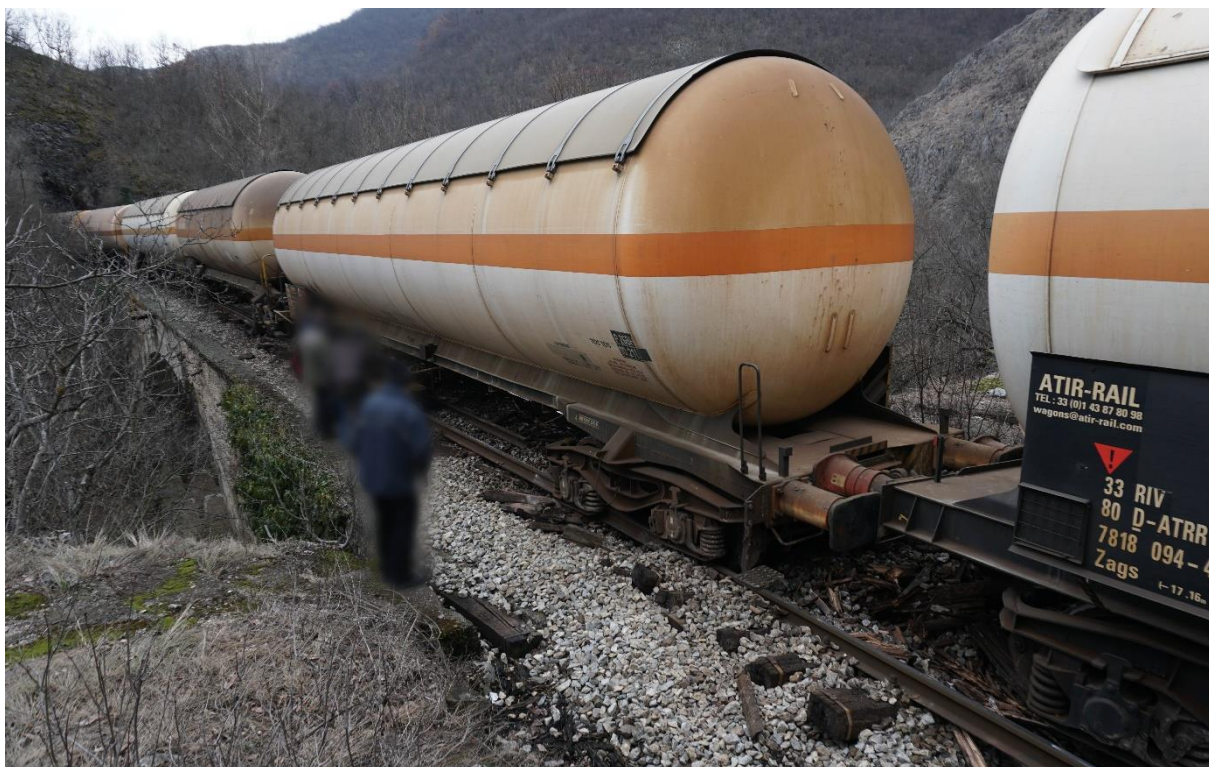
On 14.02.2019. at 01:45 at km 55+252 of the regional track Crveni Krst - Zaječar - Prahovo Pristanište, between the station Svrljig and Knjaževac, on the open line on the concrete bridge above the river Svrljiški Timok, between the tunnel No.21 and the tunnel No.22, it came to derailment of the train No. 52770. From the train composition, viewed from the train locomotive 661-318, third wagon of the series Zags derailed, No. 33 87 7814 136-0 with two axles of the first bogie, fourth wagon of the series Zags No. 33 80 7818 085-2 with all the axles, fifth wagon of the series Zags No. 33 80 7818 094-4 with all the axles, sixth wagon of the series Zags No. 33 87 7813 564-4 with all the axles, seventh wagon of the series Zags No. 33 87 7816 547-6 derailed with one axle of the second bogie.

Figure 3.1.1: The appearance of the derailment site (concrete bridge between the tunnel 21 and the tunnel 22)

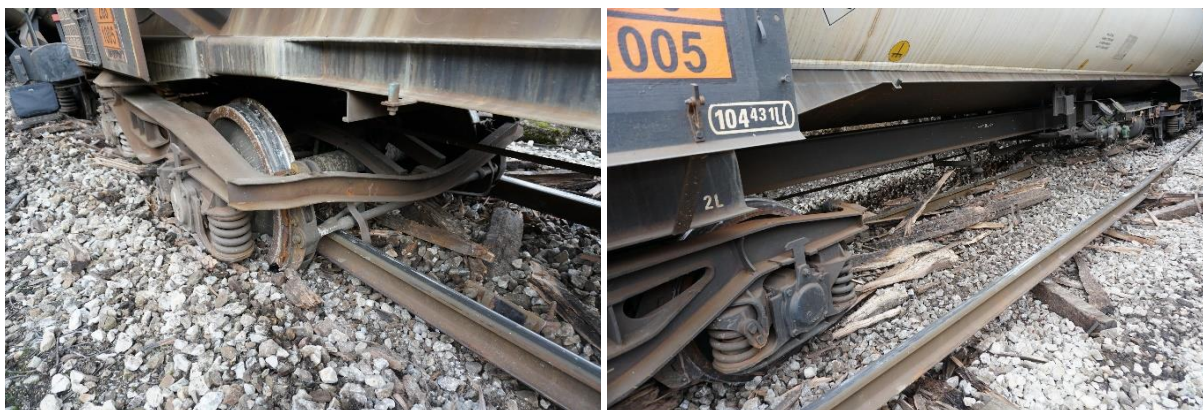
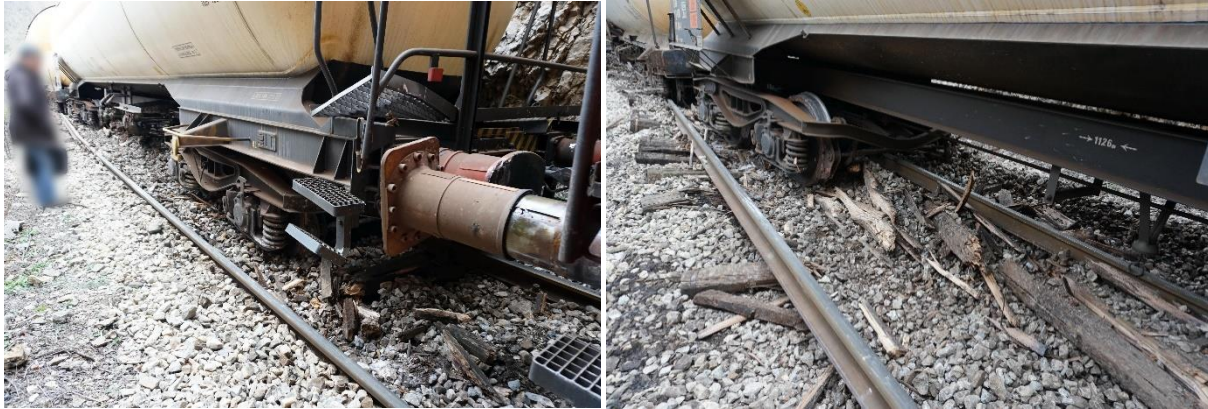
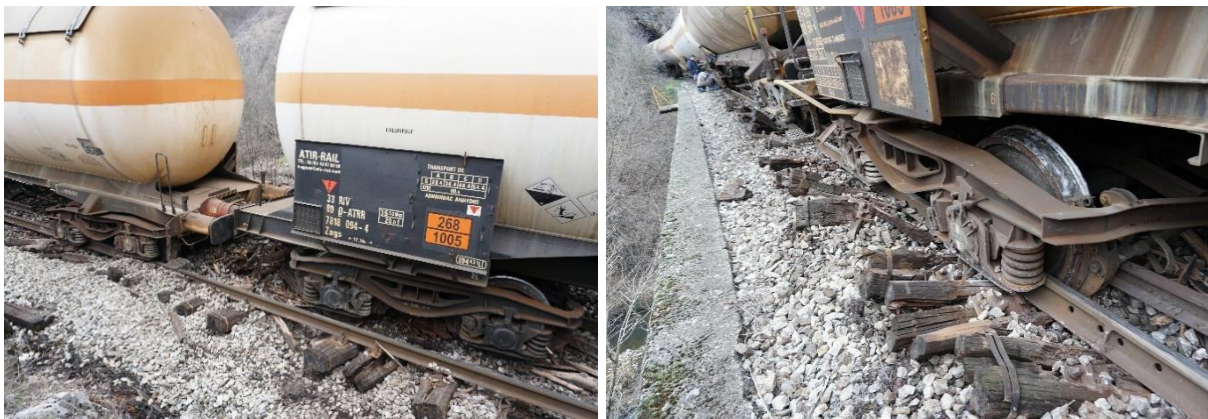
Figure 3.1.2: The appearance of the derailed wagon parts

Figure 3.1.3: The appearance of the derailed wagon parts

Figure 3.1.4: The appearance of the derailed wagon parts

After the derailment, the train passed 85 m more after which it stopped. The derailed wagon was found in the track zone, on their wheels. It did not come to tilting or overturning of the train and it did not come to the leakage of cargo.

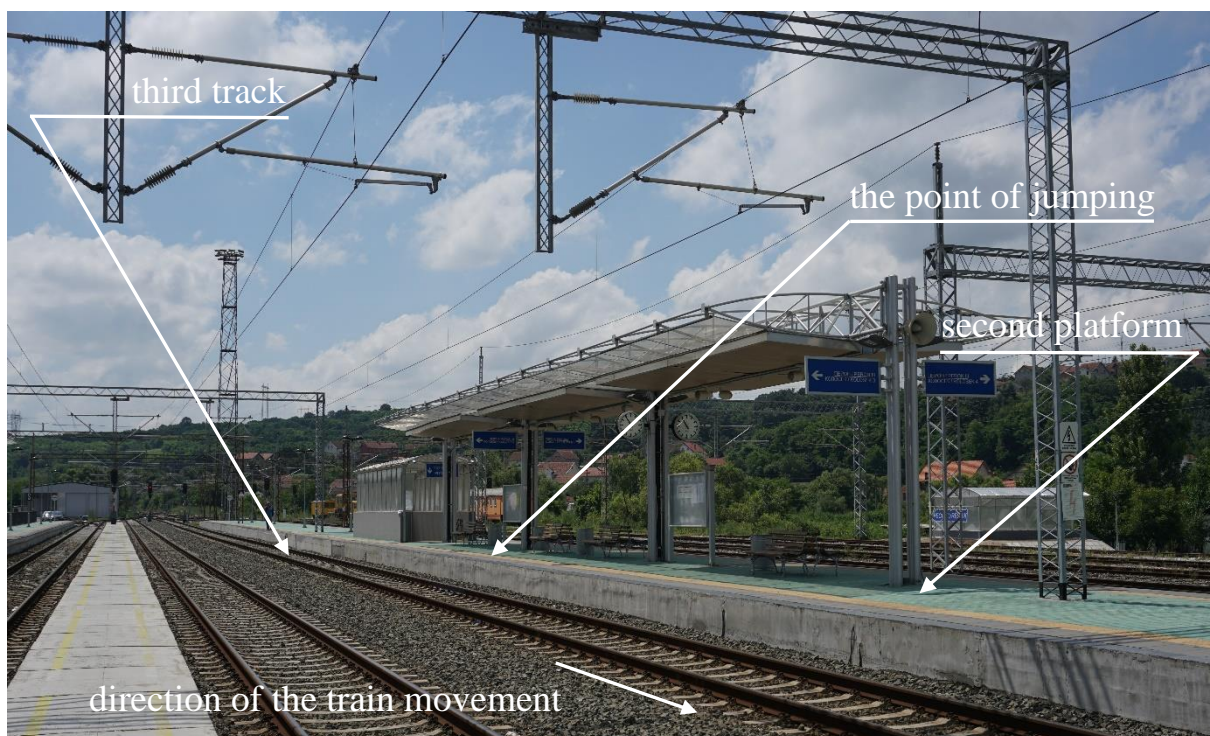
On 25.06.2019. at 06:17 at km 14+169 of the main arterial route E70/E85: Belgrade - Mladenovac - Lapovo - Niš - Preševo - state border - (Tabanovce), during the passing of the train No. 432, of the railway undertaking "Srbija Voz" a.d., through the station Resnik, during the drive on the third station track at the covered part of the second station platform, which is located between the third and fourth station track, out of the train locomotive 441-604 of the train No. 432, it came to jumping of the railway worker the train driver, employed at railway undertaking "Srbija Kargo" a.d. The railway worker the train driver has, from the train locomotive 441-604, which was in motion, through the door of the machine compartment on the left side of the station platform (viewed from the direction of the train movement) jumped in direction of the second station platform and third station track, that is, in the space between the second station platform and the train in motion. On that occasion, he sustained serious injuries, from which he died on the spot.

Figure 3.2.1: The appearance of the point of jumping site
(view from the direction of station facility - the first station track)

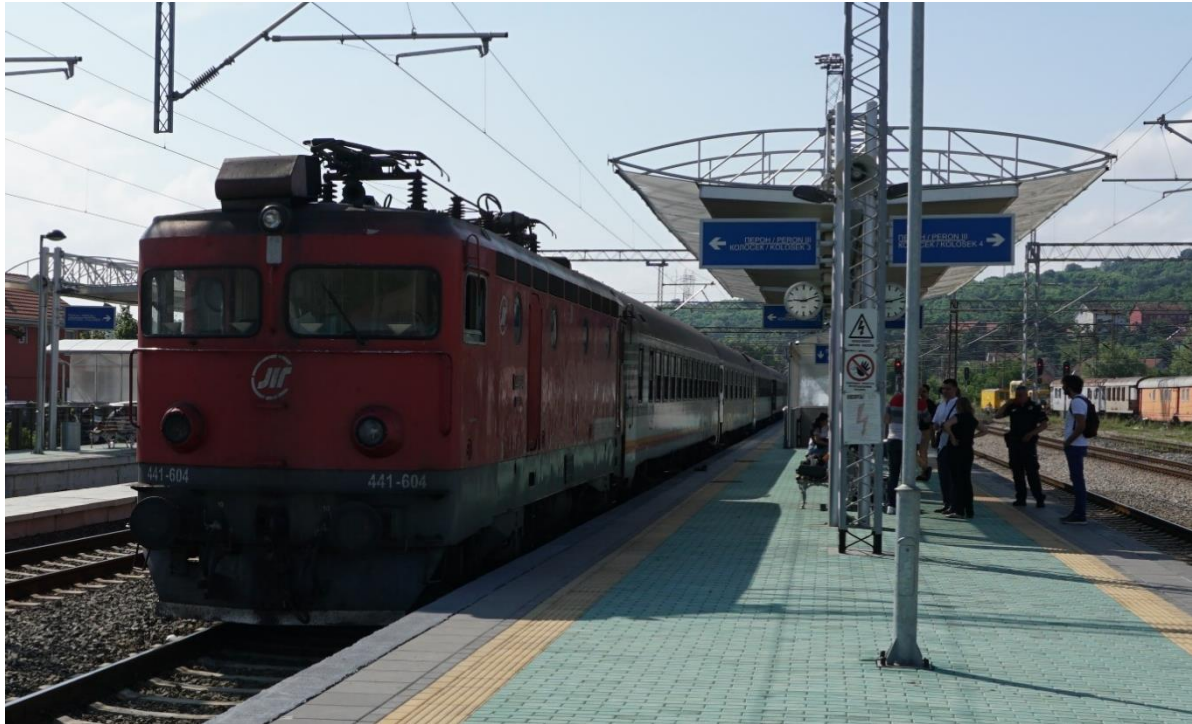
Fig. 3.2.2: The appearance of the site where the train No. 432 stopped after the serious accident

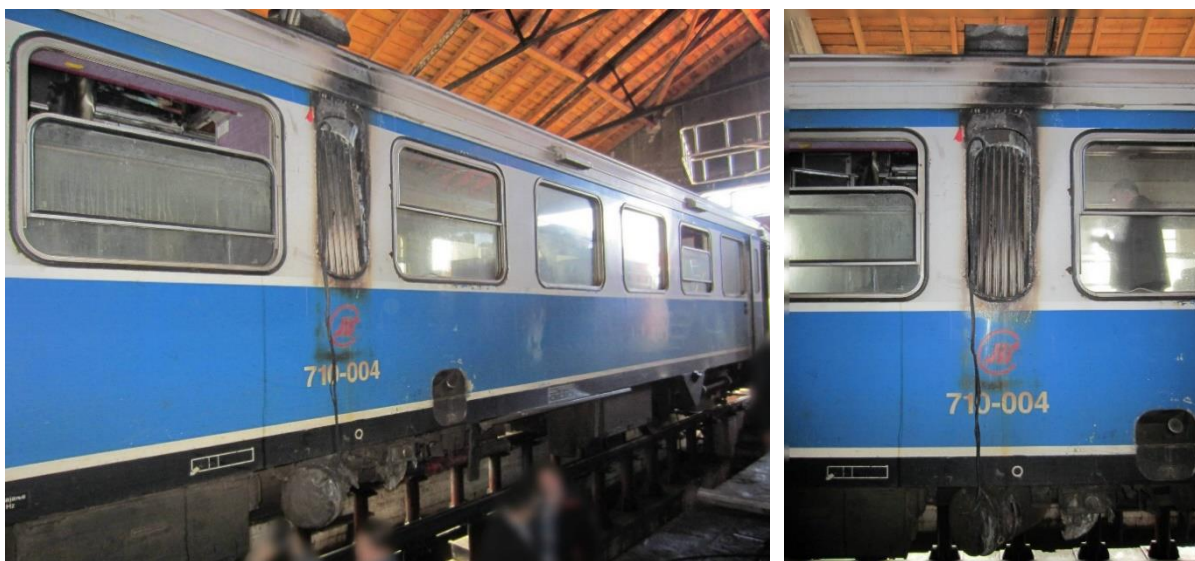
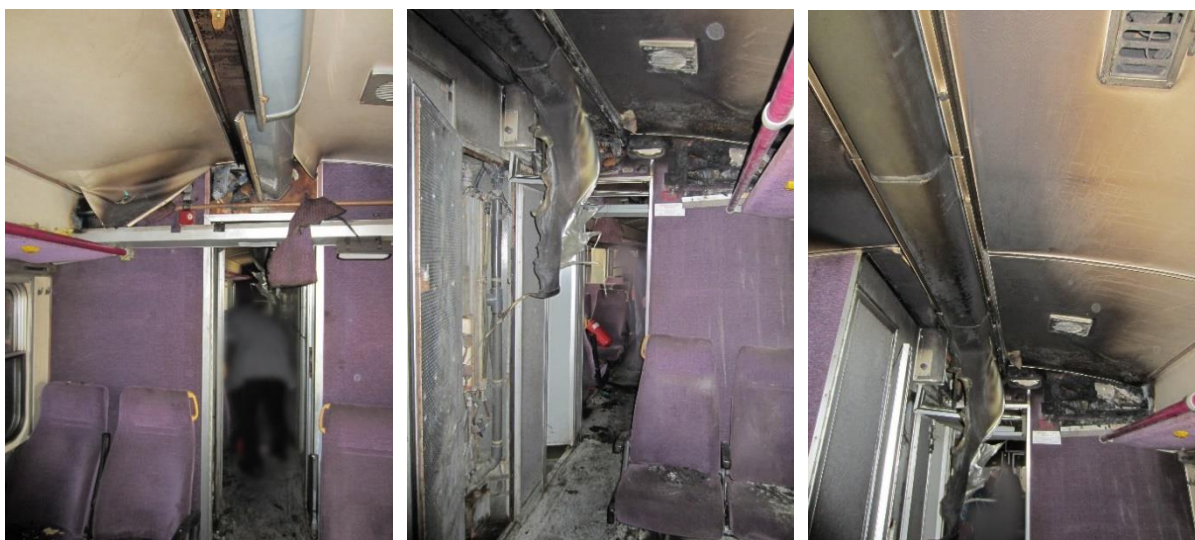
Fig. 4.1.1.1: The appearance of DMK 710-004 on fire (middle part from the outside)

Fig.4.1.1.2: The appearance of passenger compartment DMK 710-004 on fire

Due to the major load of DM "A" because DM "B" could not be connected to a joint traction due to a failure, during the overcoming of the rise, there happened an increase in the temperature and flow of a higher amount of exhaust gases through the exhaust pipe - exhaust, passing through the vertical protective channel and goes to the roof of DMK. As a consequence of the heating of the exhaust gases of the exhaust pipe to the temperatures above the temperature of the work-warmed operating engines, and due to the lack of seal on the flange connection at the extension of the exhaust pipe, the hot products directly act on the protective

tube which is then heated and due to its heating comes to inflammation of the upholstery, plastic and wooden parts in that part where the channel touches. The fire started in the upper part of the channel, and then it continued to the lower part when the parts of the burning lining fall to the bottom of the channel and melt the aluminum parts of the air intake.

SR_02/19 “Srbija Voz” a.d. that on the basis of quality control in the course of repair and final review of the DMK series 710, determine whether repairs were made in the required quality and scope of work, with the aim of adequate execution of the repairs in accordance with Article 8 of the Rulebook on the Maintenance of railway vehicles.

SR_04/19 “Srbija Voz” a.d. that, given the long exploitation period of DMK series 710, carry out technological research related to the joint work of the diesel engine - hydrodynamic transmitter - the cooling system in order to identify lacks and on the basis of them implement appropriate improvements of the drive system (replacement of the kind of coolant, check the capacity of the heat exchanger - cooler, etc.) in order to prevent failures that could lead to occurrence of the new accidents.

SR_05/19 “Srbija Voz” a.d. that due to the frequency of failures in the operating system DMK series 710 and accidents occurred - fires, conduct analysis and consider the possibility of shortening the period up to the execution of regular repairs.

SR_06/19 “Srbija Voz” a.d. that at the next regular repair DMK Series 710, during the reconstruction of the interior applies materials in accordance with EN 45545-1 and EN 45545-2:2013+A1, that is SRPS EN 45545-1:2013 and SRPS EN 45545-2:2017.

SR_07/19 Directorate for Railways to check the license for use of DMK series 710 in terms of improvement of technical solutions of the drive system and the application of appropriate materials in terms of controlling the fulfillment of conditions for issuing safety certificates for transport.

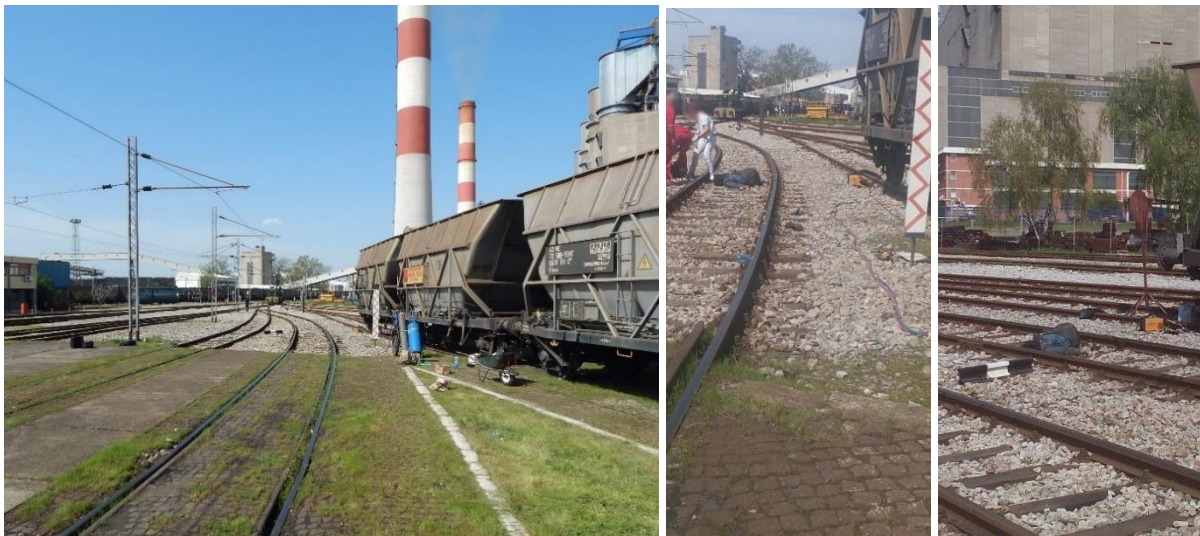
Fig. 4.2.1.1: The appearance of the site where it came to overtaking of the locomotive CEM-7 on the worker

The direct and immediate cause of a serious accident is that the deceased worker found himself on the track 10d just before the locomotive CEM-7 approached, which created a dangerous situation related to the occurrence of this serious accident.

The main cause of this serious accident is noncompliance with the Provisions from the part B, Point 9 Paragraph 4 of the Business order of the station Obrenovac No. 32063/1 from 21.10.2010. The train driver had started the locomotive without giving the aspect of a signal "Forward" by the shunter. Before starting the locomotive, the train driver did not give with a siren an aspect of a signal "Watch out" and did not repeat the aspect of a signal during the shunting drive, which is in collision with the provisions of the Article 29, B, Point 11, under a) and l) of the Rulebook 1 of the Signalling Rulebook ("Official Gazette of ZJŽ" No. 4/96, 5/96 and 1/97). During the shunting drive, the train driver had exceeded the maximum speed limit for the paved and unpaved part of the track 10d determined by provisions from the part B, Point 15 of the Paragraph 4 of the Business order of the station Obrenovac No. 32063/1 from 21.10.2010.

SR_08/19 JP "EPS" branch TENT from Obrenovac to conduct the amendment of the procedure, QP.0.14.05 edition 11 from 25.04.2018., in the part 3.1. General, Paragraph 7 (which in this part is identical to the procedure QP.0.14.05 edition 10 from 22.01.2018., and that was valid at the time of occurrence of the respective serious accident), with detailed content of the description of the procedure regarding the dangers and damages in railway traffic that the instructor for BZR and ZOP from Training Department or the Person for Health and Safety at TENT or surveillance body uses when he introduces the employees of the contractor of works and predicts the manner of check of the employees of the contractor of works or to create a special procedure that defines this.

- SR_12/19** Ministry of Labor, Employment, Veteran and Social Affairs of RS, Labor Inspectorate to carry out additional inspection within its competences in terms of fulfillment of conditions under Article 9 of the Regulation on Safety and Health on Temporary or Mobile Construction Sites (“Official Gazette of RS” 14/2009 and 95/2010), where the investor (JP “EPS” branch TENT from Obrenovac) was obliged to carry out application of the construction site on the form in Annex 3 “Construction site registration” and appoints the coordinator for execution of works.

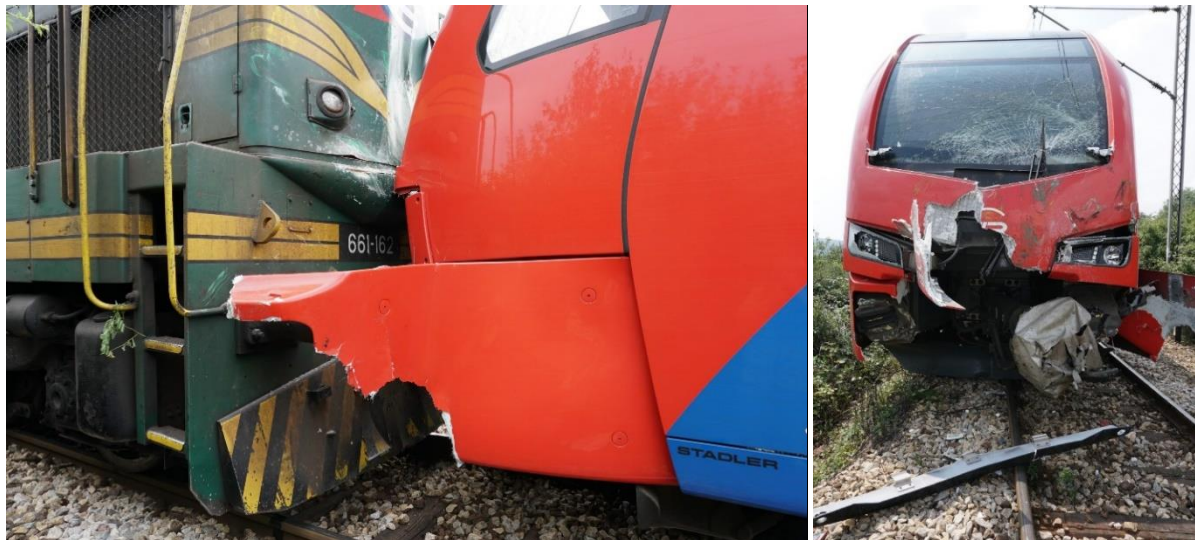
Fig. 4.3.1.1: The appearance of damages on the railway vehicles after the collision of trains

The immediate cause of the accident was that the two trains were found simultaneously in one spatial section, with one train standing (train No. 70922) while the second train was moving (train No. 2990), which is contrary to the provision in Article 37, Item 7 of Rule 2, Traffic Rules ("Official Gazette of ZJŽ" No. 3/94, 4/94, 5/94, 4/96 and 6/03).

- 1) failure to comply with the railway regulations on passing along the signal that prohibits further driving by the train driver of the train No. 2990,
- 2) faults and failures of SS devices that are repeated over a longer period of time,
- 3) unsecured minimum prescribed distance of visibility of the main signals,
- 4) untimely detection of the obstacle on the track (of the stopped locomotives) due to the vegetation near the railway track,
- 5) incomplete notification of train driver No. 2990 on train traffic situation by TK dispatcher,
- 6) frequent alienation of railway property - of certain parts of the SS devices by third parties,
- 7) weather conditions - extensive rainfall from 30.07.2018. on the mentioned railway section which contributed to the deterioration of the state of functioning of the SS devices.

SR_14/19 Directorate for Railways to define in the Rulebook on Technical Requirements for SS Devices ("Official Gazette of RS" No. 18/2016 and 89/2016) electrical parameters describing the technical condition of the track balises.

- SR_16/19** Directorate for Railways in the Rulebook on maintenance of SS devices (“Official Gazette of RS”, No. 80/2015), to define that monitoring of the condition of SS devices in order to determine their usability and correctness is performed in addition to workers handling signaling and safety devices also by maintenance workers. of the signaling and safety devices.

- SR_17/19** “IŽS”a.d. to perform the procurement and installation of the missing and due to technical malfunctioning of the off track auto-stop devices on the railway section Resnik - Velika Plana, as well as to see the possibility of the installation of the track balises and on other exit signals that are not on the main transit station tracks.

- SR_19/19** “IŽS”a.d. when, due to weather conditions or some other reason, an interruption in the operation of the TK device occurs, it shall dispose stations by the train dispatchers whose signals are considered unusable after the interruption in the operation of the TK device.

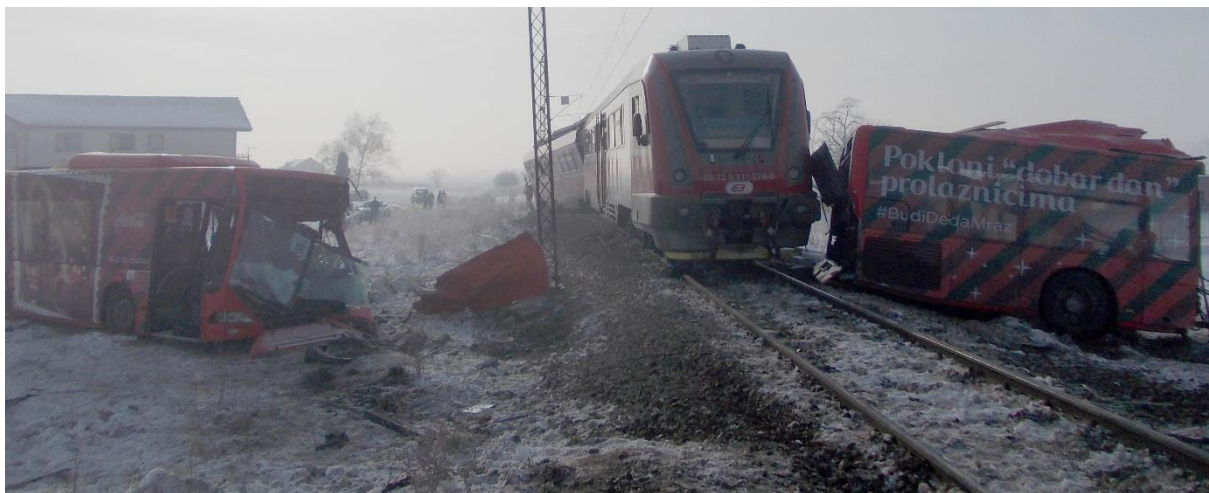
Fig. 4.4.1.1.: The appearance of the vehicle after the serious accident (view in direction to the end of the train)

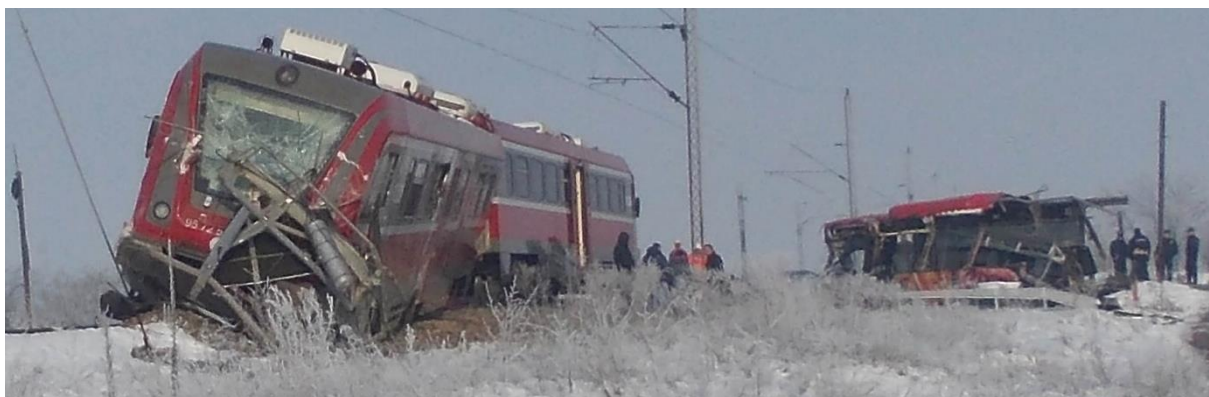
Fig. 4.4.1.2: The appearance of the vehicle after the serious accident (view in direction to the front of the train)

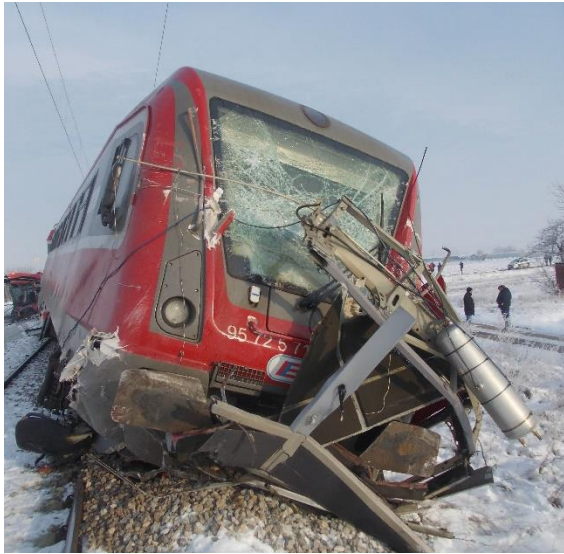
Fig. 4.4.1.3: The appearance of the head of the train

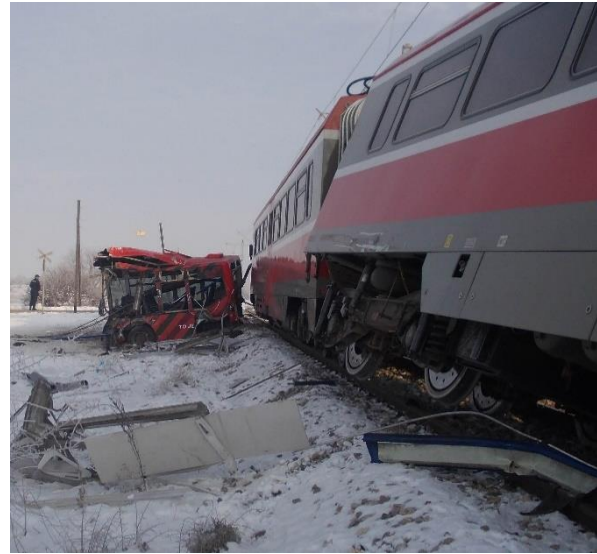
Fig. 4.4.1.4: The appearance of the part of the side part of the train and back part of the bus
