REPUBLIC OF SERBIA
CENTER FOR INVESTIGATION OF ACCIDENTS IN TRANSPORT
SECTOR FOR INVESTIGATION OF ACCIDENTS IN RAILWAY TRAFFIC
AND INTERNATIONAL COOPERATION
Nemanjina 11, 11000 Belgrade

No.: 340-00-4/2018-2-40-1

Date: 05.09.2018.

ANNUAL REPORT FOR 2017

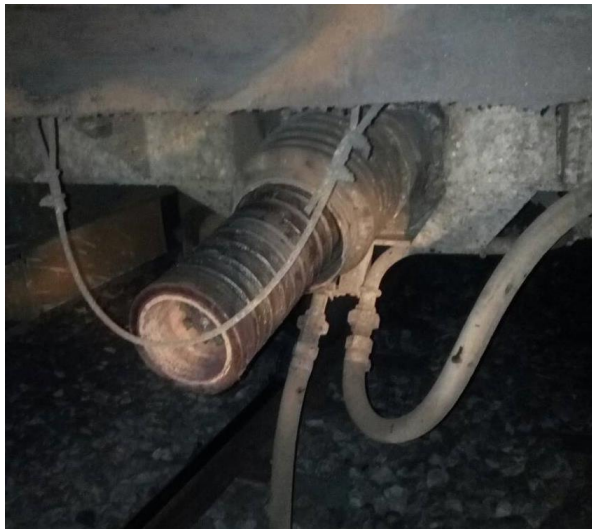
Fig. 3.1.1: Appearance of the part of decoupled clutch on the trailer 416-004

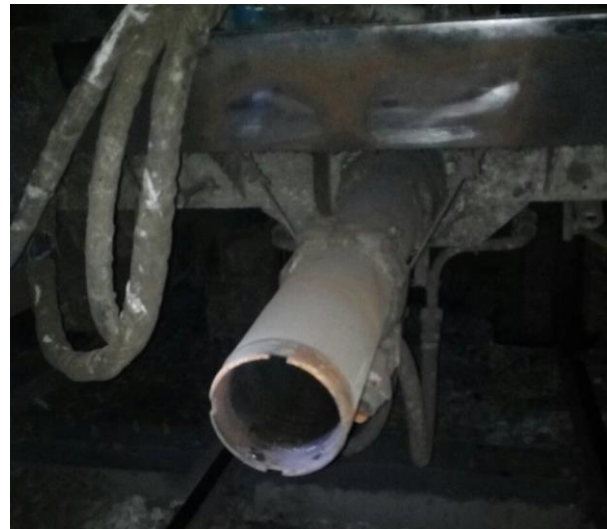
Fig. 3.1.2: Appearance of the part of decoupled clutch on the motor vehicle 412-061

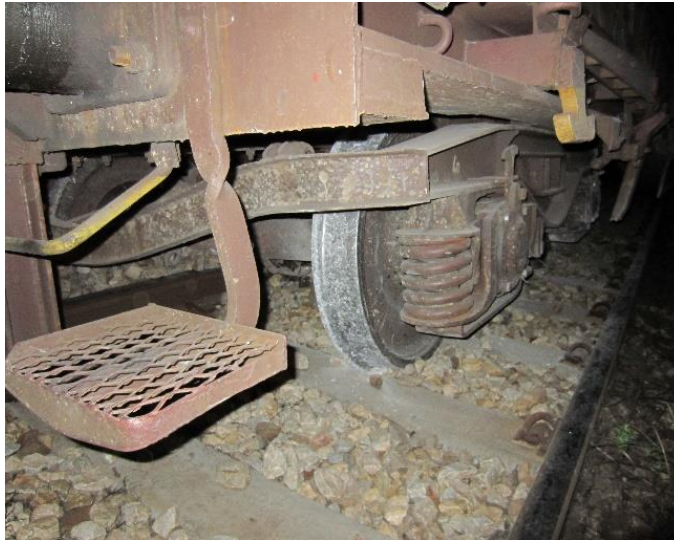
Fig. 3.2.1: Appearance of part of derailed bogie

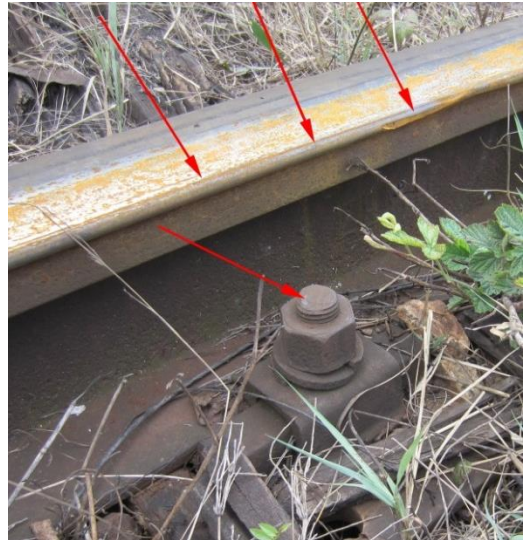
Fig. 3.2.2: First traces of derailment

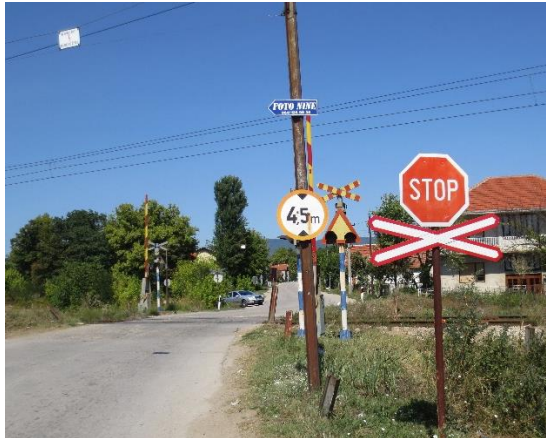
Fig. 3.3.1: Appearance of level crossing (from the direction of the settlement Kutleš)

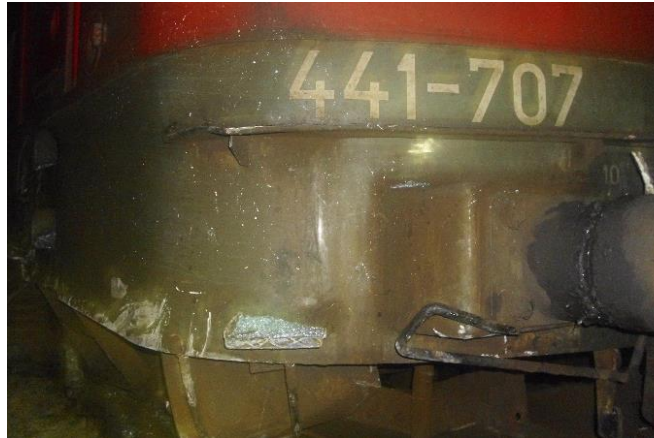
Fig. 3.3.2: Appearance of the damages on loc. 441-707

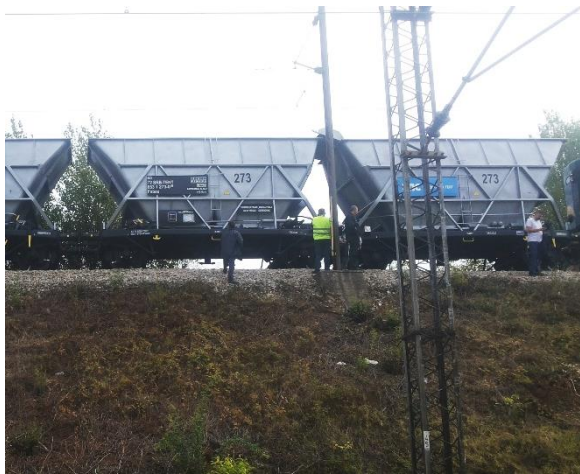
Fig. 3.4.1: Appearance of derailed wagon

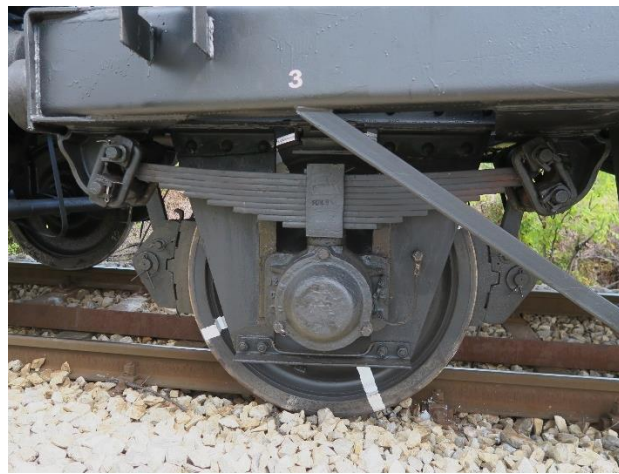
Fig. 3.4.2: Appearance of derailed wagon

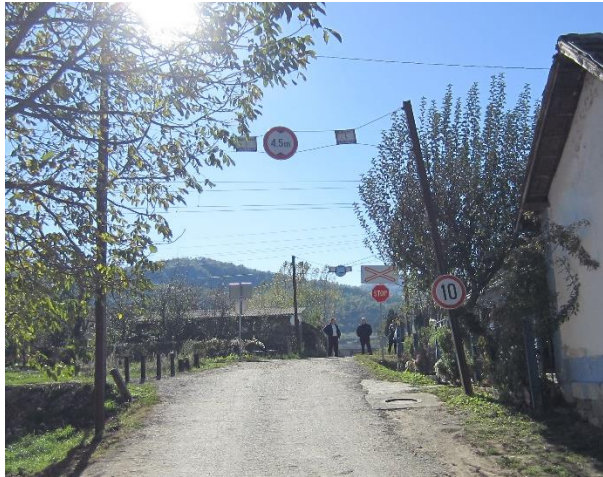
Fig. 3.5.1: Appearance of level crossing (viewed from the direction of center of Grdelica)

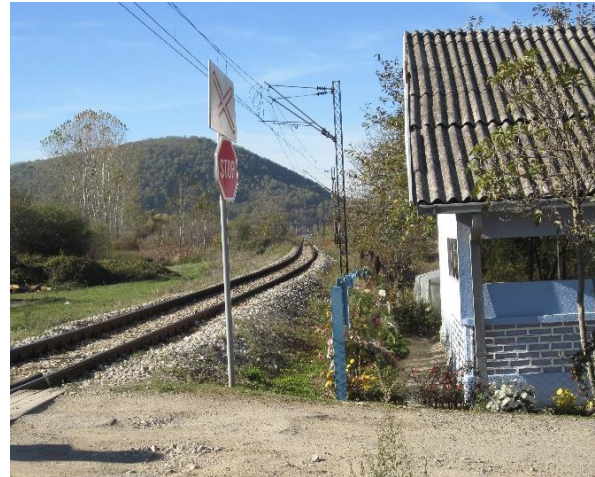
Fig. 3.5.2: Appearance of facility - watchtower

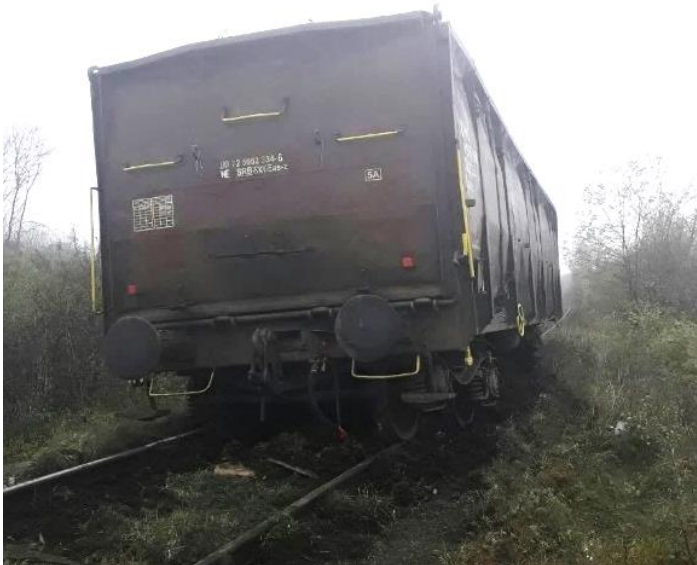
Fig. 3.6.1: Appearance of derailed wagon

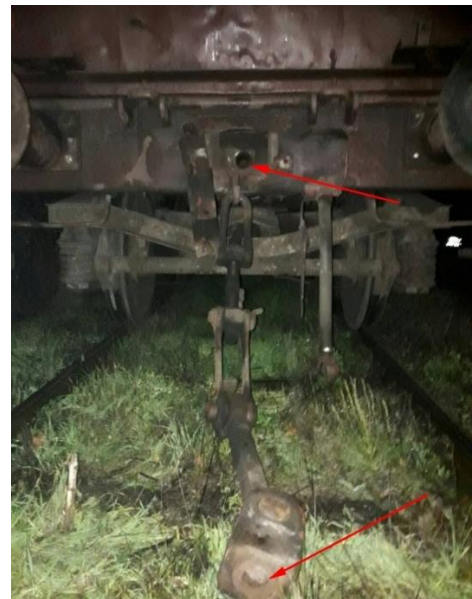
Fig. 3.6.2: Appearance of the point of decoupling

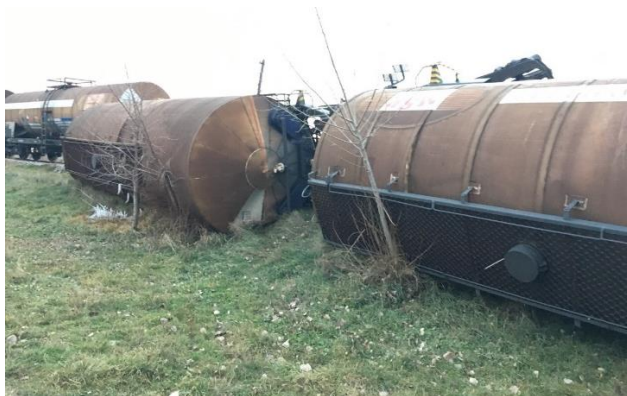
Fig. 3.7.1: Appearance of derailed wagon

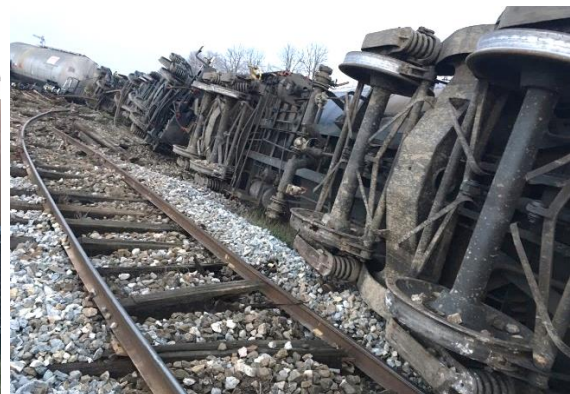
Fig. 3.7.2: Appearance of derailed wagon

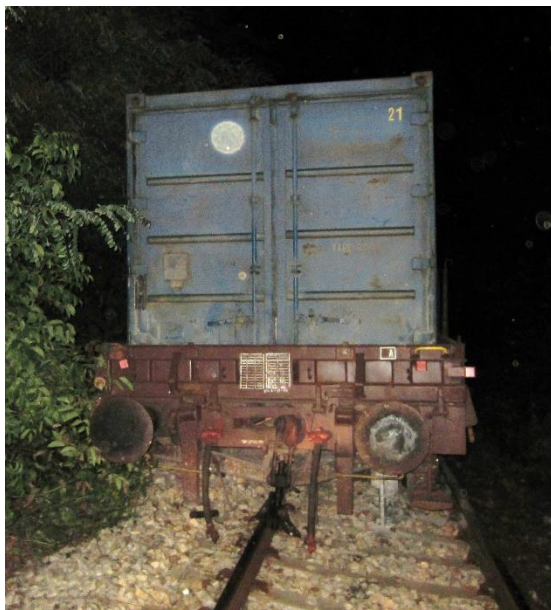
Fig. 4.1.1.1: Appearance of derailed wagon

The direct cause of the accident is unsatisfactory condition of the track on the section on which the accident occurred, and the missing loose fastening accessories and cracked or rotten sleepers in a series of sleepers of at least seven, in combination with partial enlargement of track over the exploitation maximum of +35 mm, where upon under the load occurred rail spacing and fall of front left wheel on the fifth wagon from the composition of the train in track.

Additional cause that facilitated the fall in the track is the fact that on the derailed wagon the thickness of the right flange, of the leading wheel, was at an accepted minimum (22mm).

The track condition on the section where the accident occurred is a direct consequence of the track maintenance, which is below the technically accepted minimum.

SR_01/17 Directorate shall define, as soon as possible, in the existing Rulebook on technical conditions for the maintenance of the railway superstructure ("Official Gazette of RS No. 39/2016 and 74/2016), limit conditions of the track superstructure and substructure elements that require immediate corrective actions or closing of the railway line until the unauthorized condition is eliminated.

SR_02/17 Directorate shall define in the existing Rulebook on technical conditions for the maintenance of the railway track superstructure ("Official Gazette of RS, No. 39/2016 and 74/2016), criteria for the periods in which the intermediate overhauling on the railway track superstructure shall be performed.

SR_03/17 "IŽS" a.d shall amend the Instruction on the Common Criteria for the Control of the Condition of Railway Lines on the Network of Yugoslav Railways, Instruction 339 (*Official Gazette of the ZJŽ No. 2/2001 and 4/2004*), which is, by the Decision of "IŽS" a.d, No. 4/2015-51-17 from 29 December 2015 still in force in "IŽS" a.d, in accordance with provisions from the Instruction 339 from 1989, mentioned in point 3.3.5. For future track inspection coach, recommended parameters are in accordance with the Standards: SRPS EN 13848-1, SRPS EN 13848-2, SRPS EN 13848-6.

SR_04/17 “IŽS” a.d. shall prescribe in its internal documents that, if during the measurement using the track inspection coach, there is a disruption in the continuity of the measurement, the control of the superstructure parameters must necessarily be carried out at the site of the resulting disruption and in the zone for which data are missing. The control aims to eliminate the cause of the measurement disruption and to check the condition of the superstructure, by visual control and measurement of the superstructure parameters with alternative measuring devices. After removing the cause of the disruption, it is necessary to repeat the measurement with track inspection coach on that kilometre.

SR_05/17 “IŽS” a.d. shall, having in mind inadequate maintenance and condition of the tracks, sleepers and fastening accessories, assess the risk of train traffic on the main arterial route Belgrade Marshalling Yard “A” - Junction “B” - Junction “K” - Resnik, on the section between junctions “B” and “K”.

SR_06/17 “Srbija Kargo” a.d. shall perform an additional training for the traction staff for the case of ejection of the traction protection, to check train condition by visual control from the locomotive cab (possible derailment), especially if after starting and removal of the protection, there are even the slightest twitches or uneven speeds.

SR_07/17 MGSI, Sector for Inspection, Group for inspection affairs of the Railway, shall perform an additional check of the condition of railway infrastructure on the main arterial route Belgrade Marshalling Yard “A” - Junction “B” - Junction “K” - Resnik, and, if necessary, take measures within its jurisdiction.

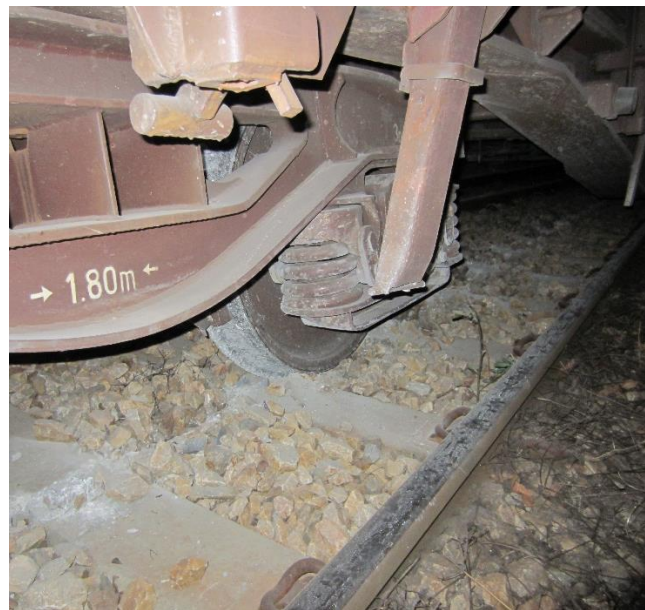
Fig. 4.1.1.2: Appearance of part of derailed bogie
