REPUBLIC OF SERBIA
CENTER FOR INVESTIGATION OF ACCIDENTS IN TRANSPORT
SECTOR FOR INVESTIGATION OF ACCIDENTS IN RAILWAY TRAFFIC
Nemanjina 11, 11000 Belgrade

No.: 06-00-7/2021-02-50-1

Date: 29.09.2021.

ANNUAL REPORT FOR 2020

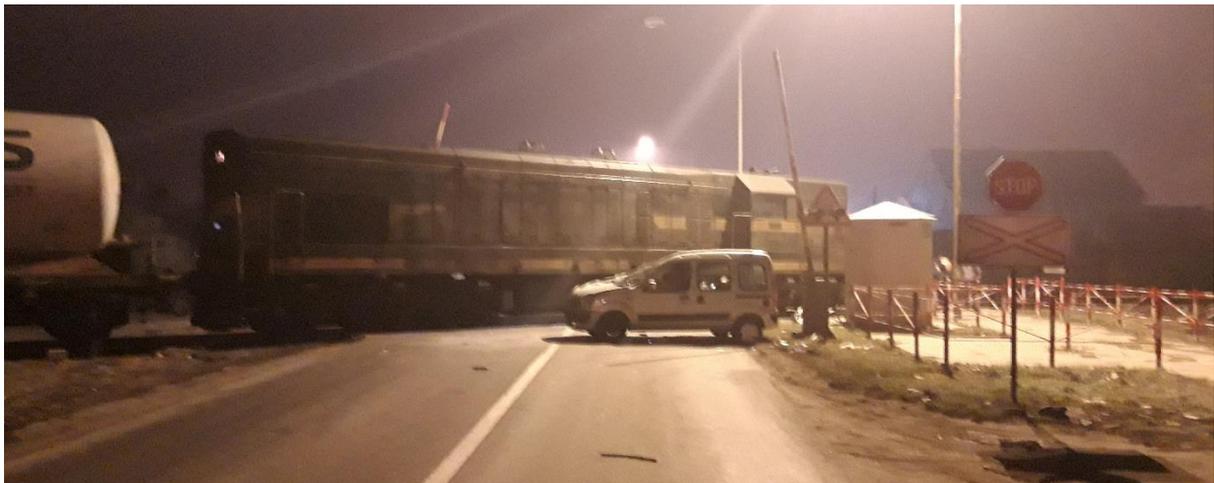
Upon overtaking, the shunting composition MS-4 continued further moving in the length of 12 m, after which it stopped (Figure 3.1.1.).

Figure 3.1.1: Appearance of the shunting locomotive 661-155 and the road passenger vehicle after the serious accident (view from the road, in the direction opposite to the direction of the road passenger vehicle movement, source: “NIS” a.d.)

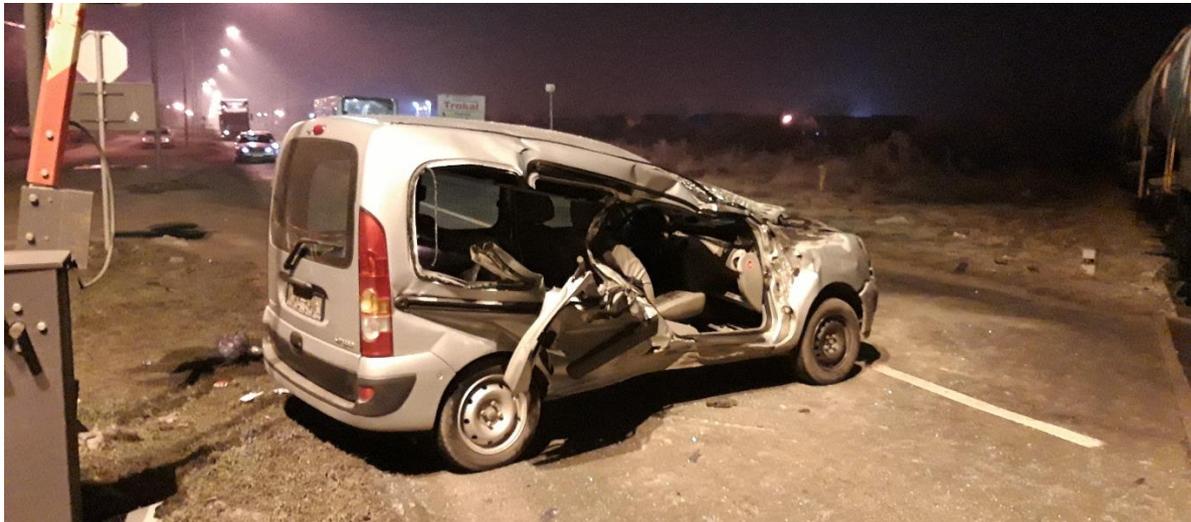
right side in relation to the direction of movement of the shunting composition MS-4, i.e., to the left side in relation to the direction of movement of the road passenger vehicle, in the next road lane, upon which the road passenger vehicle rotated 90°. On that occasion, the right side of the road passenger vehicle was significantly damaged (Figure 3.1.2.).

Figure 3.1.2: Appearance of the road passenger vehicle after the serious accident
(view in direction of the road passenger vehicle movement, source: “NIS”a.d.)

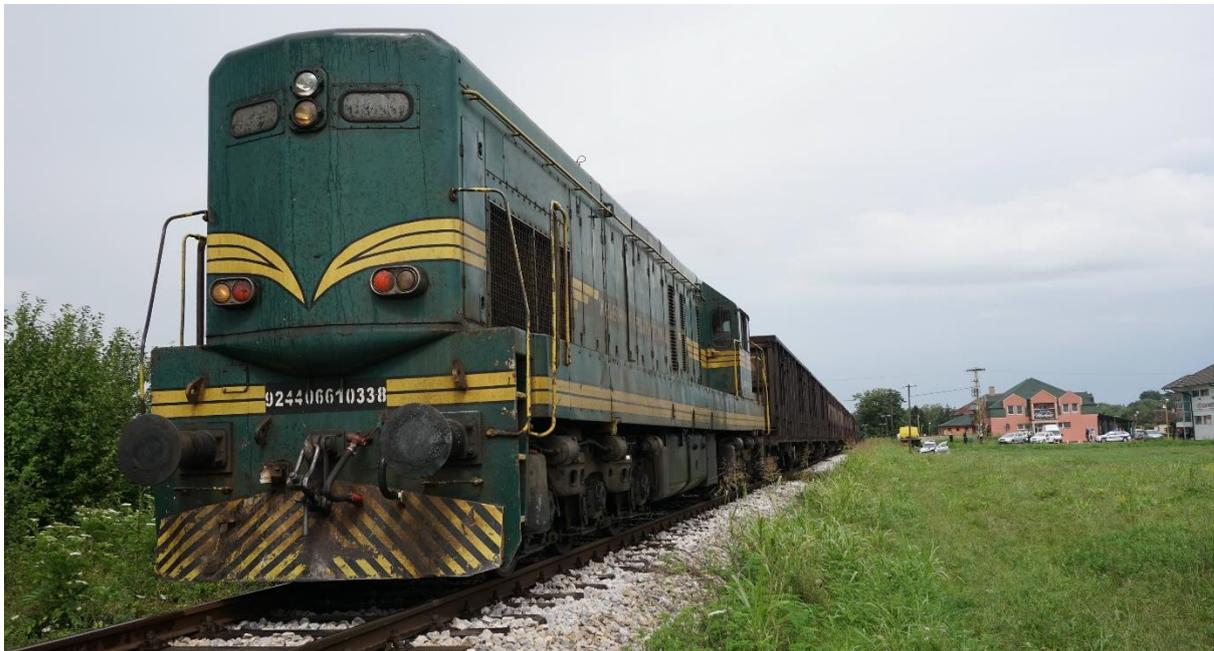
After the overtaking, the train No. 45403 continued its movement in the length of 145 m, after which it stopped, so that the front of the 661-033 series locomotive was found at km 20+792, with the longer part of the locomotive box ahead. On that occasion, no vehicle derailed out of the composition of the train No. 45403 (see Figure 3.2.1.).

Figure 3.2.1: The appearance of the train No. 45403 after the serious accident
(view in direction opposite to the direction of train movement)

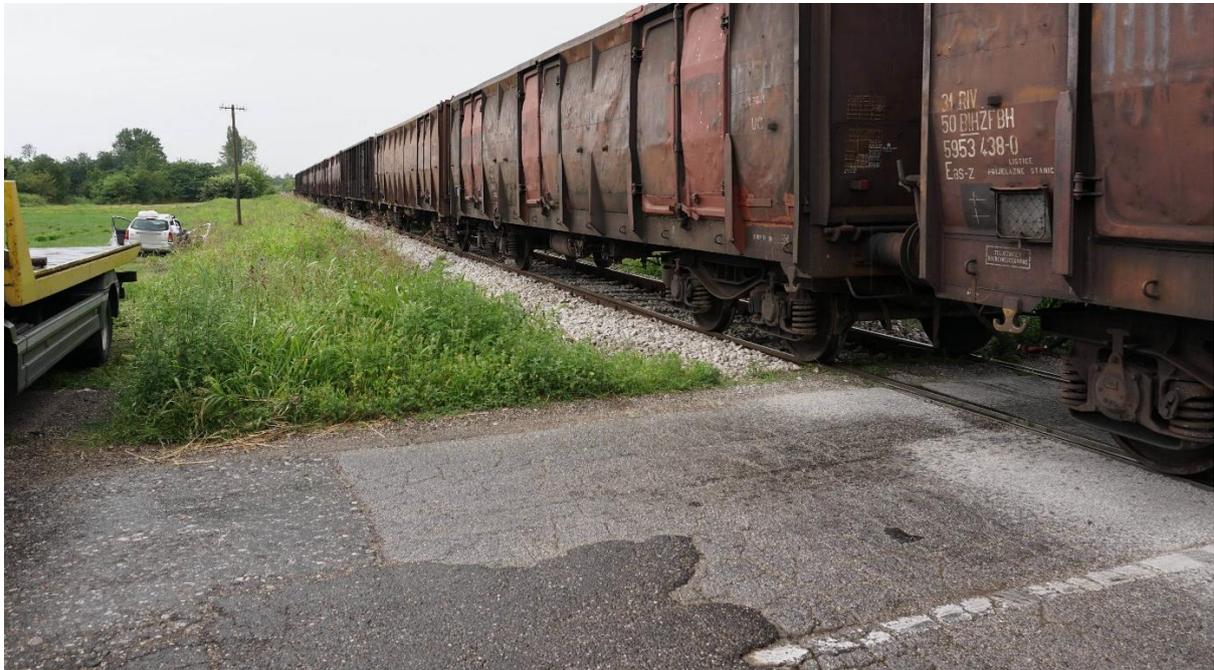
passenger vehicle was found on the left side of the track, seen in the direction of the train movement, i.e., in the direction of increasing stationing of the track, in a position parallel to the track, i.e. the train (see Figure 3.2.2.).

Figure 3.2.2: The appearance of the train No. 45403 and the road passenger vehicle after the serious accident (view in the direction of train movement)

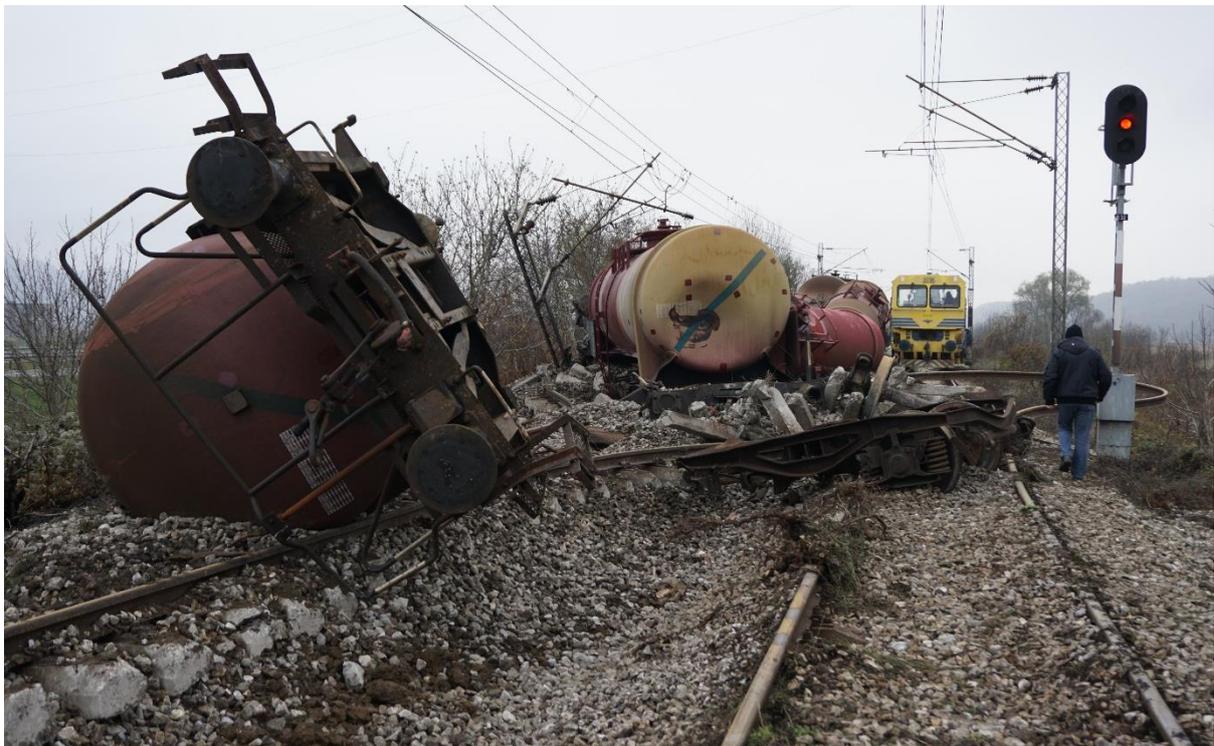
The appearance of the accident site (the point of derailment) is shown in Figure 3.3.1.

Figure 3.3.1: The view of the accident site (the point of derailment)

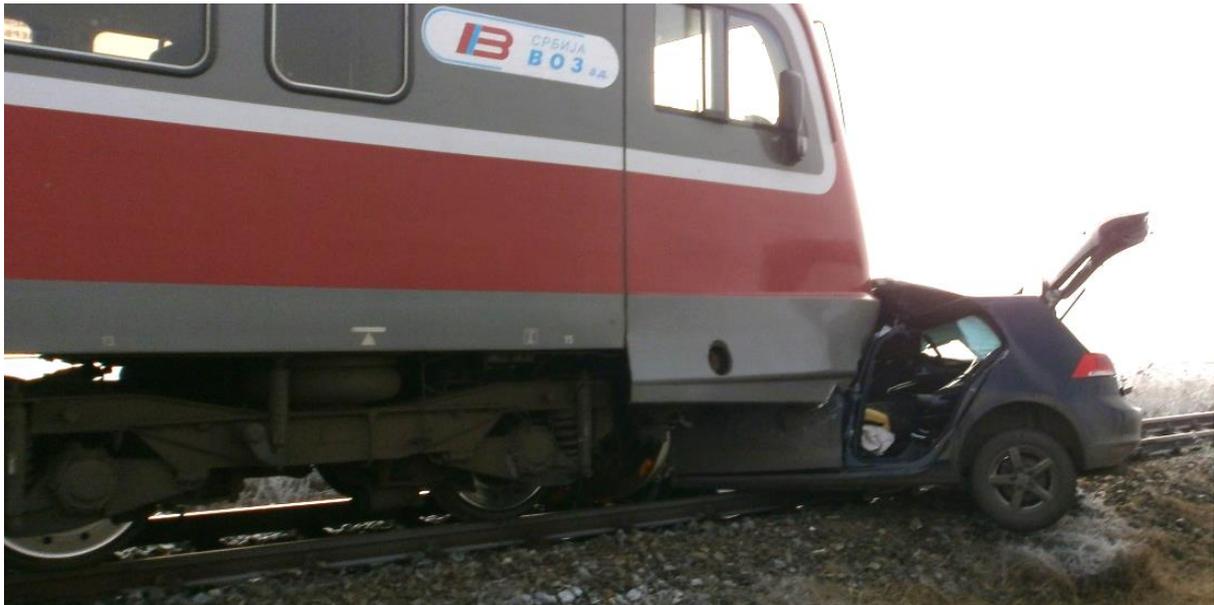
After overtaking, train No. 6431 continued its movement in the length of 165 m, after which it stopped. Due to the force of the impact, the road passenger vehicle crawled under the DMV 711-034 head (driver's cab), i.e. it remained stuck in the part between the DMV bumper and the track. On that occasion, the entire front part of the road passenger vehicle was significantly damaged (Figure 3.4.1. and 3.4.2.).

Figure 3.4.1: Appearance of DMV 711-033/034 and the road passenger vehicle after the serious accident (view from the free space between the railway line and the road, source: “IŽS”a.d.)

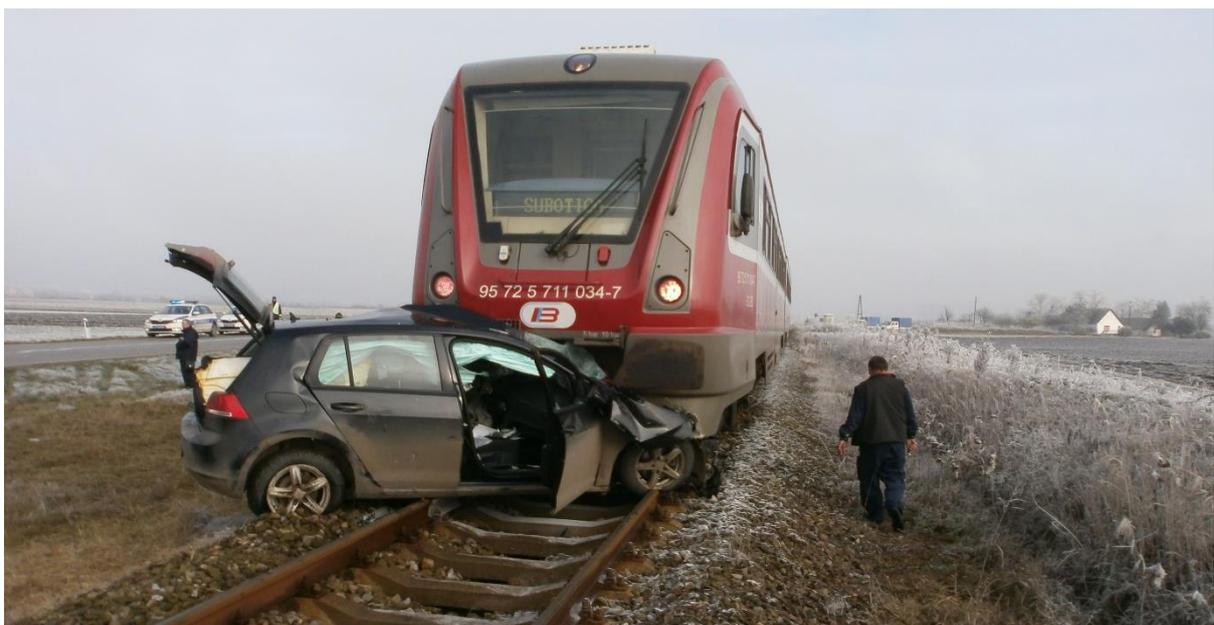
Figure 3.4.2: Appearance of the road passenger vehicle after the serious accident (view from the railway line, in the direction opposite from the direction of train movement, source: “IŽS”a.d.)

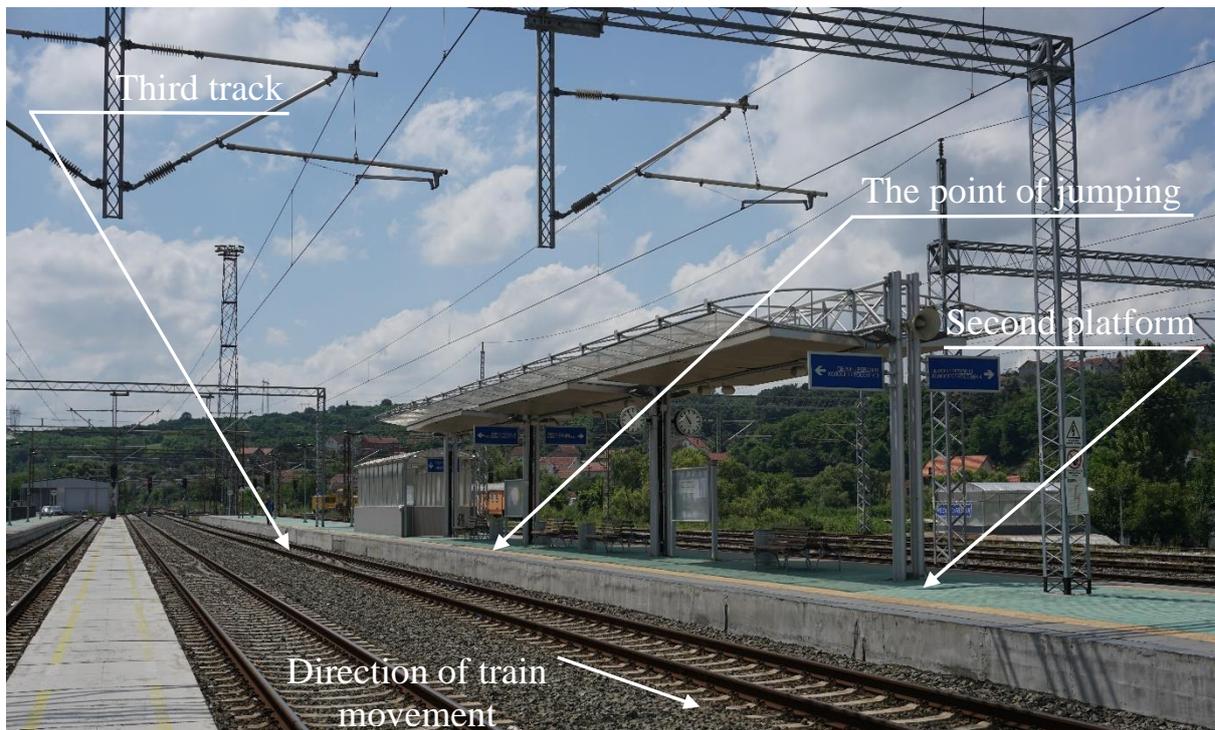
Figure 4.1.1.1: The appearance of the point of jumping
(view from the direction of the station facility - of the first station track)

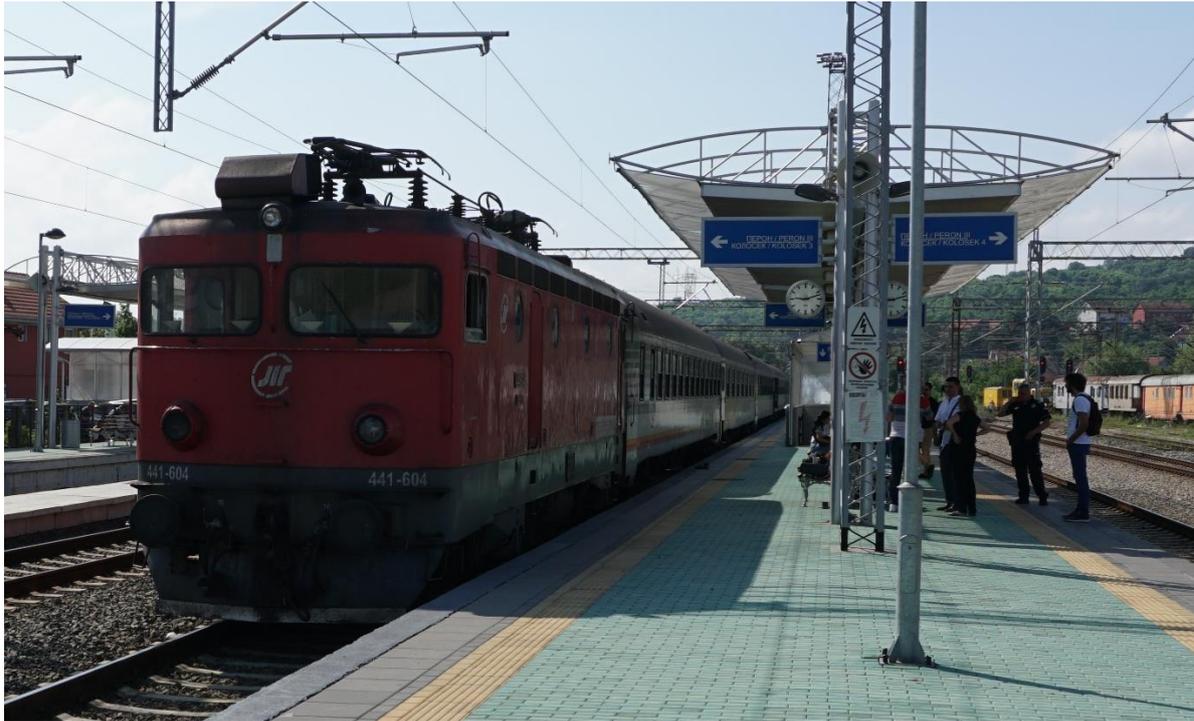
Figure 4.1.1.2: The appearance of the site where the train No. 432 stopped after the serious accident

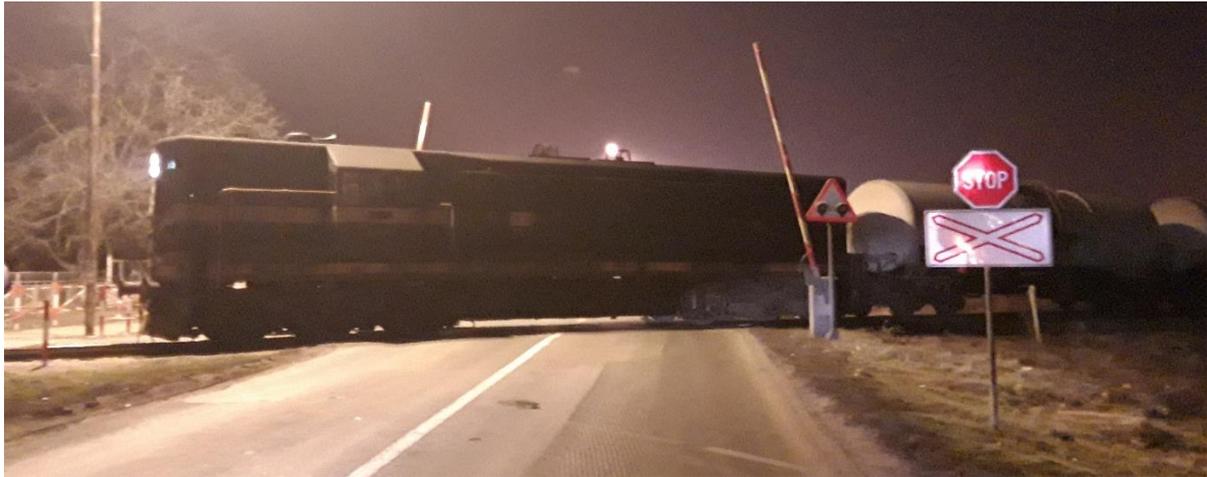
Figure 4.2.1.1: The appearance of the shunting composition locomotive 661-155 after the serious accident (view in the direction of road passenger vehicle, source: “NIS”a.d.)

Upon overtaking, the shunting composition MS-4 continued further moving in the length of 12 m, after which it stopped (Figure 4.2.1.1.).

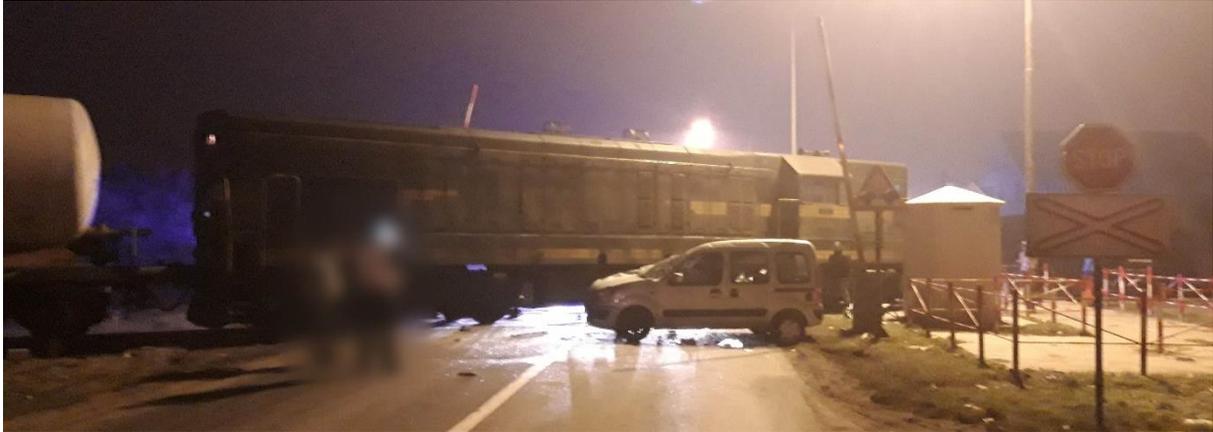
After the collision, the shunting composition MS-4 threw the road passenger vehicle to the right side in relation to the direction of movement of the shunting composition MS-4, i.e., to the left side in relation to the direction of movement of the road passenger vehicle, in the next road lane, upon which the road passenger vehicle rotated 90°. On that occasion, the right side of the road passenger vehicle was significantly damaged (Figure 4.2.1.2.).

Figure 4.2.1.2: The appearance of the shunting locomotive 661-155 and the road passenger vehicle after the serious accident (view from the road in the direction opposite of the road passenger vehicle movement direction, source: "NIS"a.d.)
