REPUBLIC OF SERBIA,
CENTER FOR INVESTIGATION OF ACCIDENTS IN TRANSPORT,
SECTOR FOR INVESTIGATION OF ACCIDENTS IN RAILWAY TRAFFIC,
Nemanjina 11, 11000 Belgrade

Date: 27.09.2022.

ANNUAL REPORT FOR 2021

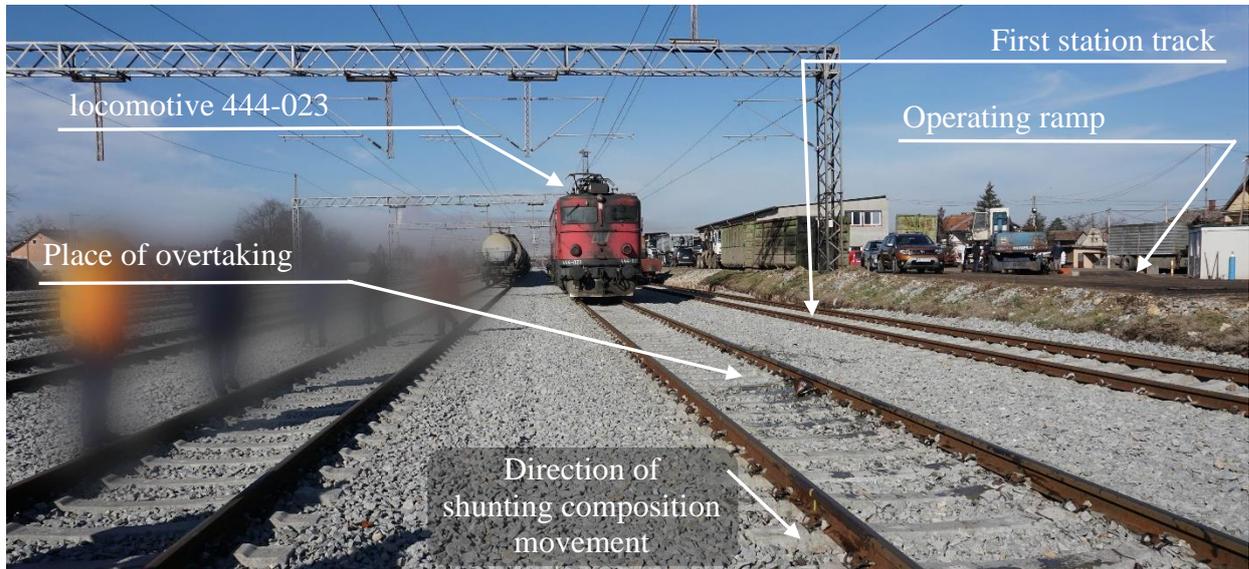
Under these conditions, there occurred an overtaking of the pulled shunting composition on the auxiliary worker. The overtaking occurred in such a way with the head of the locomotive 441-510 (locomotive dozer blade) hitting the auxiliary worker, who fell off the track from the impact, after which the entire shunting composition crossed over him. On that occasion, the auxiliary worker suffered severe bodily injuries, from which he died on the spot.

Figure 3.1.1: The appearance of the serious accident site after the overtaking of a shunting composition on a railway worker (view from direction of the switch block 2 to the station facility)

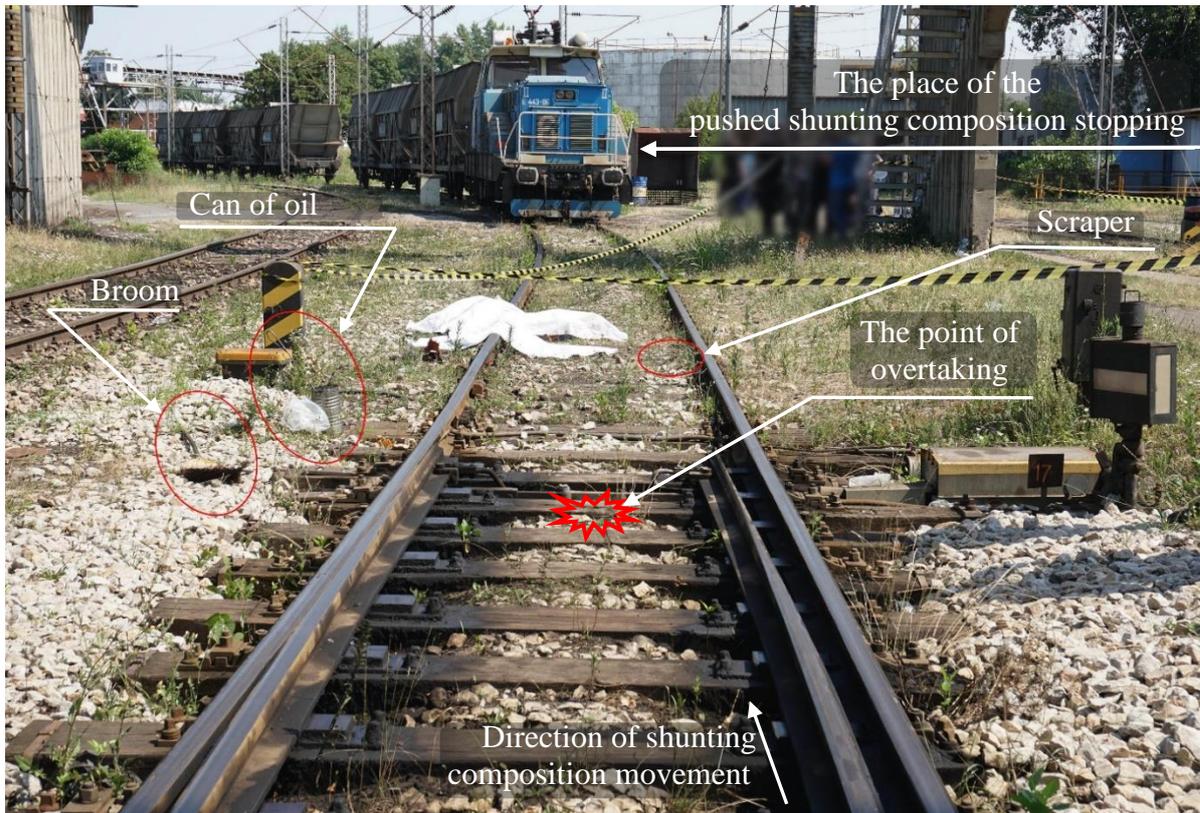
Under these conditions, there occurred a collision of the pushed shunting composition on the railway worker. The collision occurred when the front of the shunting composition (middle of the front part of the Arbel type wagon, Faboo series individual No. 43 72 6531 314-2) hit a railway worker in the area of his back, who from the impact fell into the track, after which the entire shunting composition crossed over him. On that occasion, the railway worker suffered severe bodily injuries, from which he died on the spot.

Figure 3.2.1: The appearance of the place of the serious accident after the overtaking of the pushed shunting composition on the railway worker (view from the direction of the second track to the second turnout track)

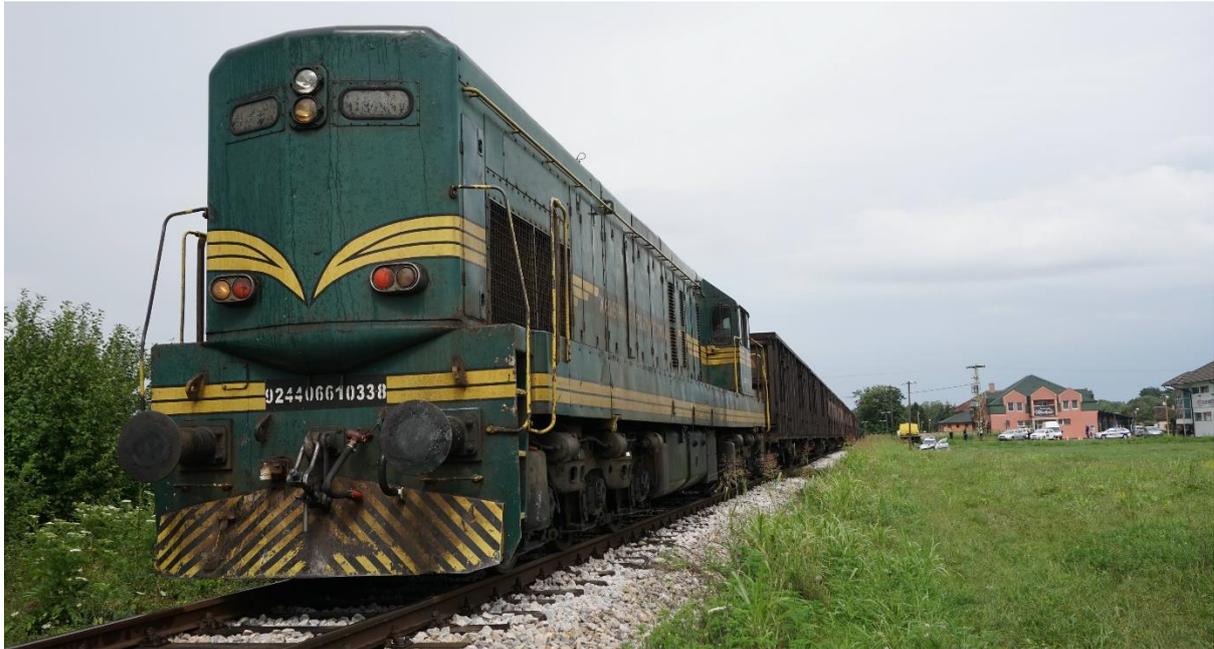
After the overtaking, the train No. 45403 continued its movement in the length of 145 m, after which it stopped, so that the front of the 661-033 series locomotive was found at km 20+792, with the longer part of the locomotive box ahead. On that occasion, no vehicle derailed out of the composition of the train No. 45403 (see Figure 4.1.1.1.).

Figure 4.1.1.1: View of the train No. 45403 after the serious accident
(view in direction opposite to the direction of train movement)

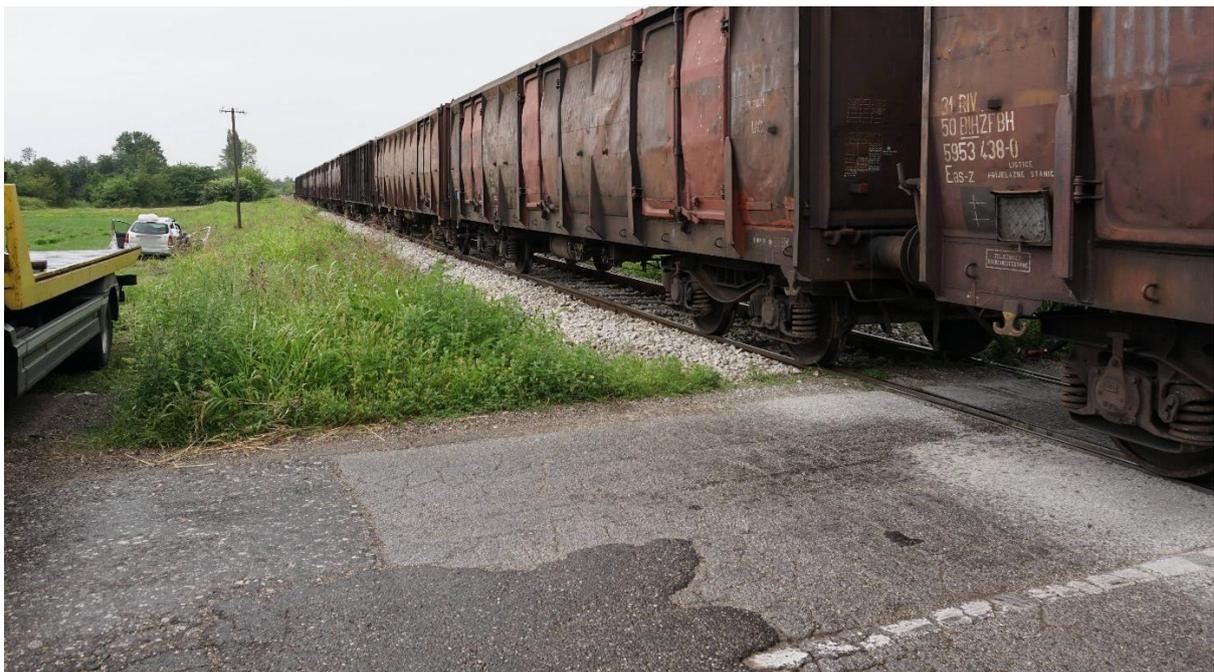
After the impact, the train threw the road passenger vehicle next to the track, to the left in relation to the direction of the train, after which the road passenger vehicle continued moving along the track for approximately 30 m, after which it stopped. The road passenger vehicle was found on the left side of the track, seen in the direction of the train, i.e. in the direction of increasing stationing of the track, in a position parallel to the track, i.e. the train (see Figure 4.1.1.2.).

Figure 4.1.1.2: View of the train No. 45403 and the road passenger vehicle after the serious accident
(view in the direction of train movement)

Direct and immediate cause of the occurrence of the respective serious accident is that the road passenger vehicle was on track just before arrival of the train No. 45403, thus creating dangerous situation related to the occurrence of this serious accident.

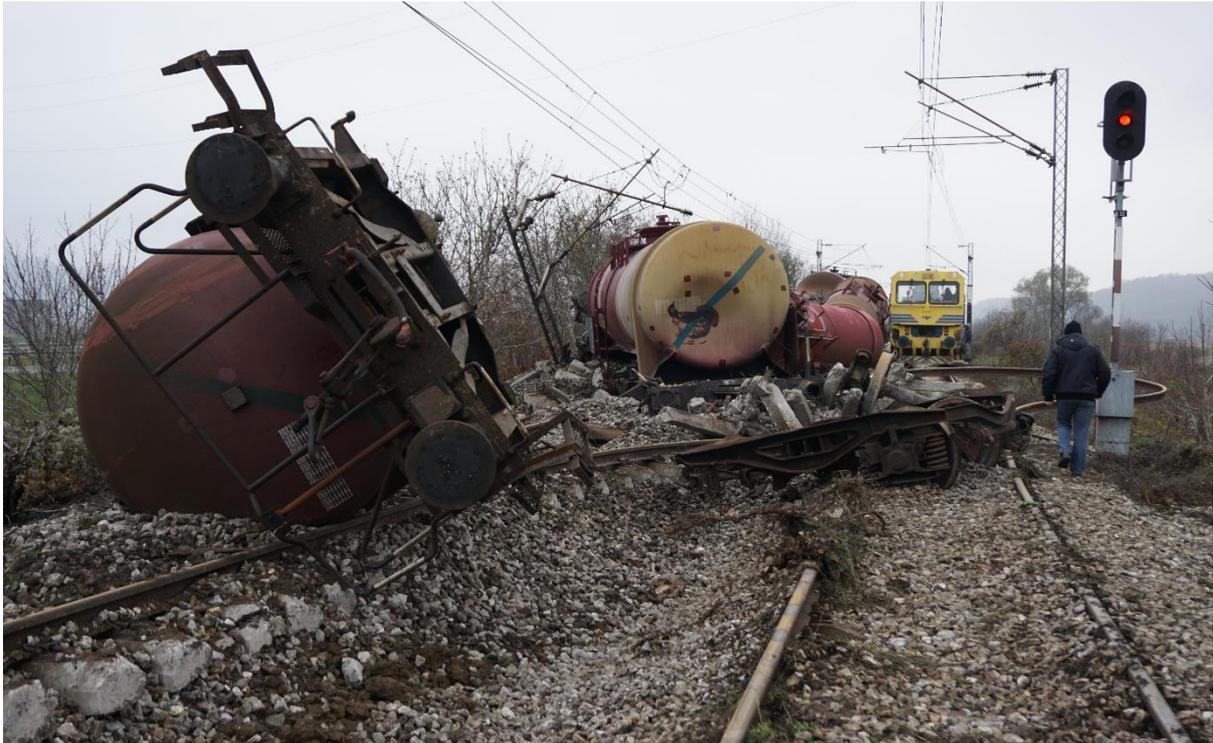
Figure 4.2.1.1: View of the accident site (the point of derailment)

Based on the facts and evidence determined during on-site investigation by the Working Group of CINS and data submitted, the probable direct and immediate cause of the accident is decoupling of the track which was not maintained in accordance with Articles 74 and 76 of the Rulebook on technical conditions and maintenance of the superstructure of railways ("Official

Maintenance of the railway line on the observed section was not performed in accordance with the Rulebook on technical conditions and maintenance of the superstructure of railways (“Official Gazette of RS” No. 39/16 and 74/16) having in mind the years of the last railway repairs, as well as insufficient number of executors, machinery and tools.

SR_12/21 Directorate for Railways, to consider the justification of the abolition of Paragraph 9 of Article 8 of the Rulebook on technical conditions and maintenance of railway lines superstructure (“Official Gazette of RS”, No. 36/16), which reads: “Alternate (mixed) installation of wooden and concrete sleepers is not allowed” and justification to return via amendments the Article 8 of the Rulebook on technical conditions and maintenance of railway lines superstructure (“Official Gazette of RS”, No. 36/16 and 74/16).

SR_13/21 “IŽS” a.d., to conduct the risk assessment of train traffic on the main arterial line 102: Belgrade Center - Junction “G” - Rakovica - Mladenovac - Lapovo - Niš - Preševo - state border - (Tabanovce), left track, from Markovac station (exclusively) km 101+057 to Jagodina station (inclusive) km 136+000, given the inadequate maintenance and condition of tracks, sleepers and fasteners and the insufficient number of executors for maintenance from the construction industry; and take measures to reduce the risk to an acceptable level.

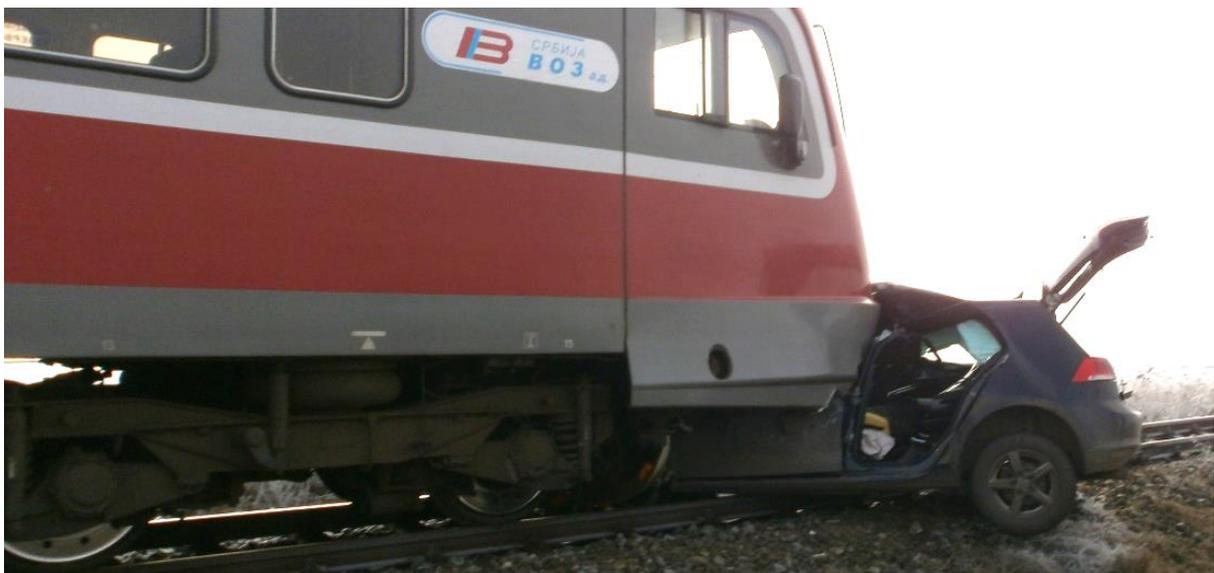
After overtaking, train No. 6431 continued its movement in the length of 165 m, after which it stopped. Due to the force of the impact, the road passenger vehicle crawled under the DMV 711-034 head (driver’s cab), i.e. it remained stuck in the part between the DMV buffer and the track. On that occasion, the entire front part of the road passenger vehicle was significantly damaged.

Figure 4.3.1.1: Appearance of DMV 711-033/034 and the road passenger vehicle after the serious accident (view from the free space between the railway line and the road, source: “IŽS” a.d.)

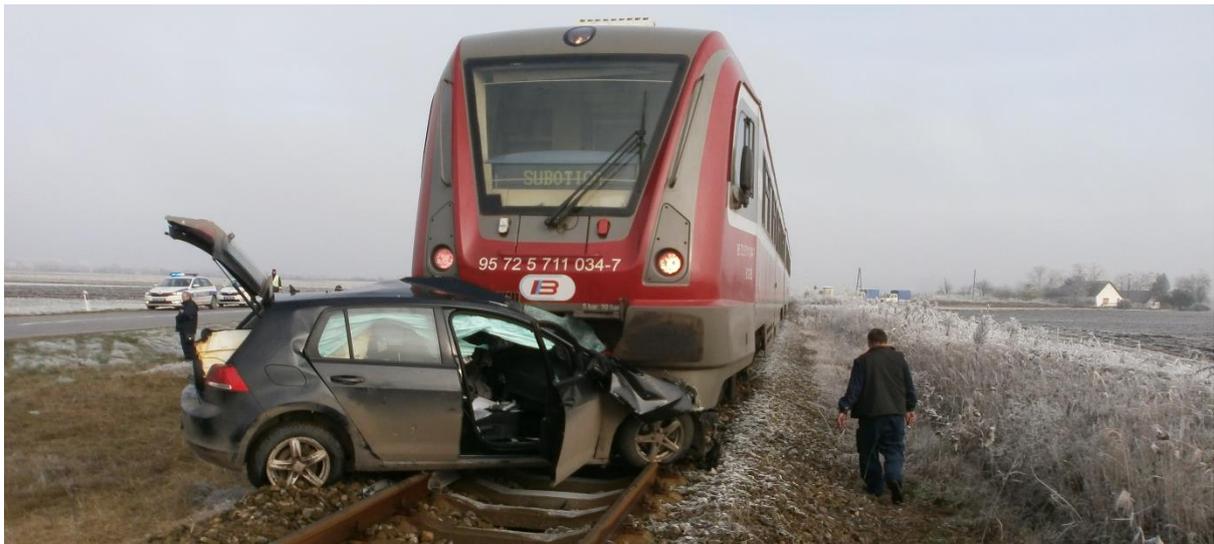
Figure 4.3.1.2: Appearance of the road passenger vehicle after the serious accident (view from the railway line, in the direction opposite from the direction of train movement, source: “IŽS”a.d.)
