**REPUBLIC OF SERBIA**  
**CENTER FOR INVESTIGATION OF ACCIDENTS IN TRANSPORT**  
**SECTOR FOR INVESTIGATION OF ACCIDENTS IN RAILWAY TRAFFIC**  
**Nemanjina 11, 11000 Belgrade**

**No.: 340-00-9/2019-02-21-1**

# **ANNUAL REPORT FOR 2018**

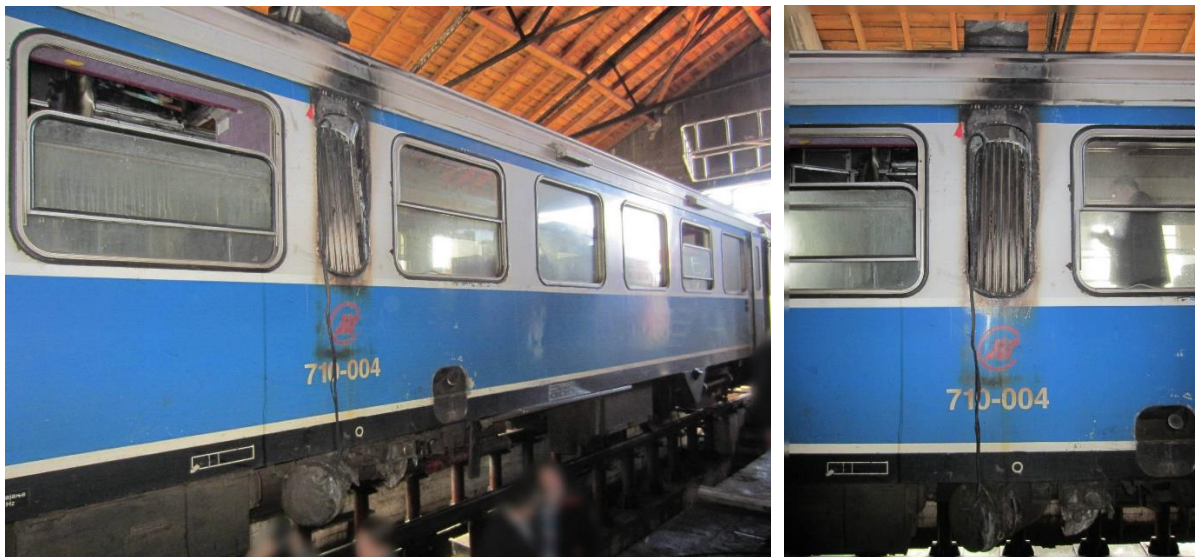
Figure 3.1.1: The appearance of DMK 710-004 caught on fire (middle part from the outside)

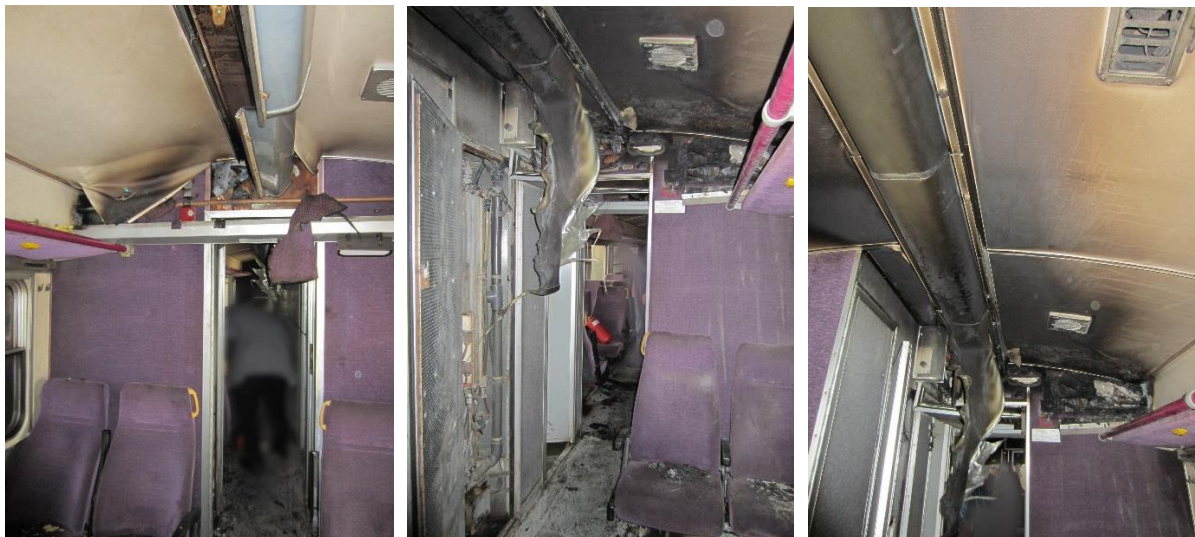
Figure 3.1.2: View on passenger compartment DMK 710-004 on fire

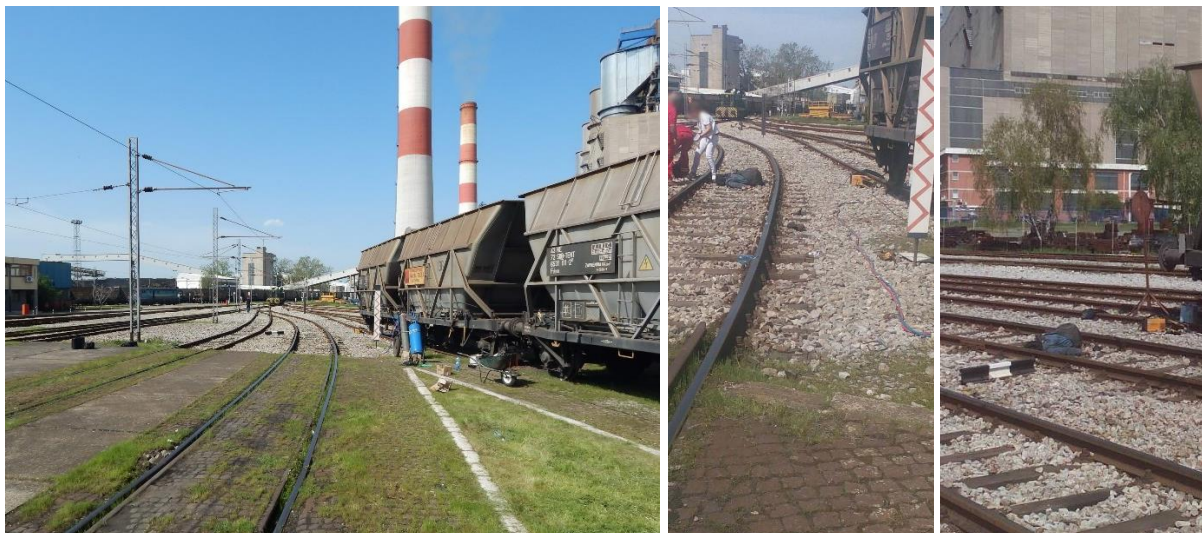
**Figure 3.2.1:** The appearance of the accident site where it came to overtaking of the loc. CEM-7 on the worker

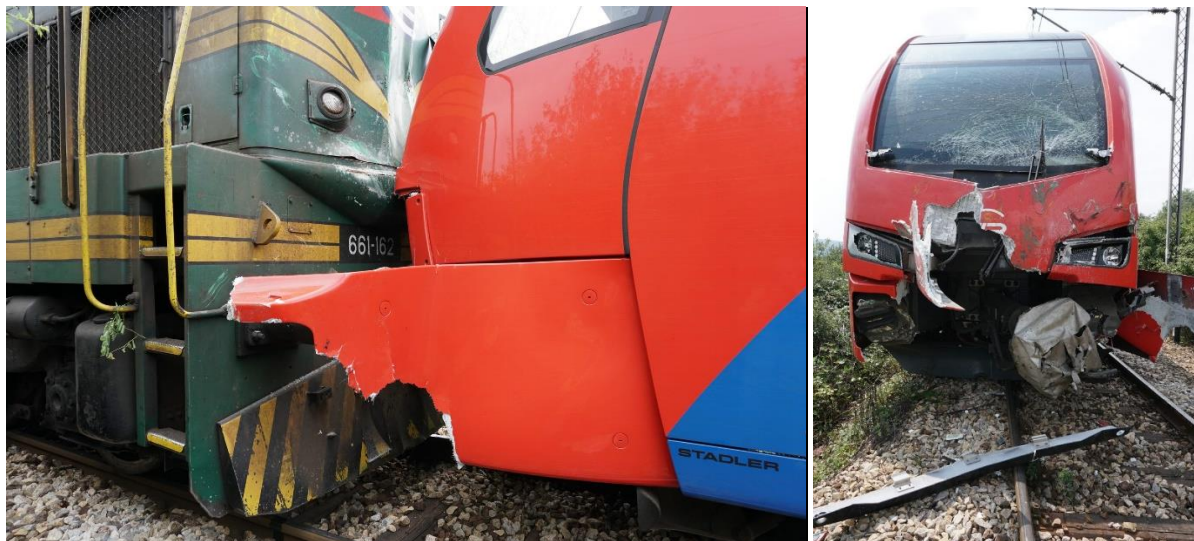
**Figure 3.3.1:** The appearance of the damage on the railway vehicles after the collision of trains

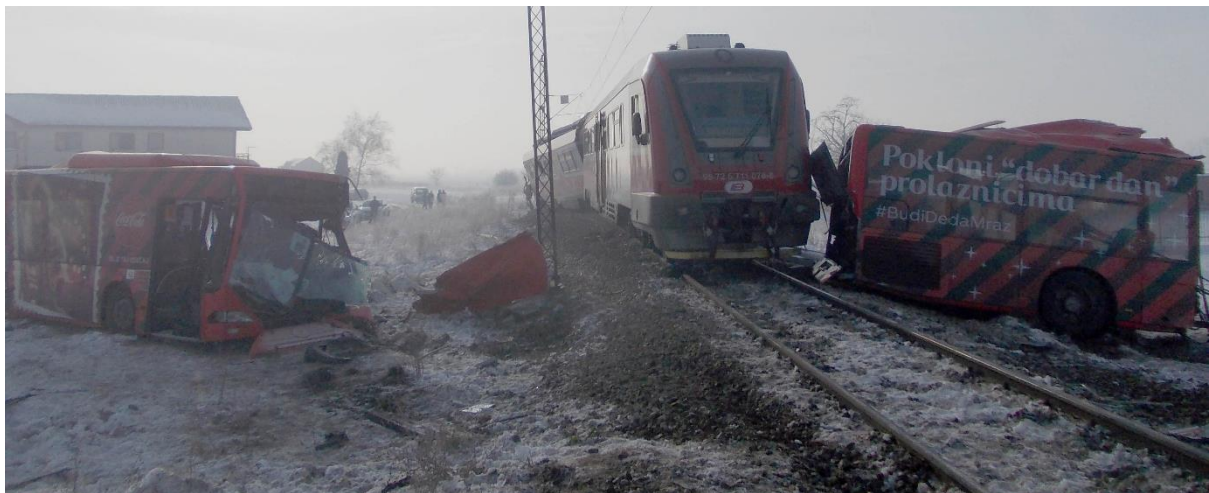
**Figure 3.4.1:** Appearance of the vehicle after the serious accident (view in direction to the end of the vehicle)

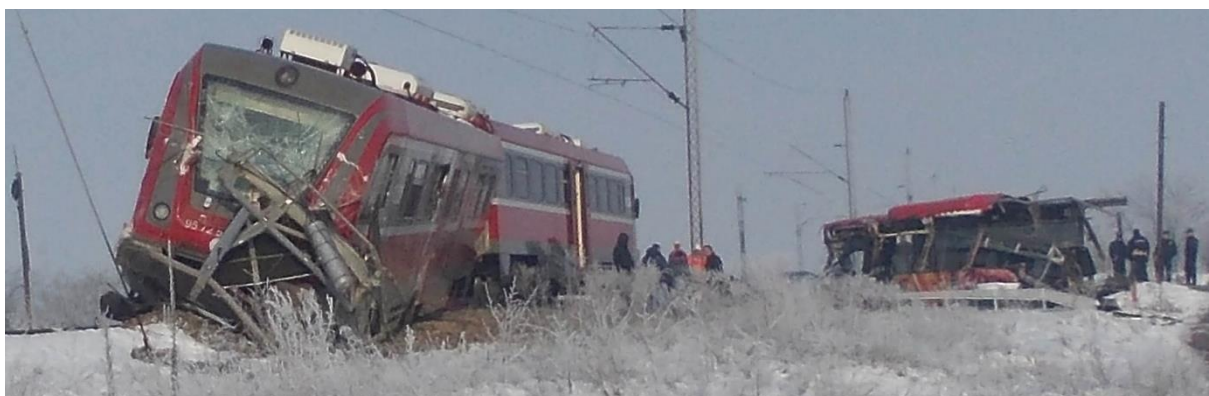
**Figure 3.4.2:** Appearance of vehicle after the serious accident (view in direction to the head of the train)

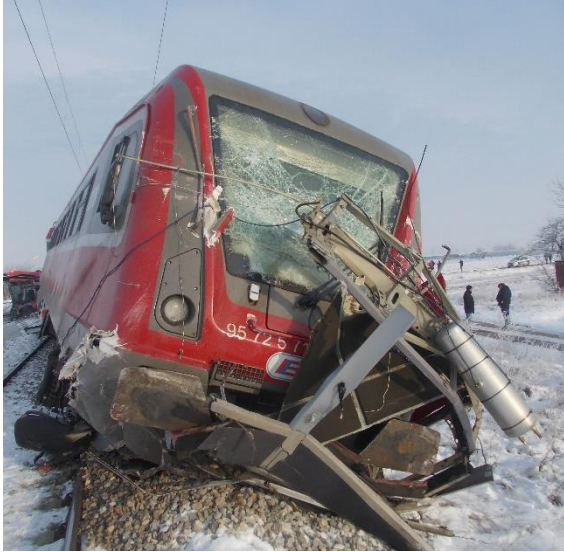
**Figure 3.4.3:** Appearance of the head of the train

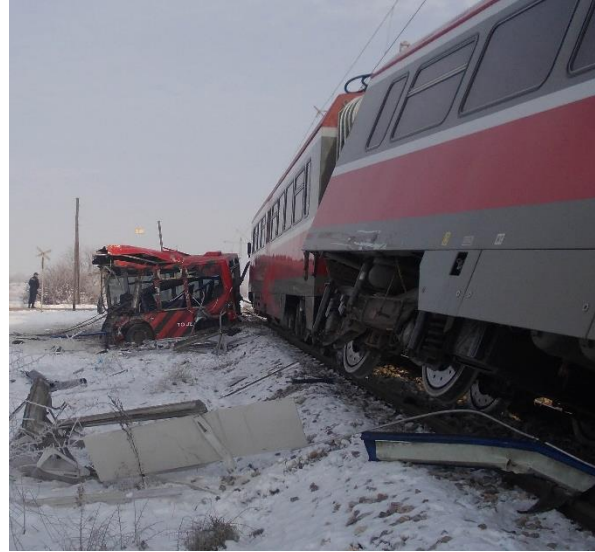
**Figure 3.4.4:** Appearance of the part of the side of the train and rear of the bus

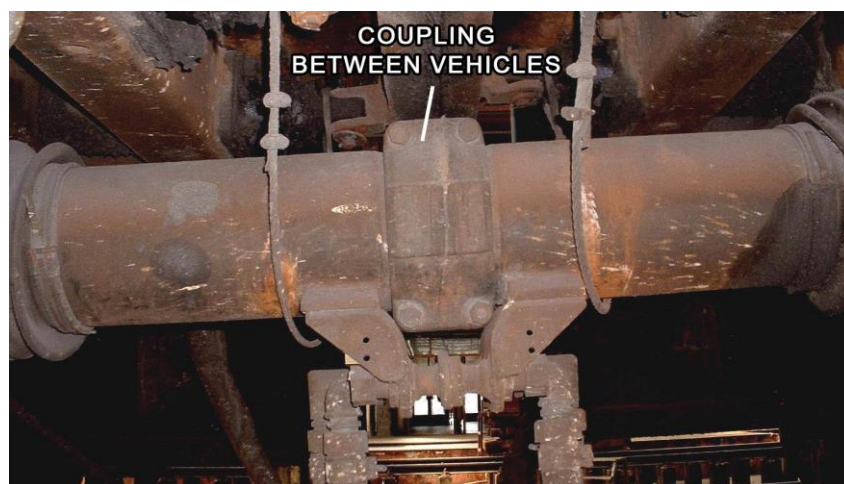
Figure 4.1.1.1: Appearance of the coupling between vehicles installed in EMV series 412/416

Based on the analysis performed, it can be concluded that the immediate cause of the incident is the wear of the threaded joint between the nut of the draw bar set and the housing of the tight coupling between vehicles, due to which the threaded joint uncoupled during the ride.

In the last regular repair in 2012, the threaded joint was not properly checked and controlled. In addition, the check list for the threaded joint has no prescribed margin (limit value), which means that it is not clearly defined when the threaded joint has to be repaired or replaced.

- SR\_01/18** “Srbija Voz“a.d. should make changes in the measurement sheet IB:594 244 so that the wording “Measurement limit“ is replaced with “Measurement limit  $d-DI$ “ and based on a corresponding analysis (calculation and similar) it should define and enter in the measurement sheet the limit value for safe operation between two regular repairs (explained in item 4.2.3).

- SR\_02/18** “Srbija Voz“a.d. should consider the possibility to make structural changes on the couplings between vehicles during regular repairs of EMV 412/416 in order to provide for a back-up alternative force transmission in case that the threaded connection is separated, or to apply other measures to reduce the risk of separation of the threaded joint (explained in item 4.2.3).

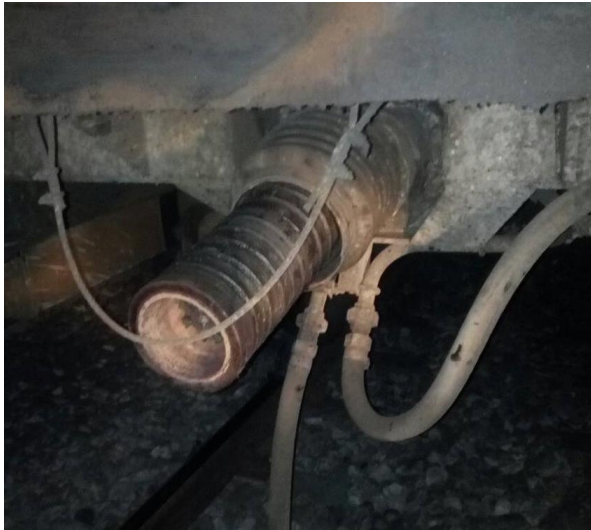
**Figure 4.1.1.2:** Appearance of a part of the decoupled coupling on the trailer 416-004

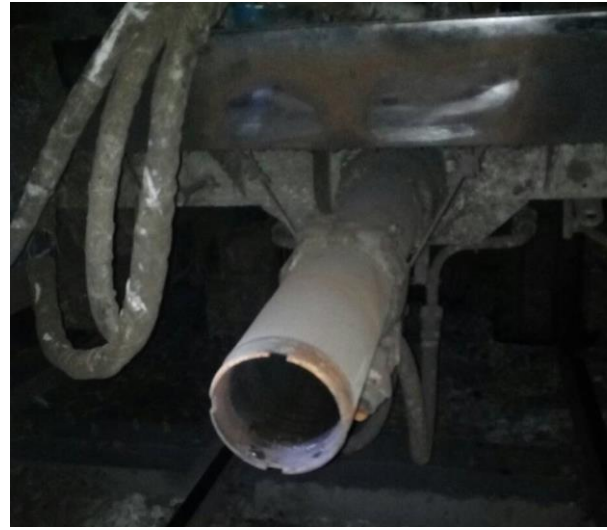
**Figure 4.1.1.3:** Appearance of a part of the decoupled coupling on the power car 412-061

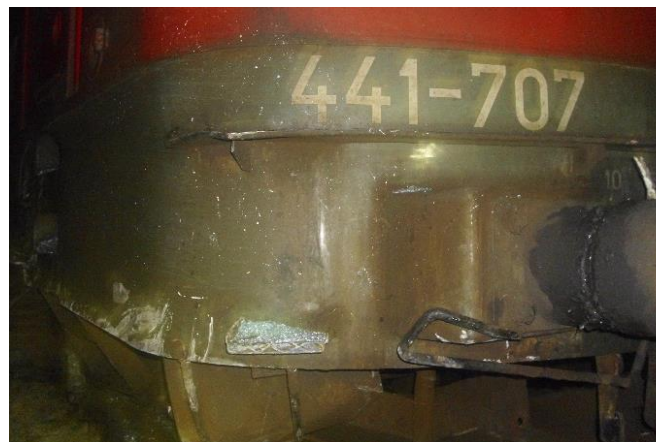
**Figure 4.2.1.2:** The appearance of the damages on the loc. 441-707

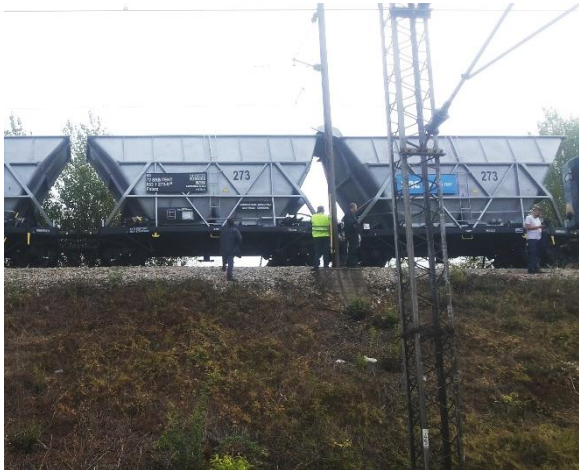
Figure 4.3.1.1: Appearance of the derailed wagon

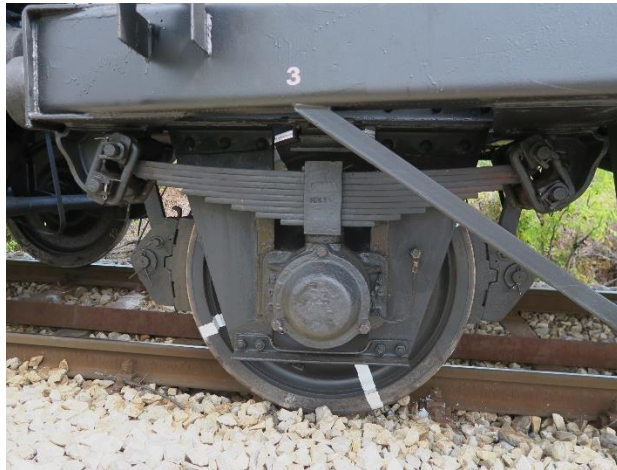
Figure 4.3.1.2: Appearance of the derailed wagon

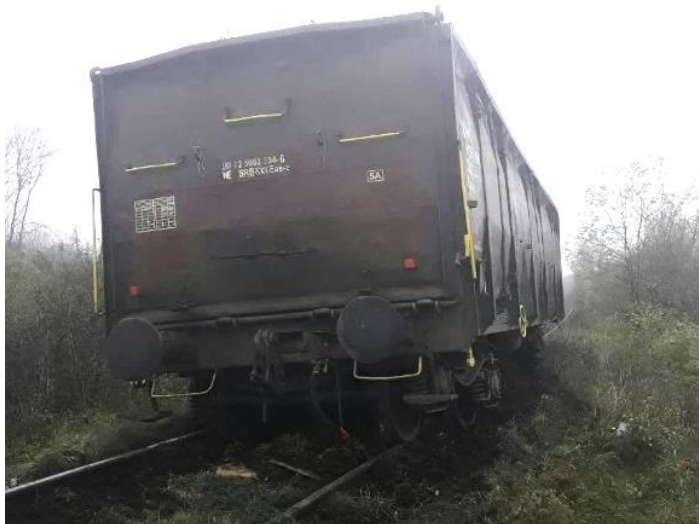
Figure 4.5.1.1: Appearance of the derailed wagon

Derailed wagon was found in the area of track on its wheels. There was no tilting or overturning of the wagon and there was no movement or dissipation of the load.

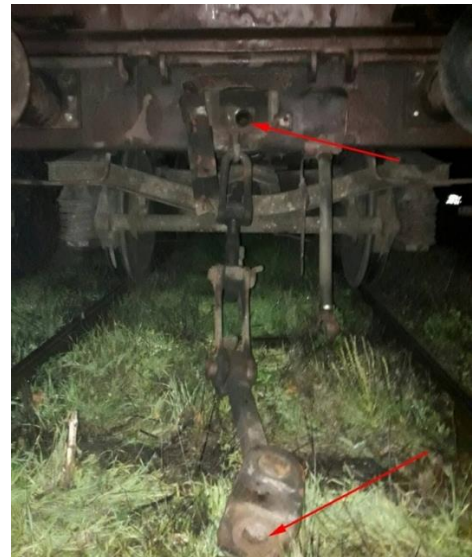
Figure 4.5.1.2: Appearance of the point of decoupling

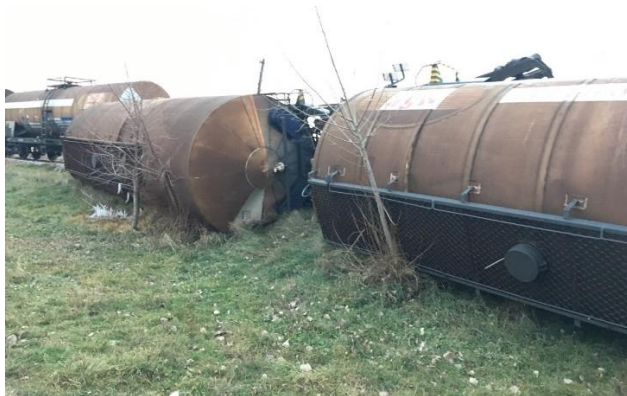
**Figure 4.6.1.1:** Appearance of the derailed wagon

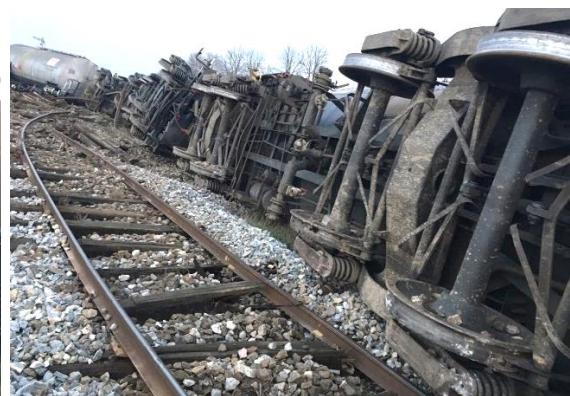
**Figure 4.6.1.2:** Appearance of the derailed wagon
