**REPUBLIC OF SERBIA**  
**CENTER FOR INVESTIGATION OF ACCIDENTS IN TRANSPORT**  
**SECTOR FOR INVESTIGATION OF ACCIDENTS IN RAILWAY TRAFFIC**  
**Nemanjina 11, 11000 Belgrade**

**No.: 340-00-7/2023-02-34**

# **ANNUAL REPORT FOR 2022**

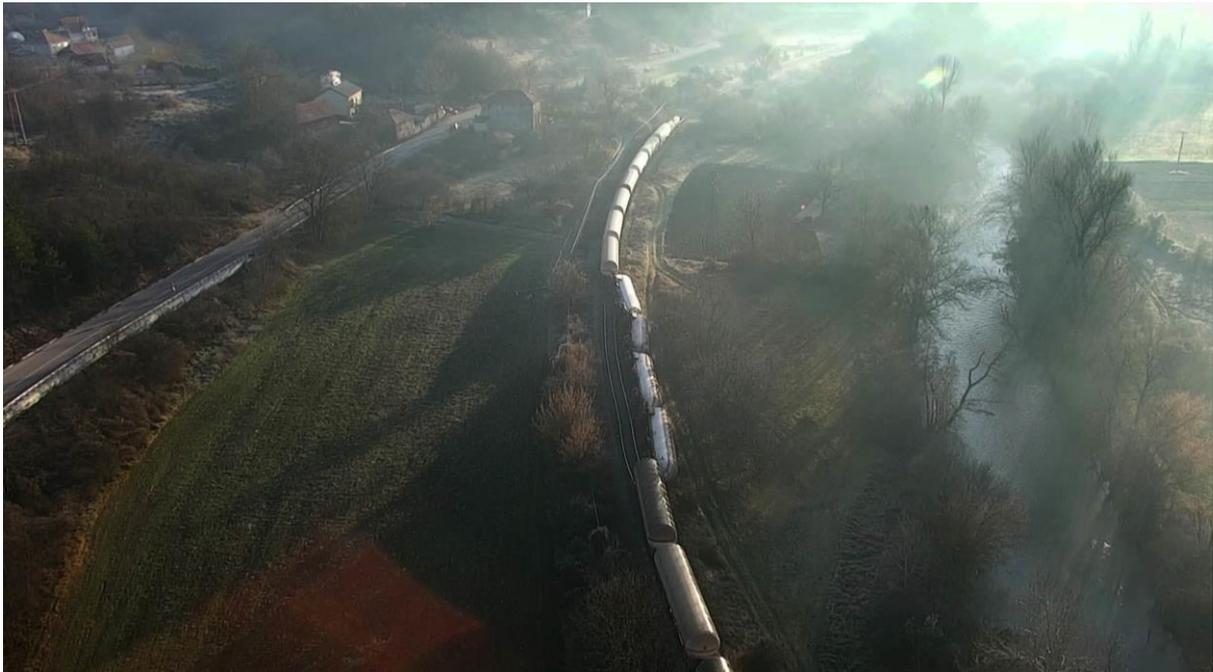
From the overturned thirteenth wagon No. 33 80 7818 081-1, there occurred ammonia leakage.

**Figure 3.1.1:** The appearance of the serious accident site (source: MUP, Sector for Emergency Situations)

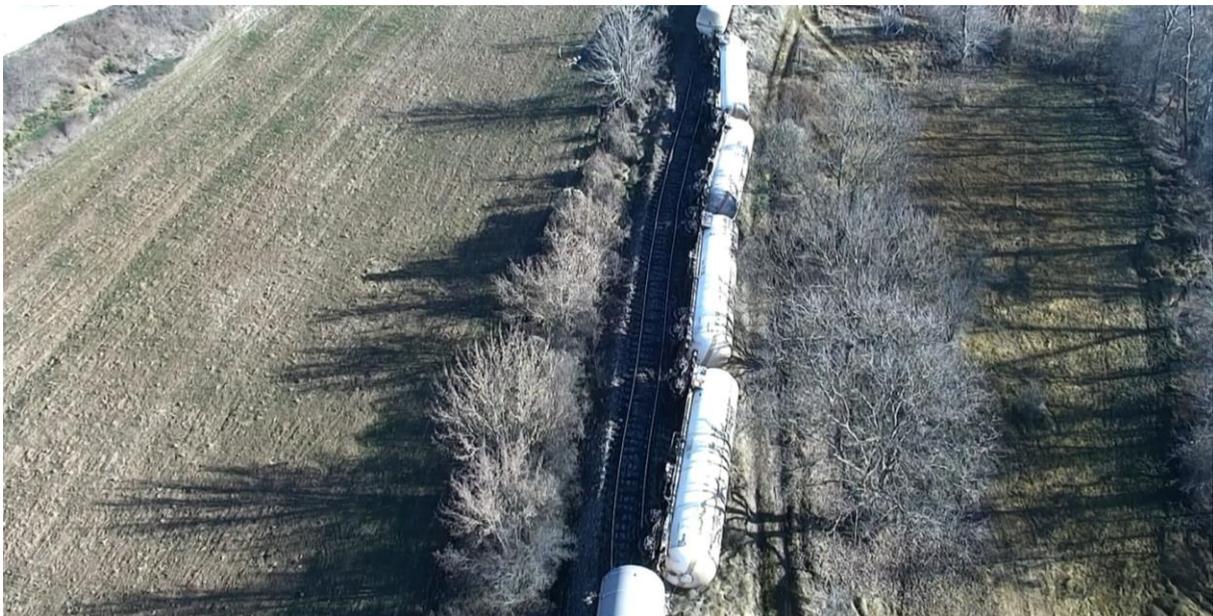
**Figure 3.1.2:** Appearance of the point of overturning of the wagons-tanks  
(source: MUP, Sector for Emergency Situations)

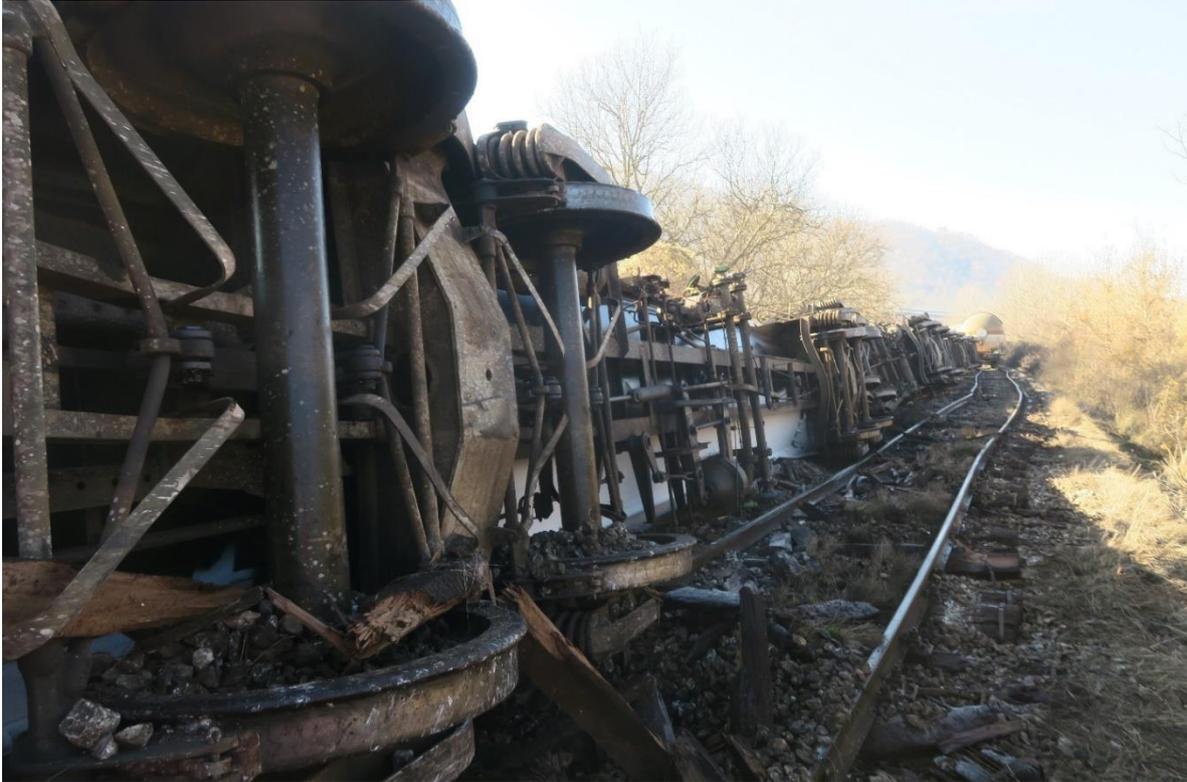
**Figure 3.1.3:** Appearance of the derailed wagons

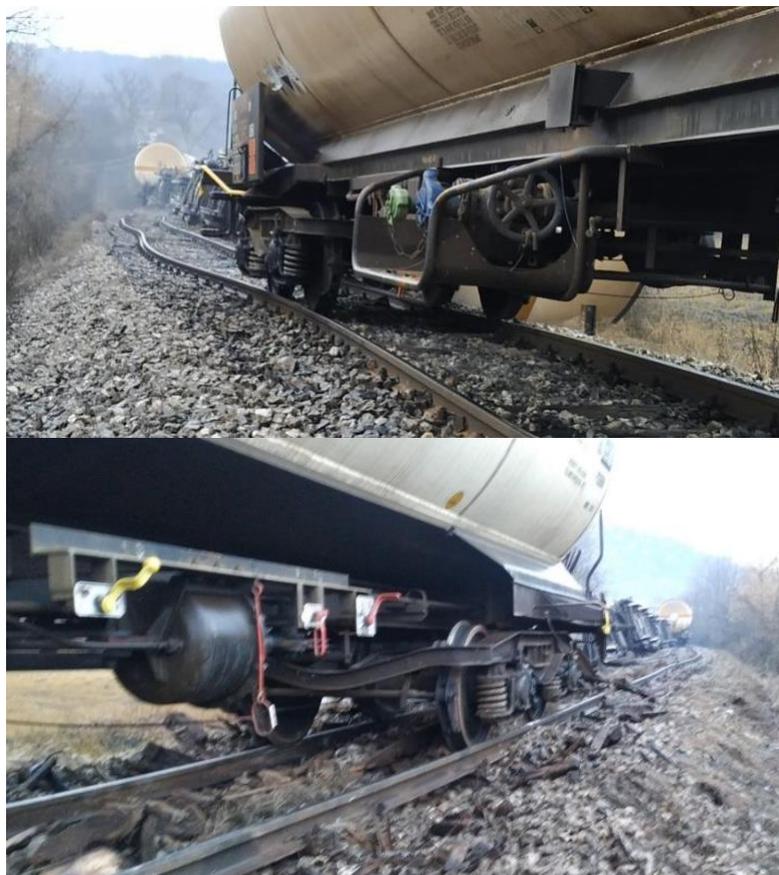
**Figure 3.1.4:** Appearance of the derailed ninth (up) and fourteen wagon (down) (source: “IŽS” a.d.)

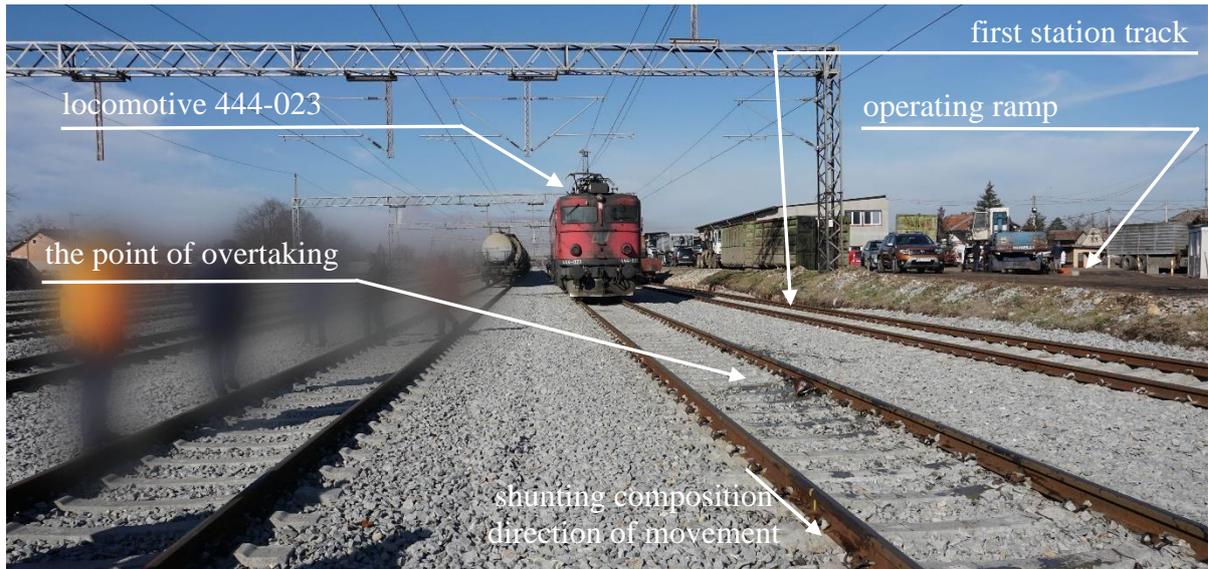
Under these conditions, there occurred an overtaking of the pulled shunting composition on the auxiliary worker. The overtaking occurred in such a way with the head of the locomotive 441-510 (locomotive dozer blade) hitting the auxiliary worker, who fell off the track from the impact, after which the entire shunting composition crossed over him. On that occasion, the auxiliary worker suffered severe bodily injuries, from which he died on the spot.

**Figure 4.1.1.1:** The appearance of the serious accident after the overtaking of the shunting composition on the railway worker (view from direction of the switch block 2 to the station facility)

The direct and immediate cause of this serious accident is that the auxiliary worker, employed by the railway infrastructure manager “IŽS” a.d. was on the second track of Mala Krsna station at the time of the shunting composition arrival, which is contrary to Article 16, paragraph 1 under 1. and 18. of the Rulebook on special measures of protection at work in railway traffic (“Official Gazette of the SRS”, No. 19/85), thus creating a dangerous situation related to the occurrence of this serious accident.

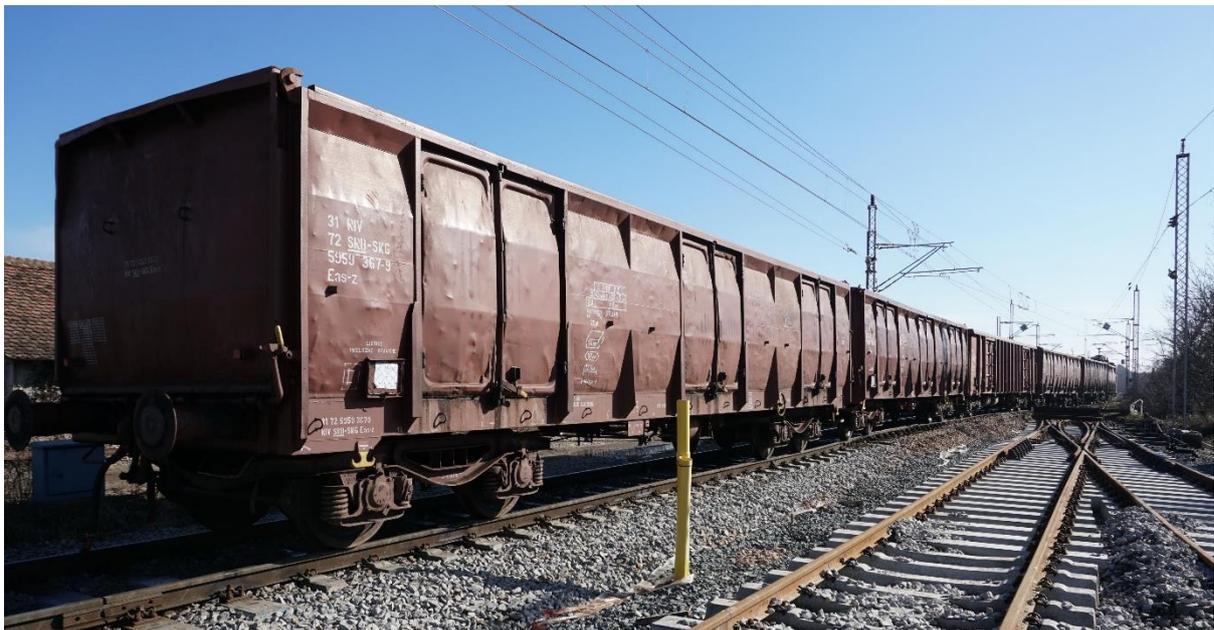
Since the staff on the shunting composition did not notice that there was an overtaking, the pulled shunting composition continued driving until it got off the second station track and stopped at the switch block 2, where it was planned as part of the shunting work. The occurrence of the serious accident in question was first noticed by the train driver and the shunter who were on the locomotive 444-023, which was shunting along the second track from the direction of the train dispatcher's office in the direction of the switch block 2, just behind the shunting composition involved in the serious accident.

**Figure 4.1.1.2:** The appearance of the place where the shunting composition stopped on the switch block 2 after serious accident (view from the direction of the station Mala Krsna to the open track in direction towards the stations Požarevac and Osipaonica)

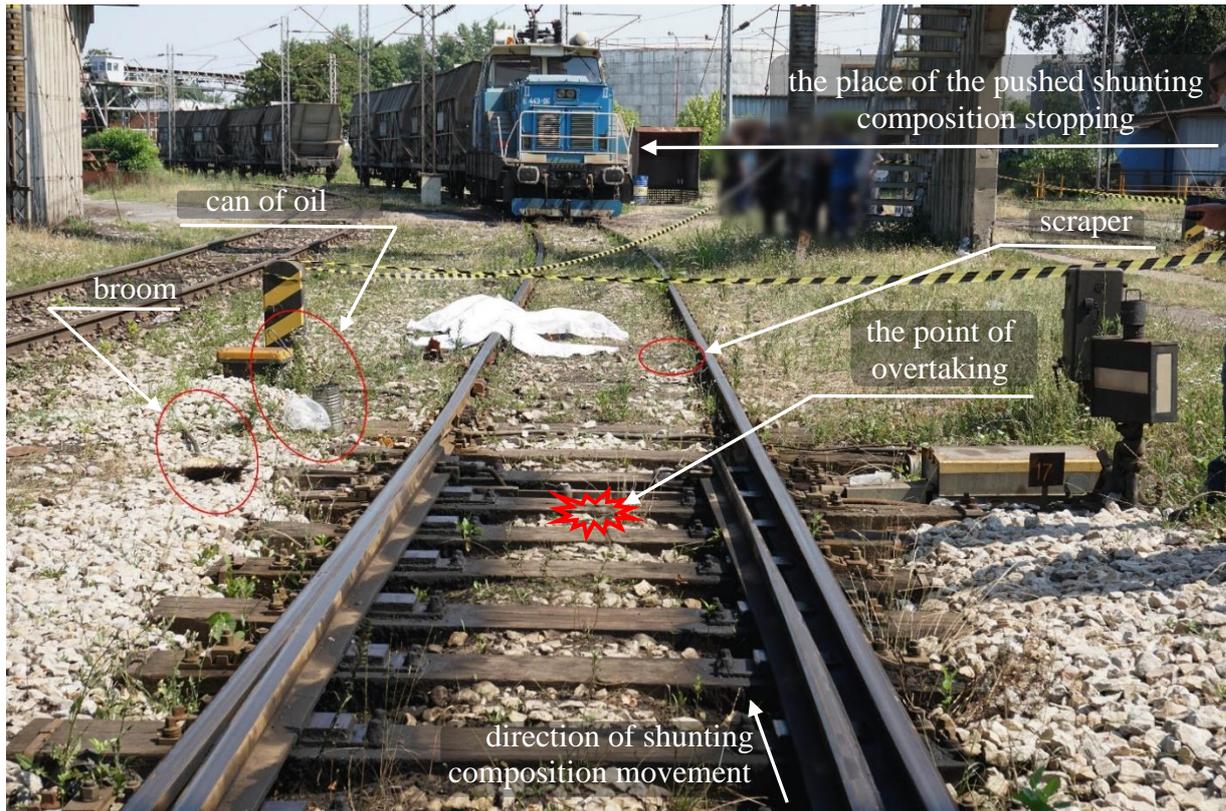
Under these conditions, there occurred an overtaking of the pushed shunting composition on the railway worker. The overtaking occurred when the front of the shunting composition (middle of the front part of the Arbel type wagon, Faboo series individual No. 43 72 6531 314-2) hit a railway worker in the area of his back, who from the impact fell off the track, after which the entire shunting composition crossed over him. On that occasion, the railway worker suffered severe bodily injuries, from which he died on the spot.

**Figure 4.2.1.1:** The appearance of the place of the serious accident after the collision of the pushed shunting composition on the railway worker (view from the direction of the second track to the second turnout track)

The direct and immediate cause of the serious accident is that the railway worker, employed in “Pro Tent” d.o.o. from Obrenovac was located on the second track of Obrenovac station in the area of the switch No. 17, performing cleaning of switches at the time of the pushed shunting composition arrival, which is contrary to Article 12, paragraph 1 and Article 16, paragraph 1 under 1 of the Rulebook on special occupational safety measures in railway traffic (“Official Gazette of SRS”, No. 19/85), which created a dangerous situation related to the occurrence of this serious accident.

**SR\_06/22** JP “EPS” Branch TENT from Obrenovac, to perform extraordinary training of the shunting staff (train driver, shunting operator and the shunter) in terms of proper execution of the shunting tasks, with special reference to the conditions for safe start and movement of the shunting composition, the position of the shunter and the shunting operator when driving the shunting composition, in accordance with the items 23, 116 and 117 of the Shunting Instruction 42 (“Official Gazette ZJŽ” No. 3/80, 6/83, 3/87, 4/88, 6/91 and 2/94), that is, the Article 75 of the Traffic Rulebook (“Official Gazette RS” No. 34/22).
