## ОКОНЧАТЕЛЕН ДОКЛАД

разследване на авиационно произшествие, реализирано на 07.06.2014 г. със самолет PIPER PA-28-161, рег. знаци YU-DDB, при извършване на полет за разпръскване на ваксина в района на с. Градище, област Шумен

investigation of an aviation incident, occurred on June 07, 2014 with PIPER PA-28-161, registration marks YU-DDB, while in a vaccine dispersal flight in the vicinity of Gradishte village, Shumen district

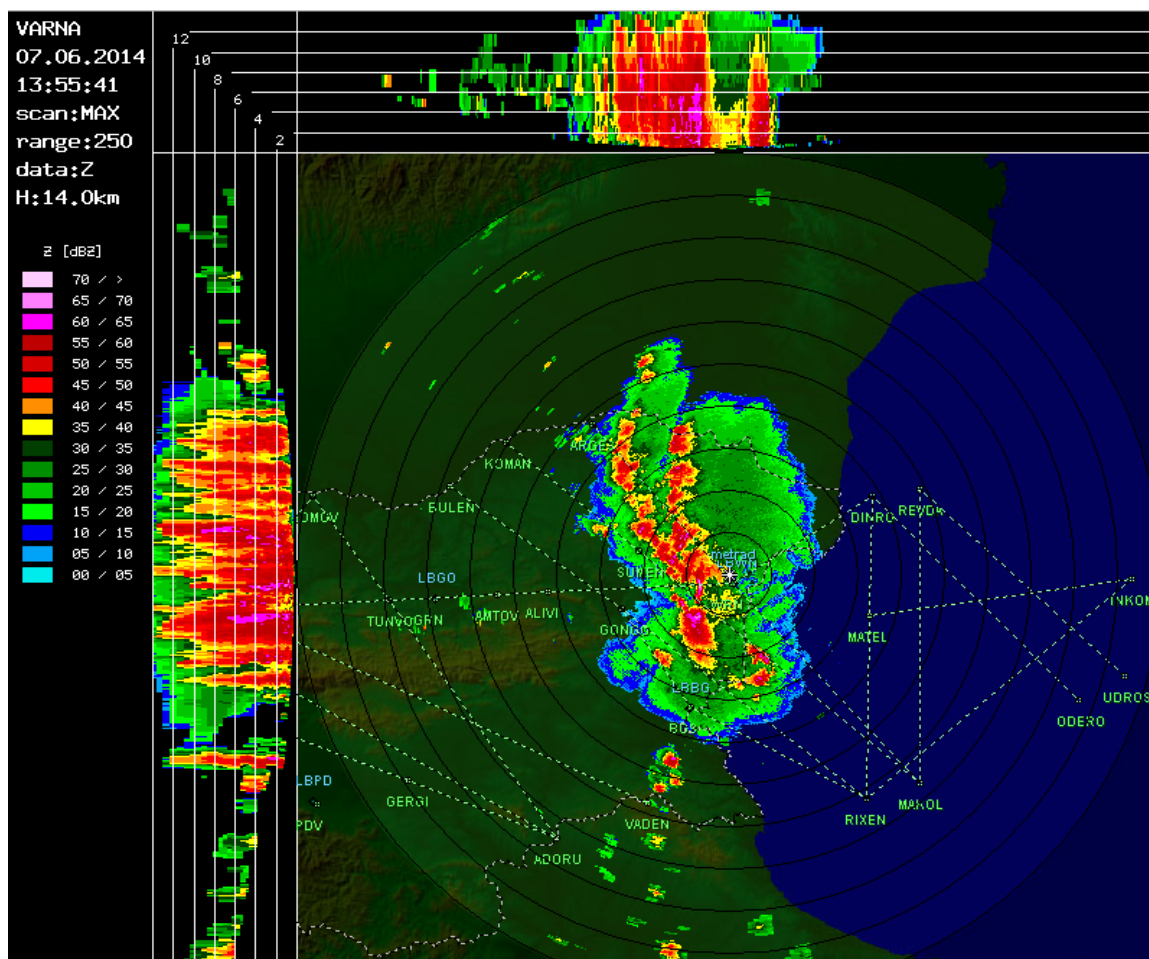
Развитието на шкваловата линия е видно от радарното изображение, показано на фиг. 1.

Заклучение: Преобладаващите метеорологични условия в периода 14:00...17:00 h местно време часа за района на Шумен-Търговище са били:

Вятър североизточен 2-5m/s, Видимост – над 10km, Облачност разкъсана до ясно.

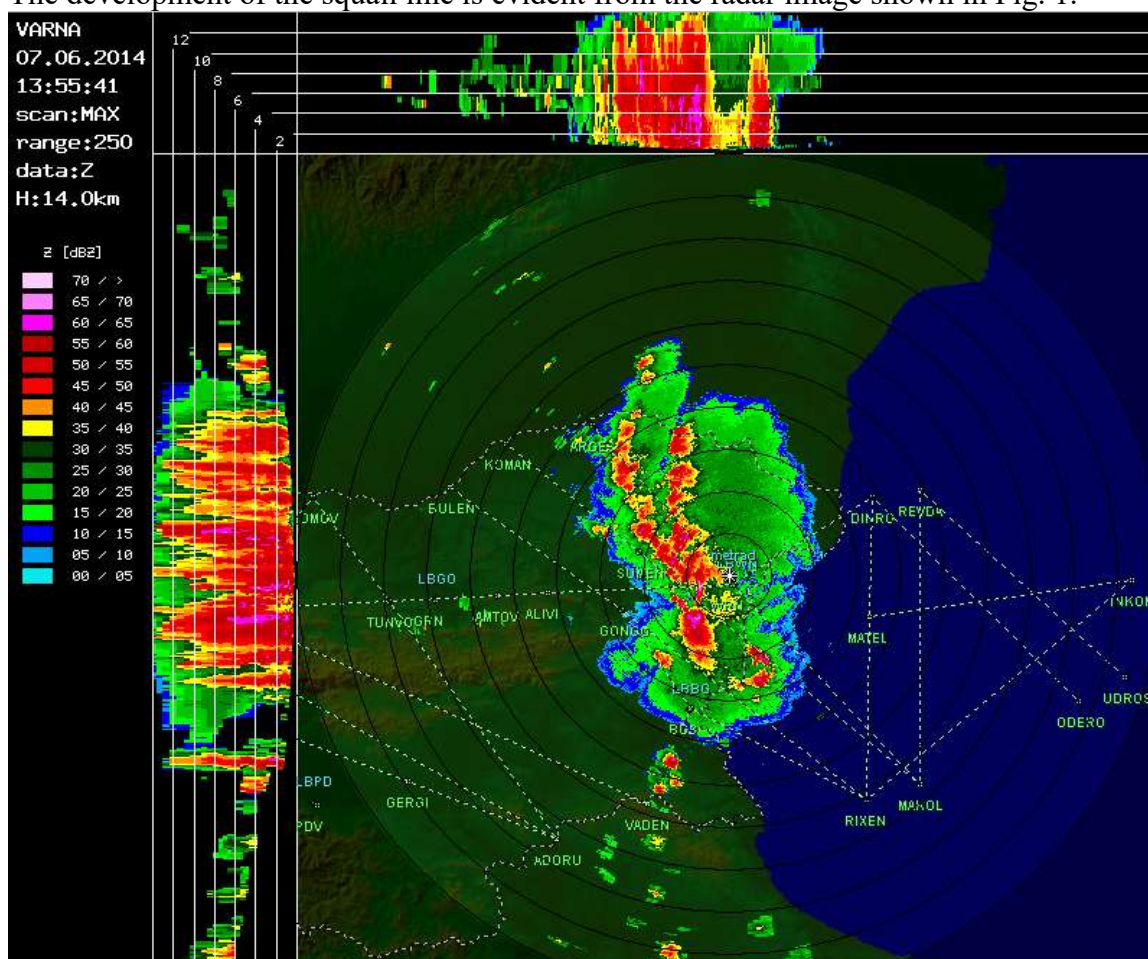
The development of the squall line is evident from the radar image shown in Fig. 1.

Conclusion: The predominant meteorological conditions from 14:00 hrs till 17:00 hrs local time for Shumen-Targovishte region are: Wind from northeast 2-5 m/s, Visibility - over 10 km, Clouds - scattered to clear. With the northeast squall line approaching between 16:00 hrs and 17:00

hrs local time, there was a strong unoriented wind with gusts of 12 to 20 m/s, conditions for reduced visibility due to rainfall to 3-5 km, a cut wind, turbulence, increasing clouds to overcast with thunders.
