REPUBLIC OF SERBIA,
CENTER FOR INVESTIGATION OF ACCIDENTS IN TRAFFIC,
SECTOR FOR INVESTIGATION OF ACCIDENTS IN WATERBORNE TRAFFIC,
NEMANJINA 11, 11000 BELGRADE

No.: 342-00-7/2023-03-34

Date: 28.12.2023.

ANNUAL REPORT FOR 2022

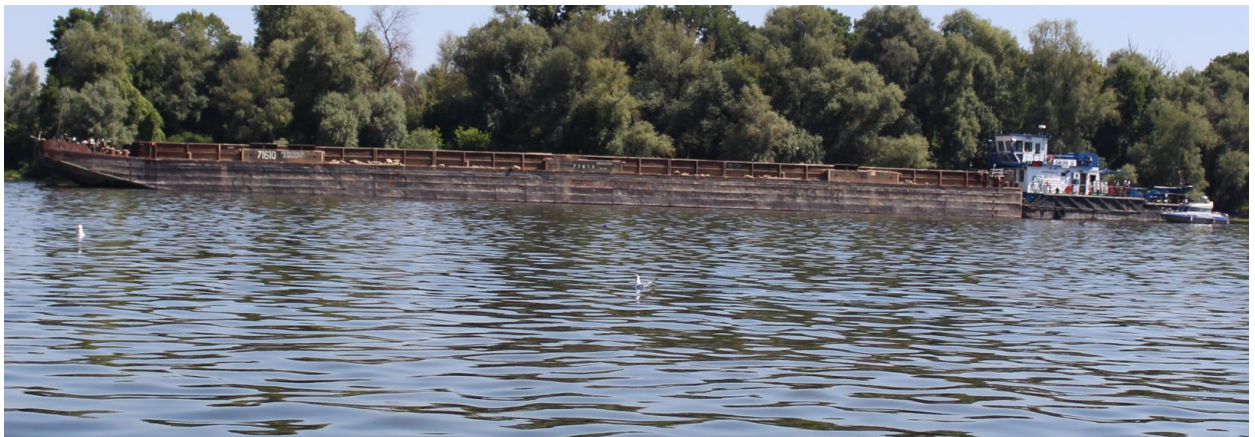
Figure 4.1.1.1. Pushed composition of the vessel "GAJO II"

On August 6th, 2022. around 00:50 a.m., the vessel "GAJO II" in downstream navigation with two empty barges of registration marks "71611" and "71610" in one row, has hit the floating object under construction, which was anchored by the left bank of the Sava River at a position of 7 km + 250 m. Due to the impact of the downstream pushed composition of the vessel "GAJO II" a damage to the floating object has occurred.

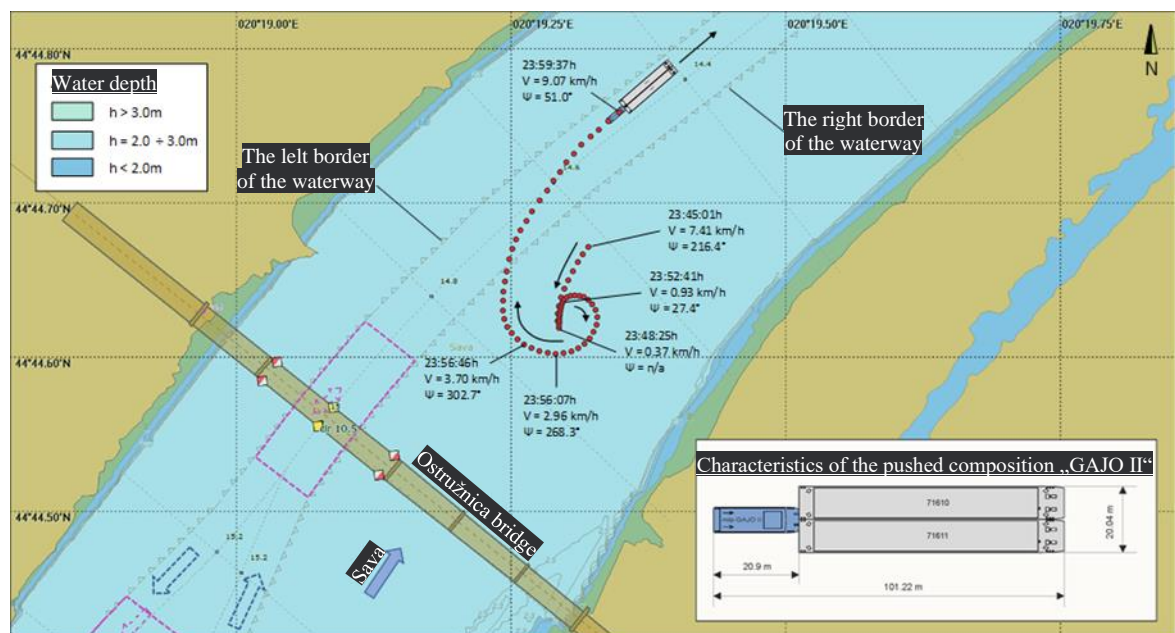
Figure 4.1.1.3. Trajectory of the pushed composition „GAJO II“ immediately after the start of the downstream sail

In Figure 4.1.1.3. the trajectory of the cargo composition "GAJO II" in the period between 11:45 p.m. and 11:59:37 p.m. is shown, as well as the dimensions of the waterway, which are determined by the left and right borders of the waterway. Having crossed the right border of the waterway at 11:58 p.m., at a speed of 7.22 km/h, relative to the bottom, the downstream pushed composition of the vessel "GAJO II" sailed into the axis of the waterway, gradually increasing its speed.

At 11:59:37 p.m. at a speed of 9 km/h, the pushed composition is sailing downstream along the left border of the waterway, which is shown in Figure 4.1.1.3. Initially, on this section, the vessel "GAJO II" first sails upstream about 100 m, then turns to sail downstream and descends downstream about 30 m at a speed of 3.6 km/h, which is shown in Figure 4.1.1.3. After that, the speed of the pushed composition begins to increase gradually, which indicates the beginning of sailing towards Ada Huja.

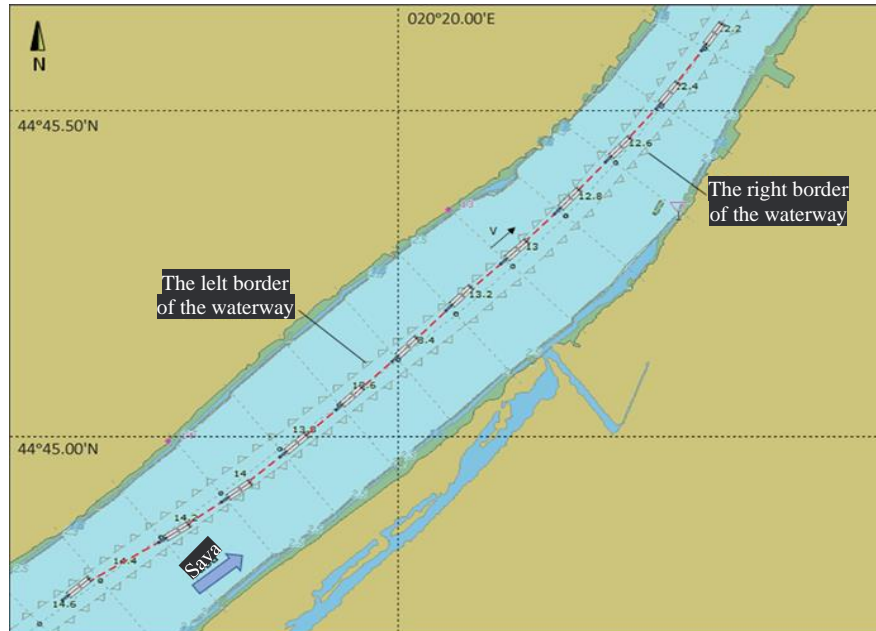
Figure 4.1.1.4. Trajectory of the pushed composition „GAJO II“ in the section between 14 km + 500 m and 12 km + 600 m

In Figure 4.1.1.4. the trajectory of the downstream pushed composition "GAJO II" in the next 2.300 m is shown. It is clearly observed that the pushed composition follows the waterway, moving between the left and right borders.

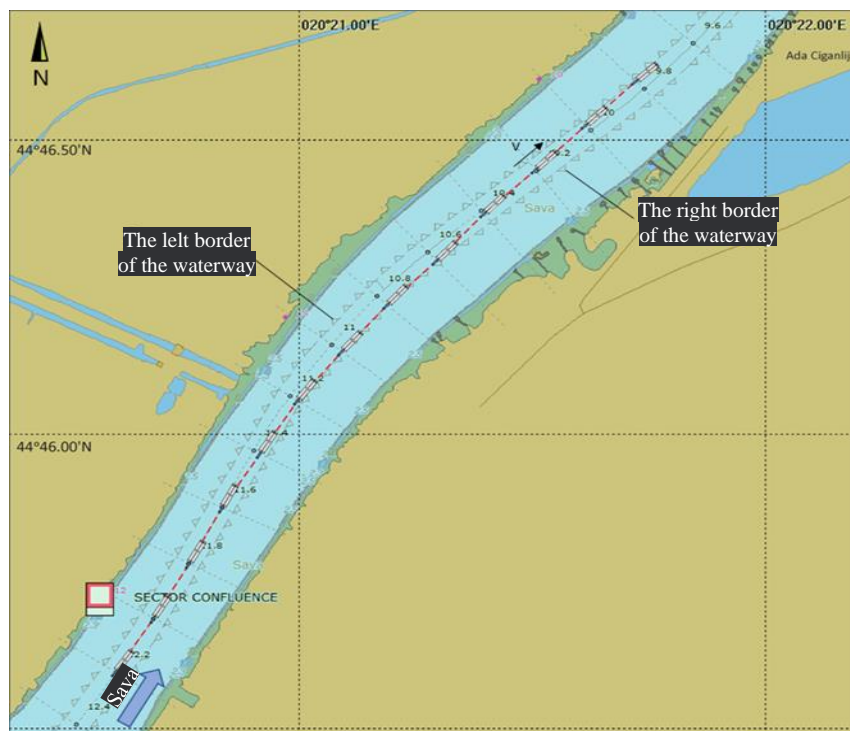
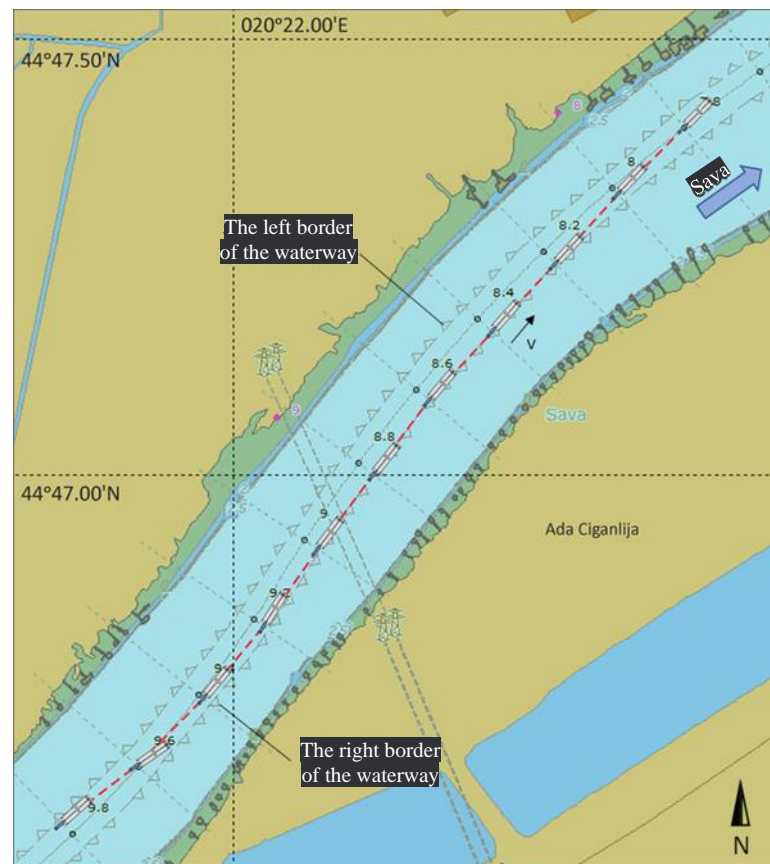
The trajectory of the downstream pushed composition "GAJO II" in the next 4 km is shown in Figures 4.1.1.5. and 4.1.1.6. The course and speed of the pushed composition are uniform and range between $\Psi=40^\circ$ and $\Psi=50^\circ$, that is, around 9.5 - 10.0 km/h.

From the trajectory shown in Figures 4.1.1.5. and 4.1.1.6. it can be observed that the pushed composition of "GAJO II" always sails within the limits of the waterway, at a uniform speed, which indicates the correctness of the drive, steering device and control devices, as well as the navigation safety algorithm sets.

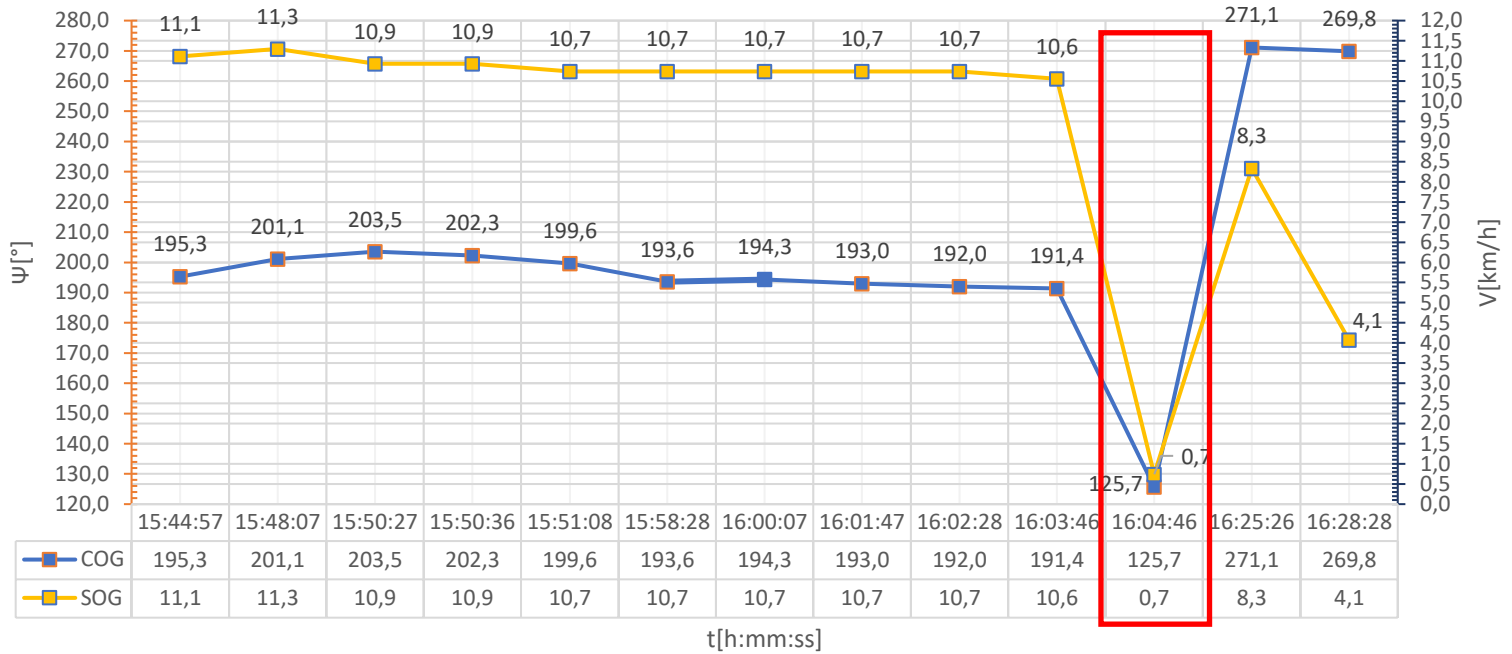
Figure 4.2.1.3.

- The above navigation parameters are constant until the moment of the impact of the downstream vessel composition on the right bank at 04:04:46 p.m. at the position of 1145 km + 400 m, when the speed of the formation drops to 0.7 km/h, at the moment of the initial impact, change of speed and course in time are given on the diagram (Figure 4.2.1.3.). After hitting the shore, the vessel composition suddenly changes its cardinal course over the left side and amounts to $\Psi=125.7^\circ$ and continues sailing towards the right edge of the waterway, i.e. towards the left bank (Figure 4.2.1.4.), where it performed the maneuver of anchoring the composition closer to the shore, out of the waterway at 4:10 p.m. at 1145 km.
