**REPUBLIC OF SERBIA**  
**CENTER FOR INVESTIGATION OF ACCIDENTS IN TRANSPORT**  
**SECTOR FOR INVESTIGATION OF ACCIDENTS IN RAILWAY TRAFFIC**  
**Nemanjina 11, 11000 Belgrade**

**No.: 340-00-9/2019-02-21-1**

# **ANNUAL REPORT FOR 2018**

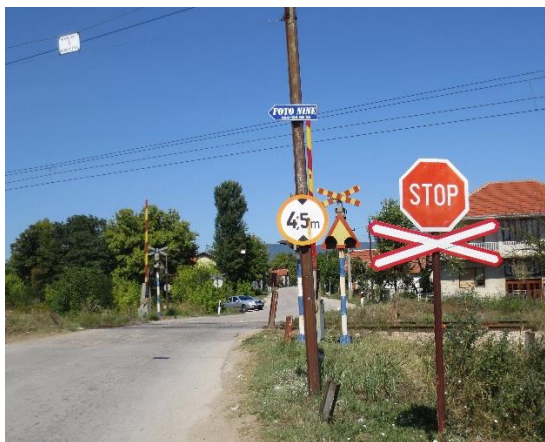
On 21.08.2017. at 19:38 at the *km* 268+318 of the main arterial route *E 70/E 85*: Belgrade - Mladenovac -Lapovo - Niš - Preševo - state border - (Tabanovce), at level crossing PBE 1, secured with automatic devices on the level crossings (half-barriers and road light and sound signaling), which is located in the area of the switch block 2 of unmanned TK station Brestovac (between entrance signal from the direction of crossing Pečenjevce and first entrance switch), there was an overtaking of the train No. 4905 on the road vehicle brand Ford type Galaxy, registration number NI 161-CL.

**Figure 4.2.1.1:** The appearance of the crossing (from the direction of the settlement Kutleš)

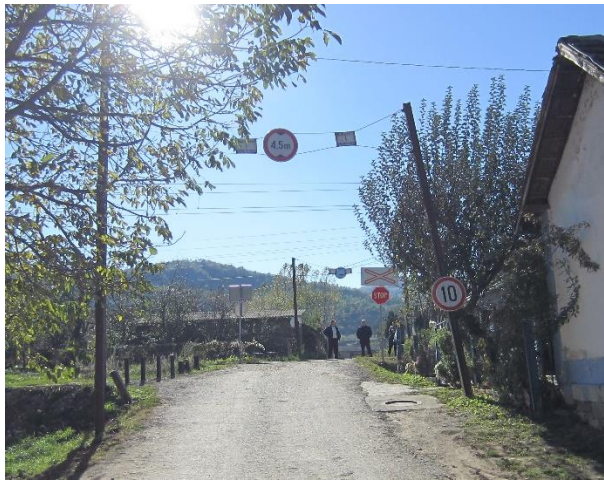
On 09.10.2017. at 20:26 on the main arterial route E 70/E 85: Belgrade - Mladenovac - Lapovo - Niš - Preševo - state border - (Tabanovce), in the area of the populated settlement Gornje Polje, at level crossing ensured with the traffic signs on the road and the necessary visibility zone, which is located on the open track between the stations Grdelica and Predejane at km 304+277, there has been overtaking of the train No. 4905 on the road passenger vehicle of the brand Opel type Astra 1.4/5, registration number LE 058-LR.

**Figure 4.4.1.1:** Appearance of the level crossing (view from the direction of the center of Grdelica)

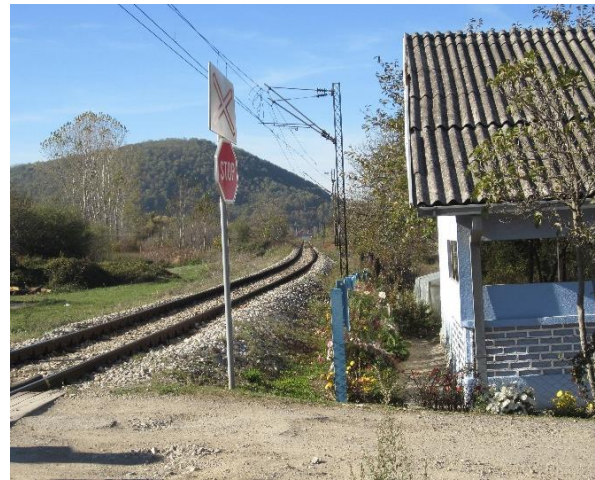
**Figure 4.4.1.2:** Appearance of the facility – the guard

The road vehicle of the brand Opel type Astra 1.4/5 registration number LE 058-LR was moving the uncategorized road from the direction of Grdelica to the settlement Oraovica. By coming to the level crossing at km 304+277, the vehicle did not stop in front of the crossing, but continued to move and in the area of the level crossing has entered the profile of the track just before the train arrived.
